Commercial Roof Condition Inspection Form

Applicant/Insured Name: 400 Beach Road Condo Assoc. Application/Policy#:					
Location Address Inspected: 400 Beach Road, Vero Beach Building Number Inspected:					
Date of Inspection: April 12, 2023 FI 32963					
·		 			
This Roof Condition Inspection Form must be completed and signed by a Florida-licensed professional. The form will not be accepted without the dated signature of one of the following appropriately licensed inspectors: Licensed roofing contractor Licensed general contractor Note: This form does not verify windstorm loss mitigation features.					
ROOF (Clear photos showing the entire roof's surface and condition must be submitted with this form.)					
Primary Roof:					
Covering material: Concrete Tile		If updated (check one):		Overall Condition of Roof:	
Roof age (years): 18 years				Excellent	
		_S Full replacement	X	Good	
	4/05	Partial replacement		Fair (explain)	\mathbf{X}
Roofing Permit Verified: **		% of replacement	_	Poor (explain)

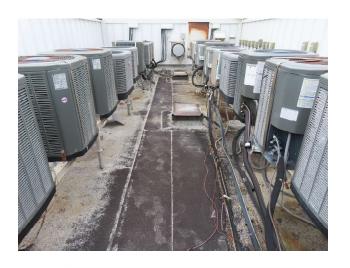
Granule loss

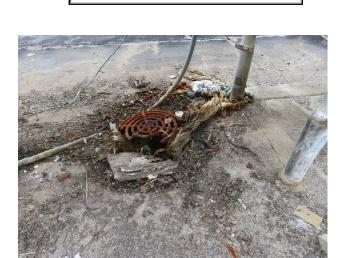
Damaged drainage grate

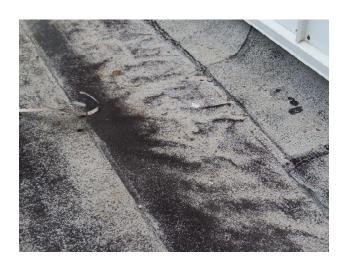
Blisters

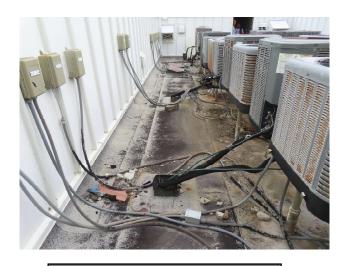
Granule loss

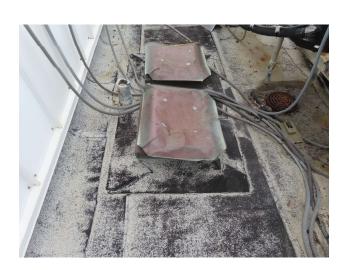
Granule loss

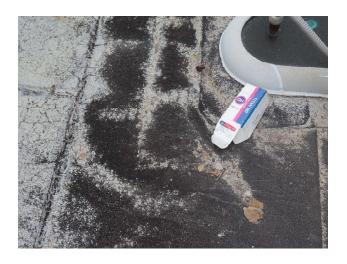
Blisters

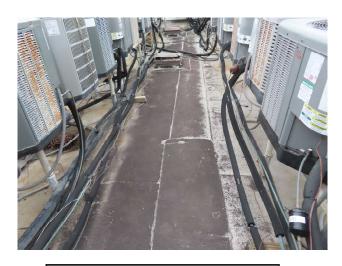
Granule loss
