Milestone Inspection Phase I Report

Bryn Mawr Ocean Towers

5055, 5059, and 5061 N Highway A1A

The intention of this report is to develop a substantially completed Milestone Inspection Phase One report per the requirements of Senate Bill 4-D and Florida Statutes 553.899.

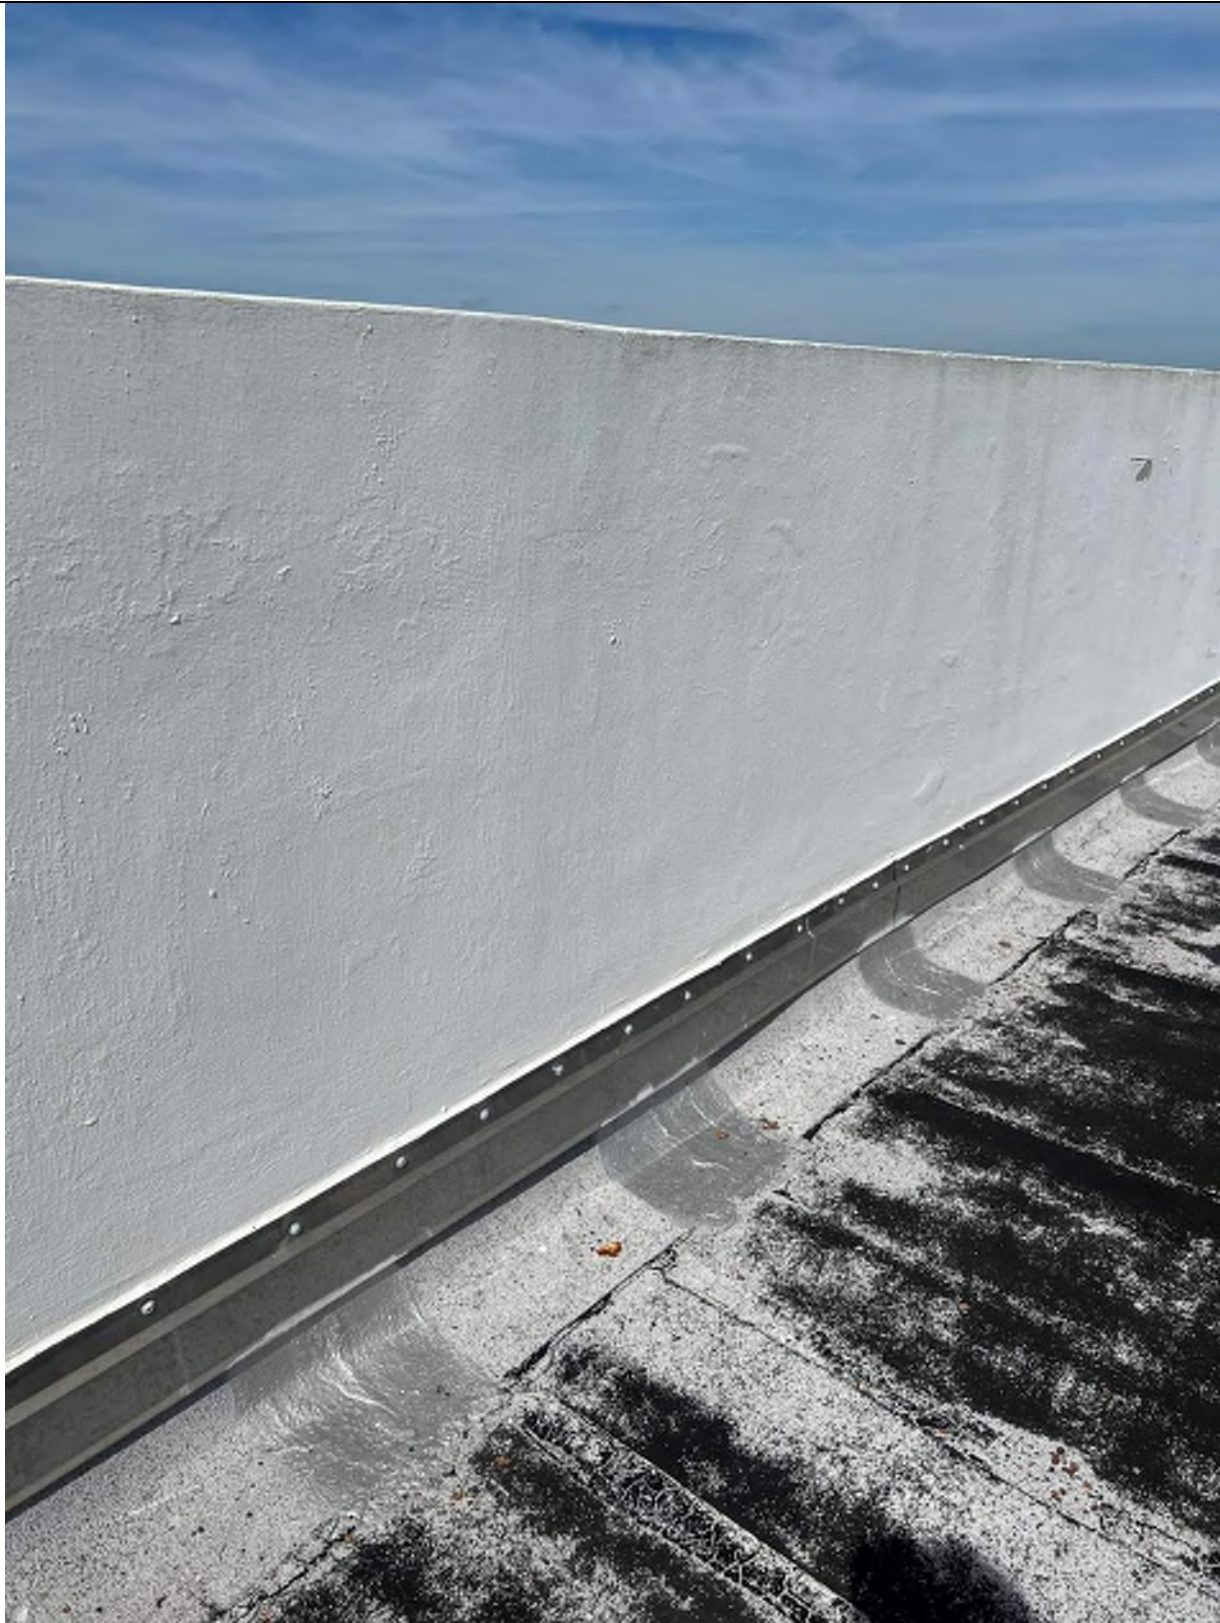
Picture 1.a.8.1

1.a.7. Roof vents and flashings – Primary building roof	Roof flashings in fair overall condition – See pictures 1.a.7.1 and 1.a.7.2.
1.a.8. Parapet wall – Primary building roof	Parapet wall is in good overall condition. See picture 1.a.8.1

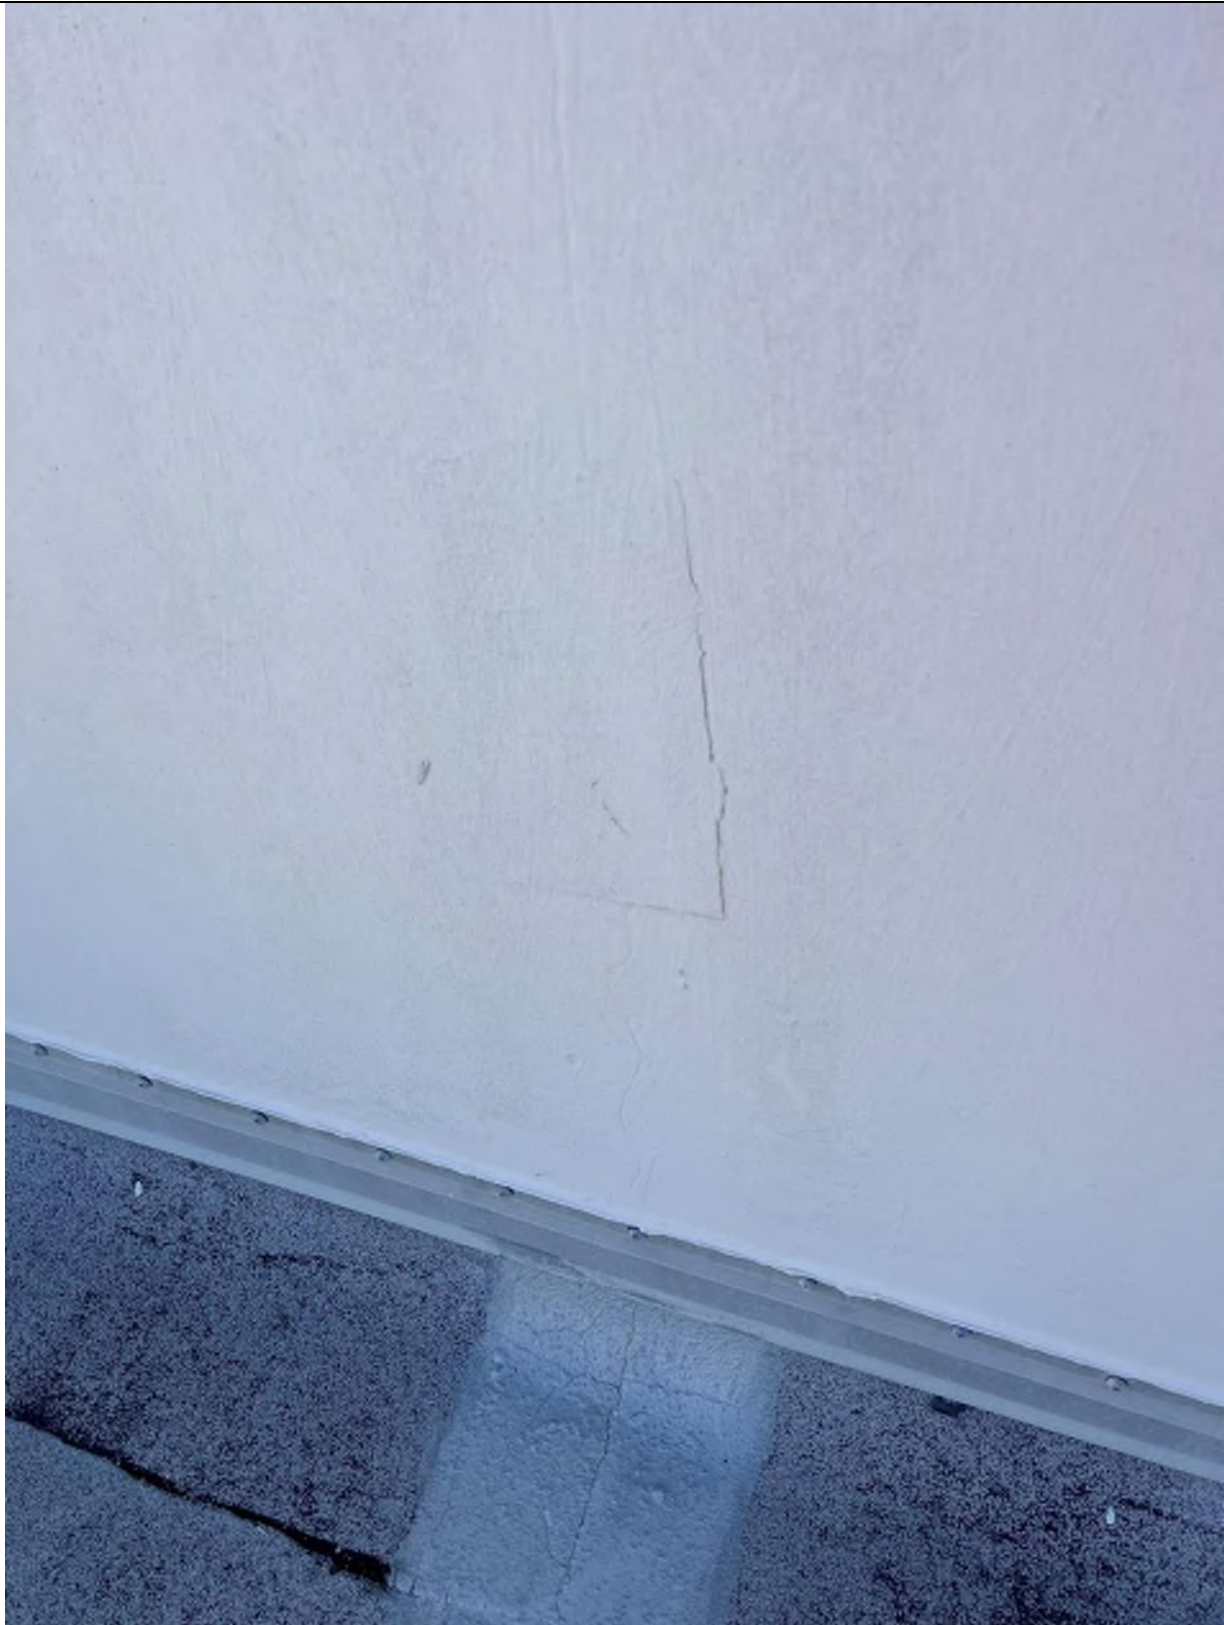
Picture 1.c.8.2

1.c.7. Roof vents and flashings – Primary building roof	Roof flashings in fair overall condition – See pictures 1.c.7.1 and 1.c.7.2.
1.c.8. Parapet wall – Primary building roof	8” concrete block wall, 64” tall, is showing signs of surface cracking. The cracks do not appear to be structural in nature; however, it is recommended to repair the surface cracks with Sto Guard Rapidseal applied with mesh. See pictures 1.c.8.1 and 1.c.8.2.

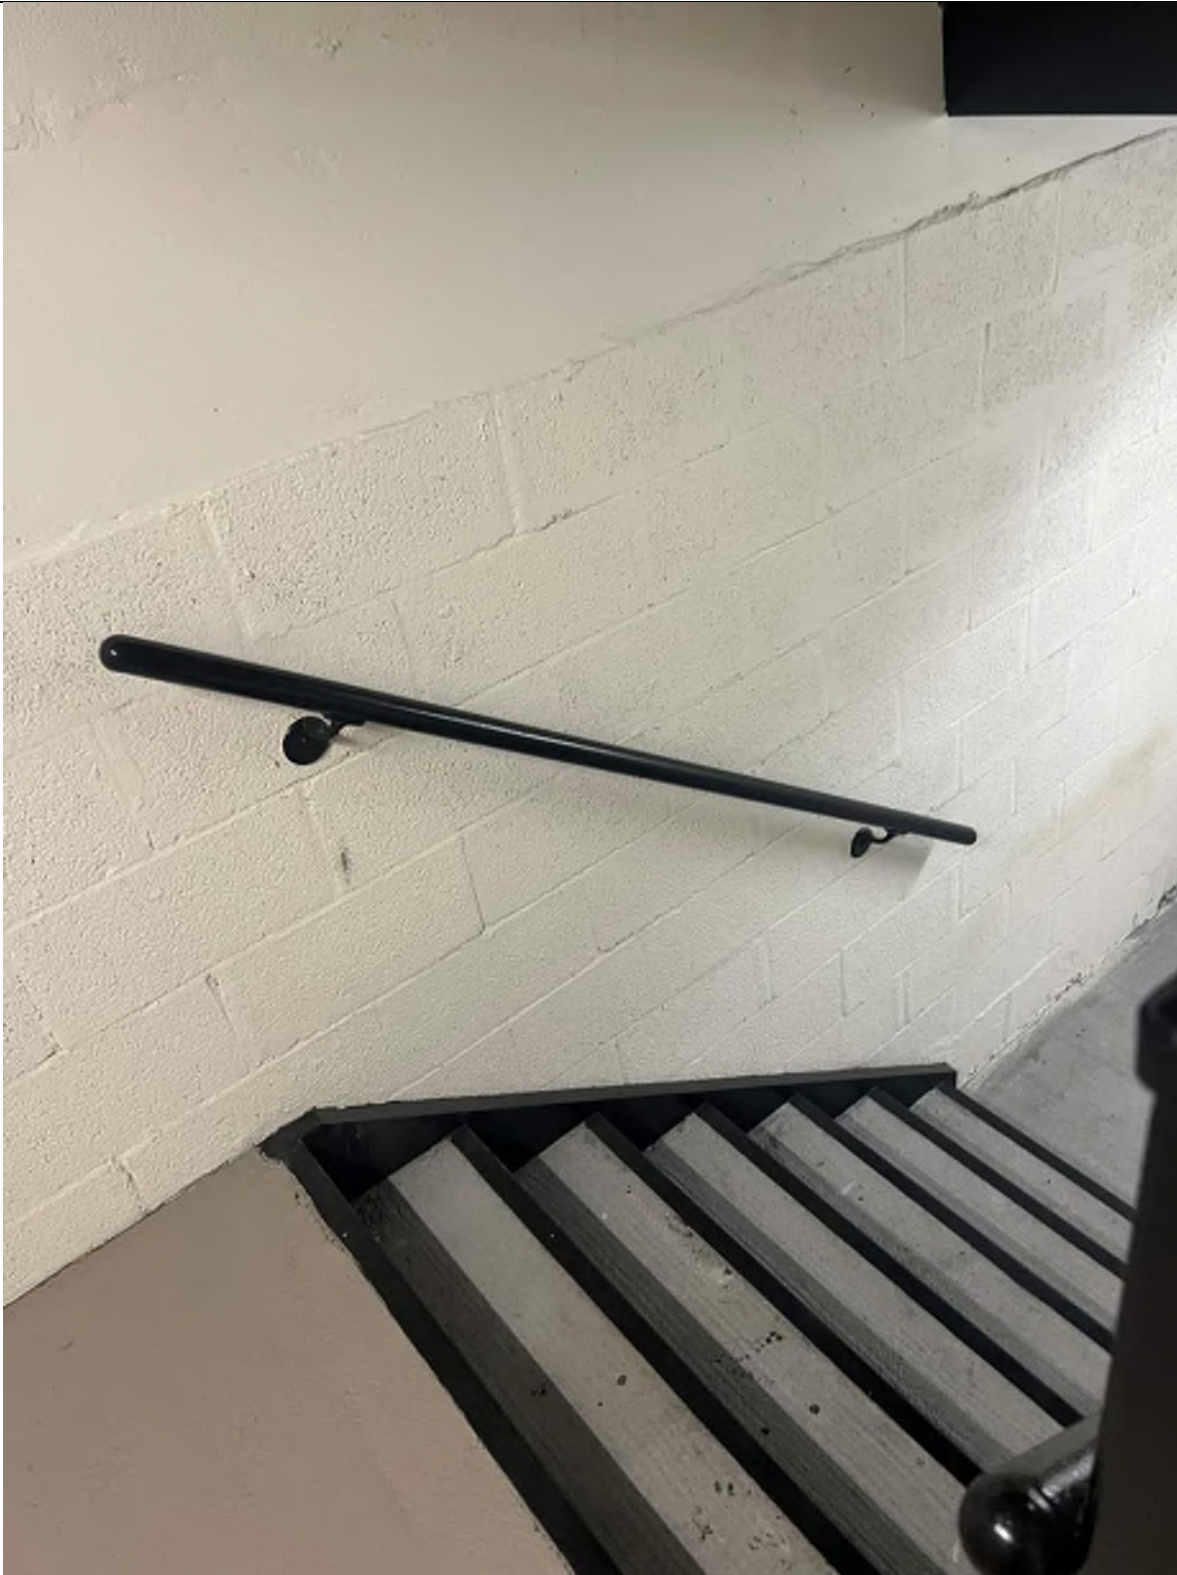
Picture 2.a.2.1

2.a.2 Overall condition	Overall good condition. The elevator shearwall and the exterior load bearing walls do not show signs of any settlement cracking or other deterioration. See picture 2.a.2.1.

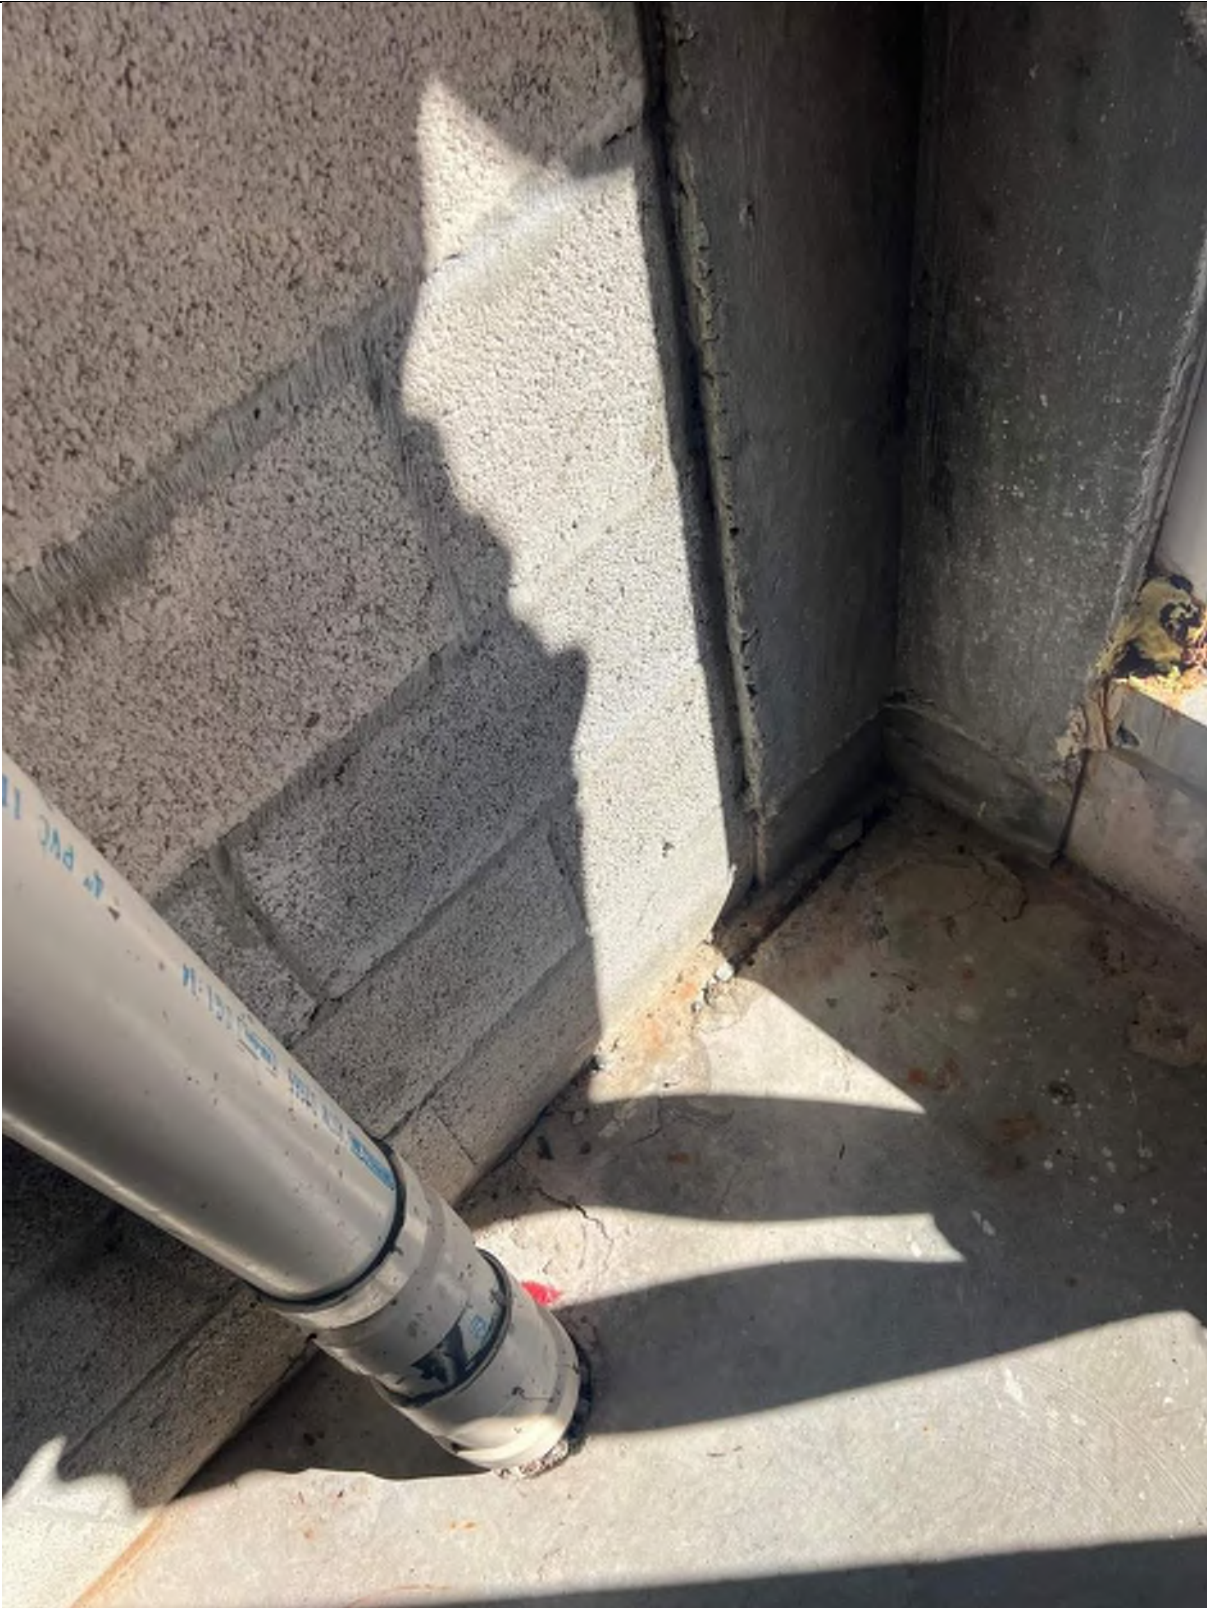
Picture 2.c.2.3

2.c.2 Overall condition	Overall good condition. The elevator shearwall and the exterior load bearing walls do not show signs of any settlement cracking; however, the C.M.U. block walls and the reinforced concrete beams/column at the central elevator tower above the roof level is showing signs of spalling. The floor slab at the interior of the doorway has some exposed reinforcement bar. This damage does not pose a risk to life safety; however, area shall be repaired according to A.C.I. and I.C.R.I. standards. See pictures 2.c.2.1, 2.c.2.2, and 2.c.2.3.

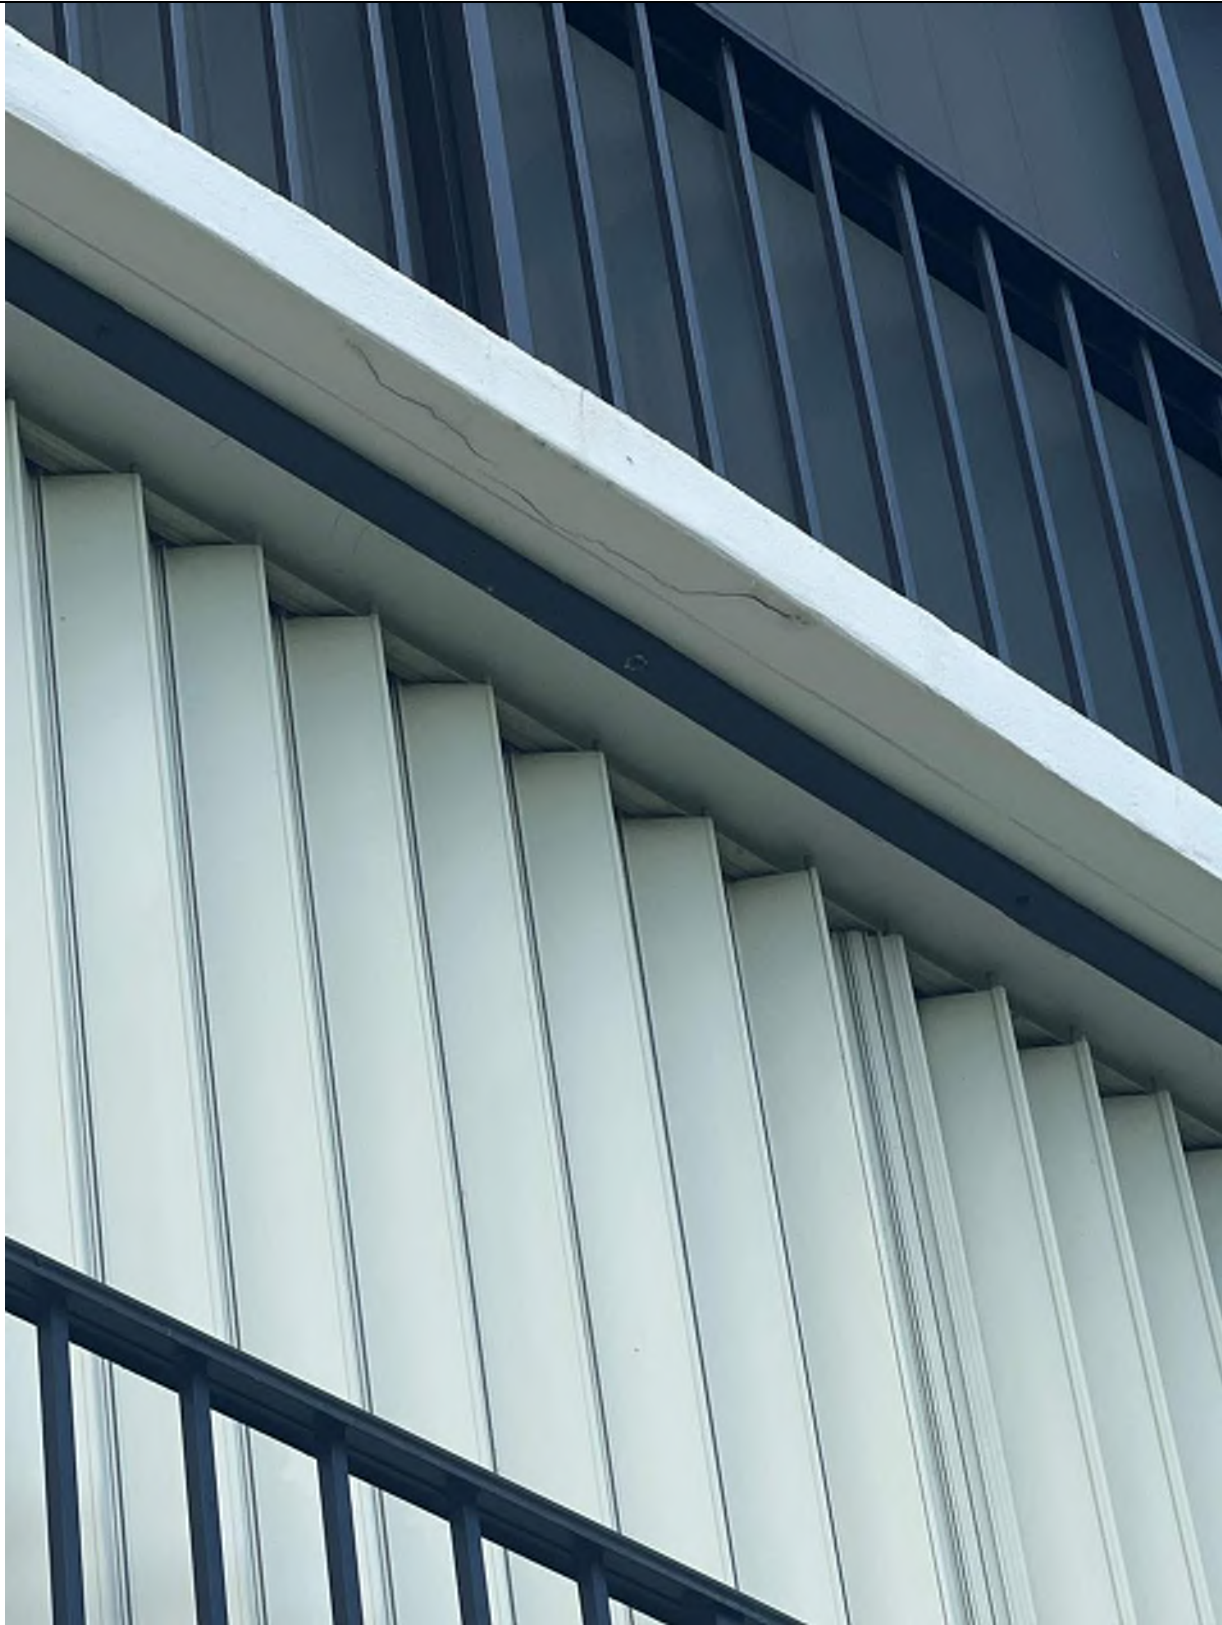
Picture 3.b.6.3

3.b.6. Structural concrete slab	Structural concrete slabs are 7" concrete "flat slabs" with #4 reinforcement bar every 12" each way. The concrete slabs are in good condition overall. See pictures 3.b.6.1, and 3.b.6.2. There are a couple balcony slabs showing the beginning stages of spalling; however, these areas do not pose a structural life safety concern. See picture 3.b.6.3.

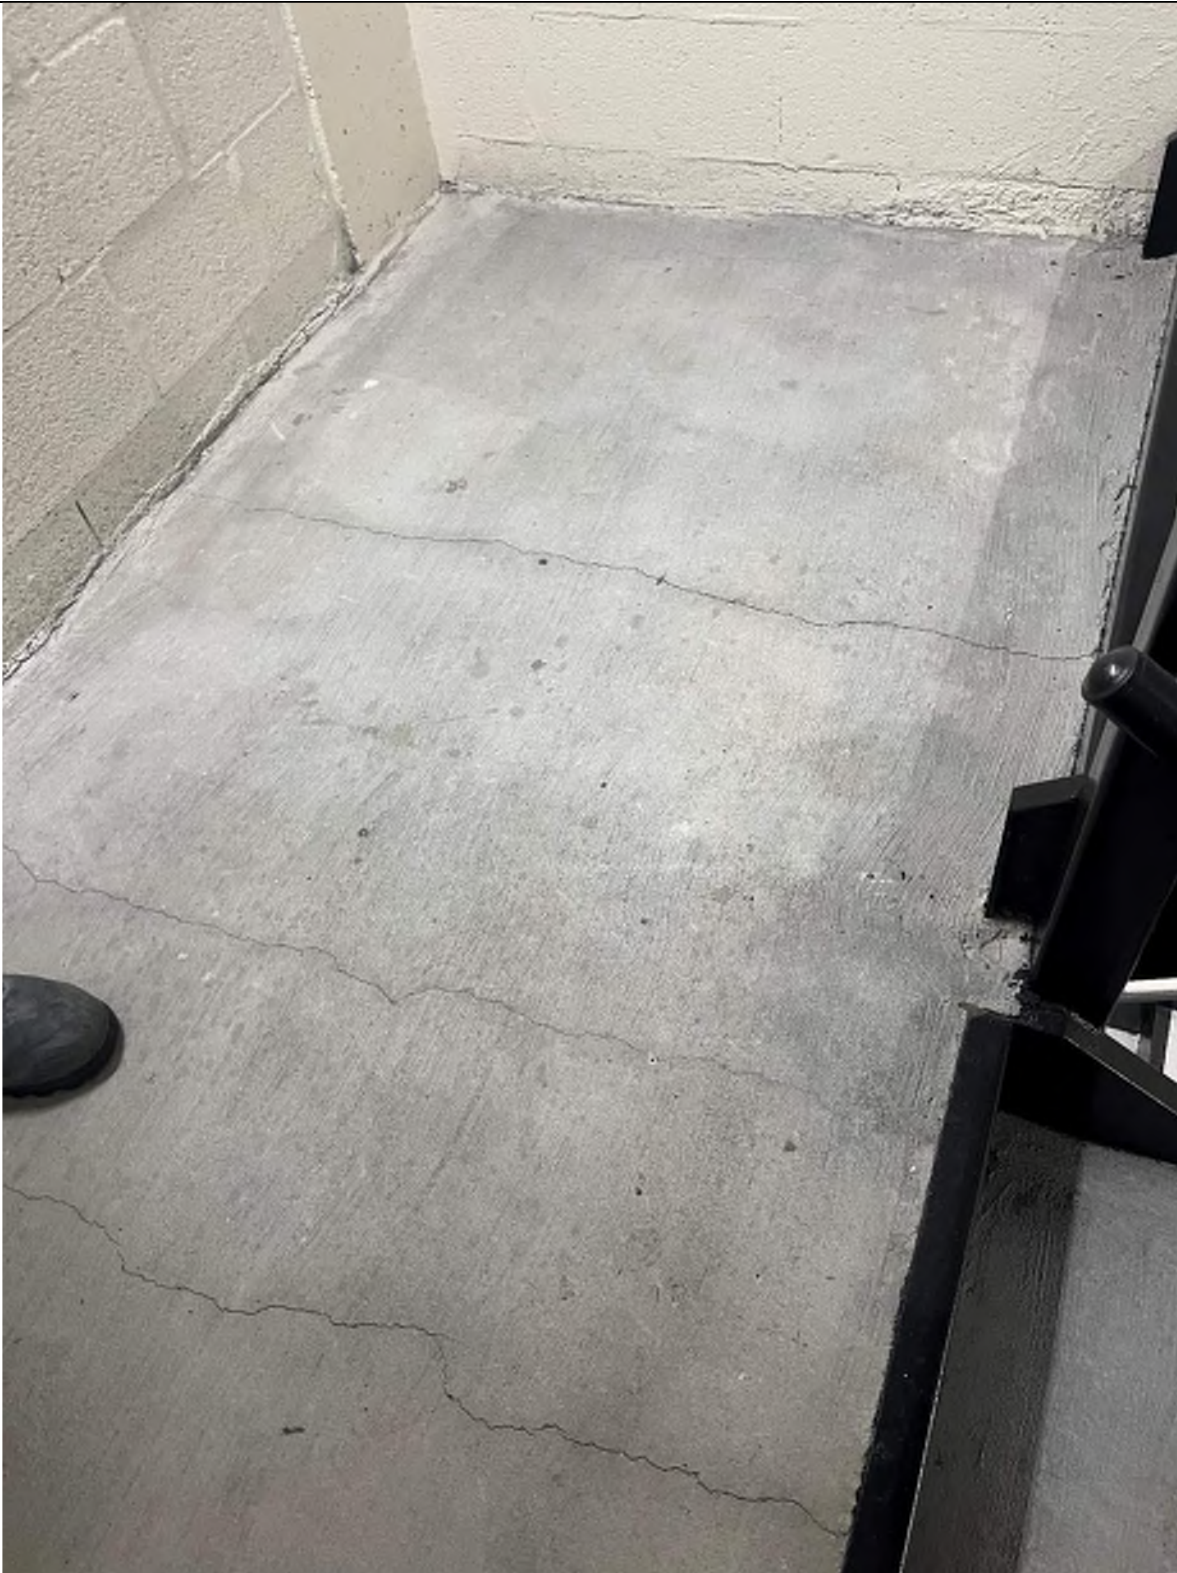
Picture 4.a.3.1

4.a.2. Plumbness	Good
4.a.3. Evidence of structural cracks	No; however, there is surface cracking throughout the interior pan deck metal composite stairs. These cracks shall be routed up to ¼” in depth and sealed with urethane caulk per section 3.3 of A.C.I. 224.1R-07. See pictures 4.a.3.1 and 4.a.3.2.

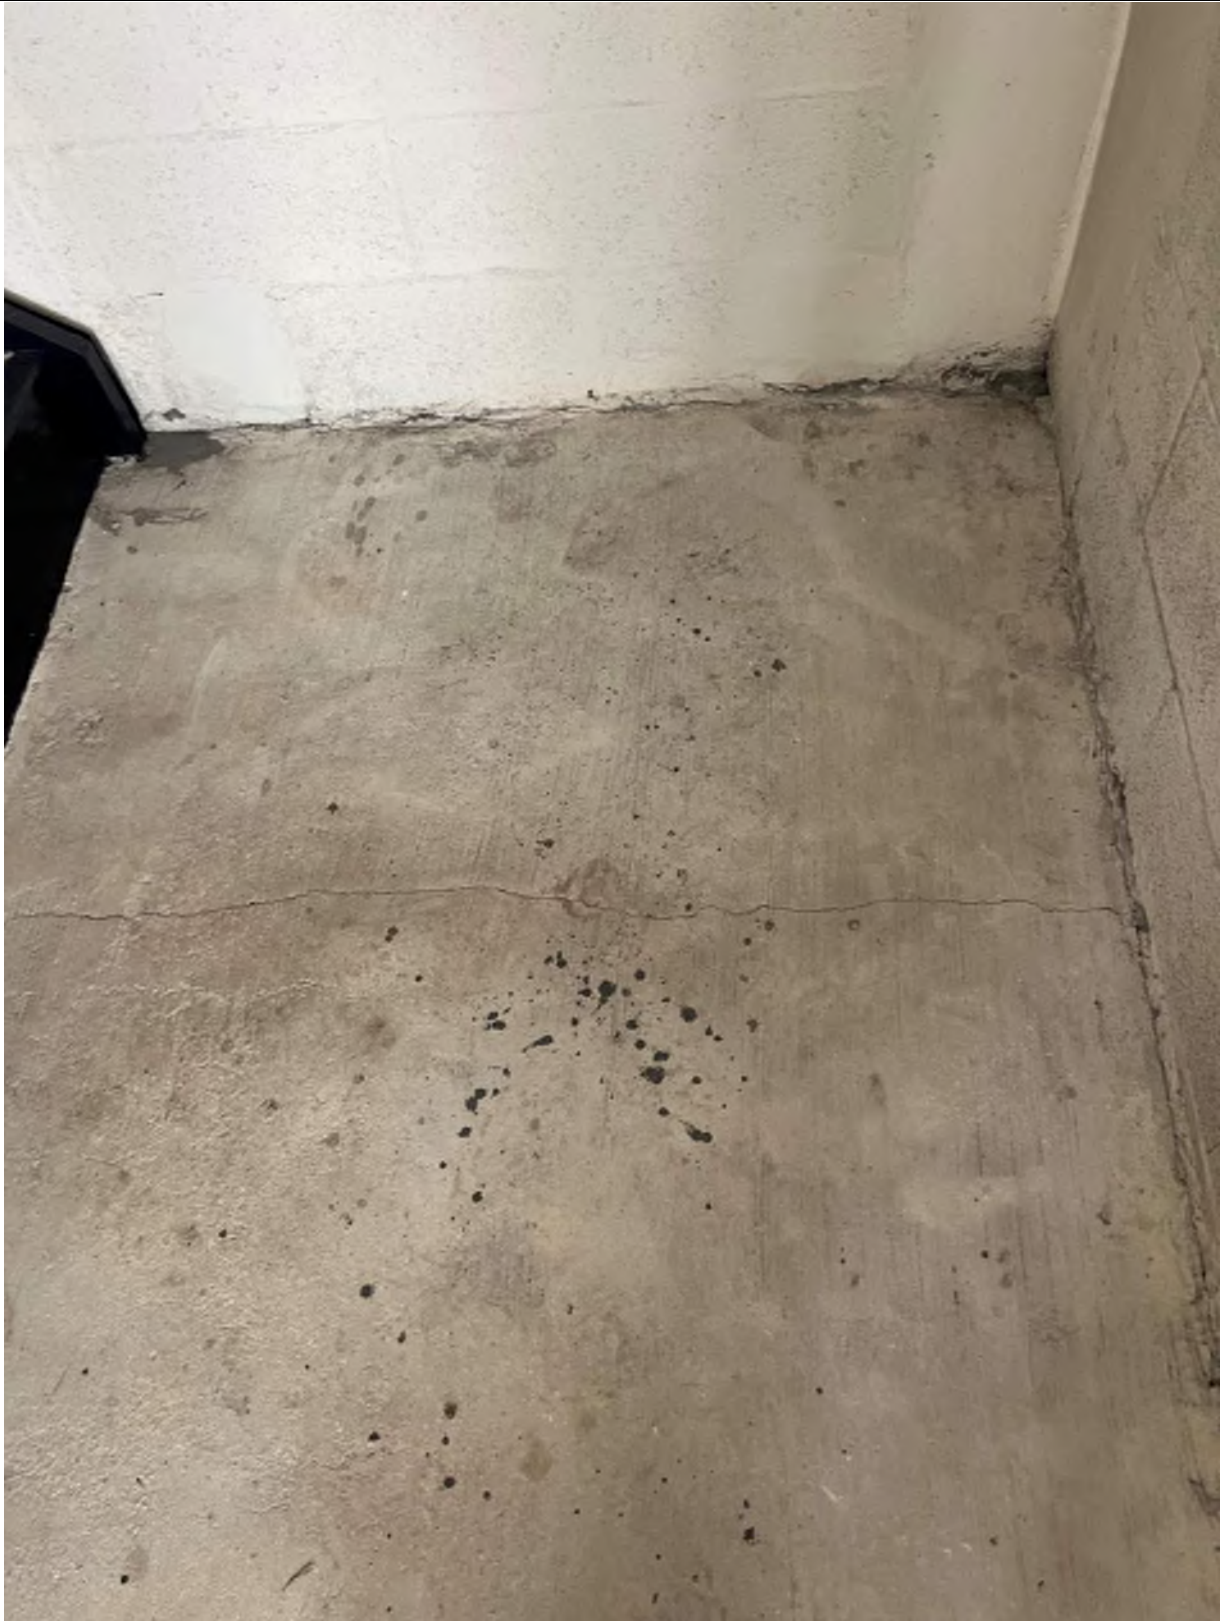
Picture 4.b.3.2

4.b.2. Plumbness	Good
4.b.3. Evidence of structural cracks	No; however, there is surface cracking throughout the interior pan deck metal composite stairs. These cracks shall be routed up to ¼” in depth and sealed with urethane caulk per section 3.3 of A.C.I. 224.1R-07. See pictures 4.b.3.1 and 4.b.3.2.

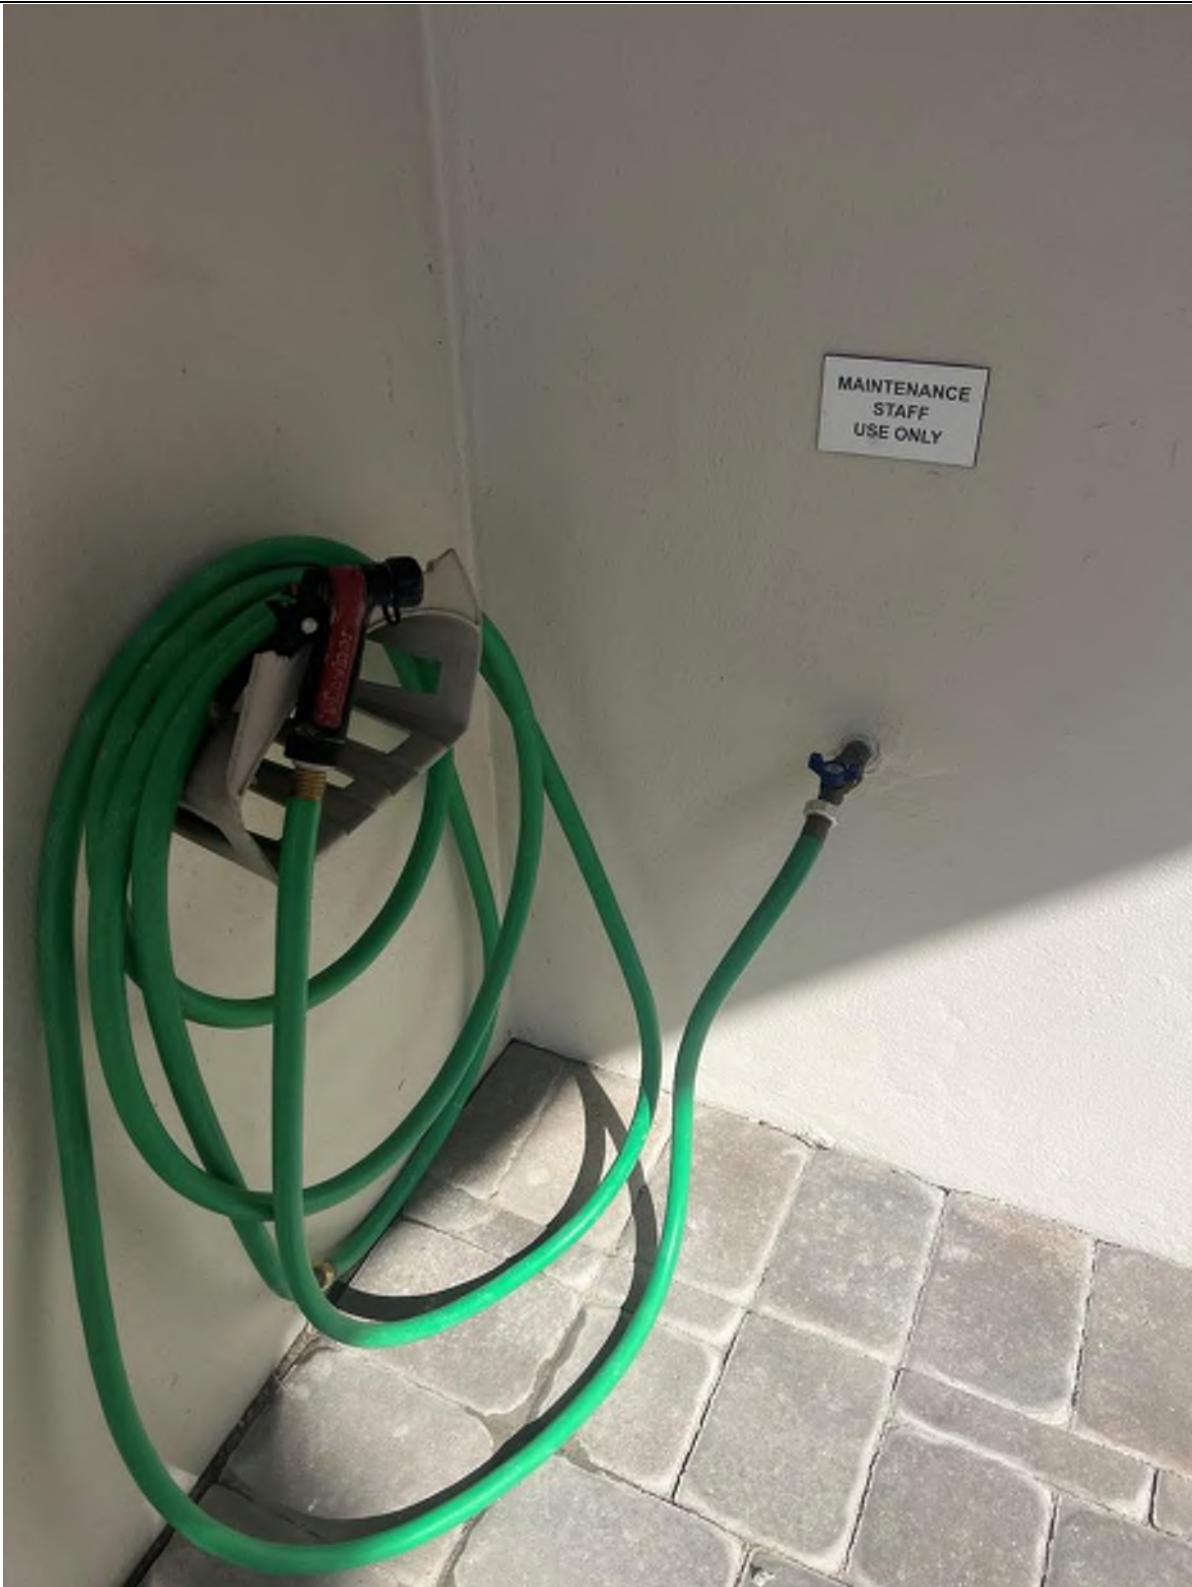
Picture 6.a.5.1

6.a.2. Water fountain useful life	10 years
6.a.3. Water fountain remaining useful life	4 years
6.a.4. Water fountain replacement cost	\$1,510
6.a.5. Domestic water connections	Domestic water connections in good condition with no signs of leaking. See picture 6.a.5.1.

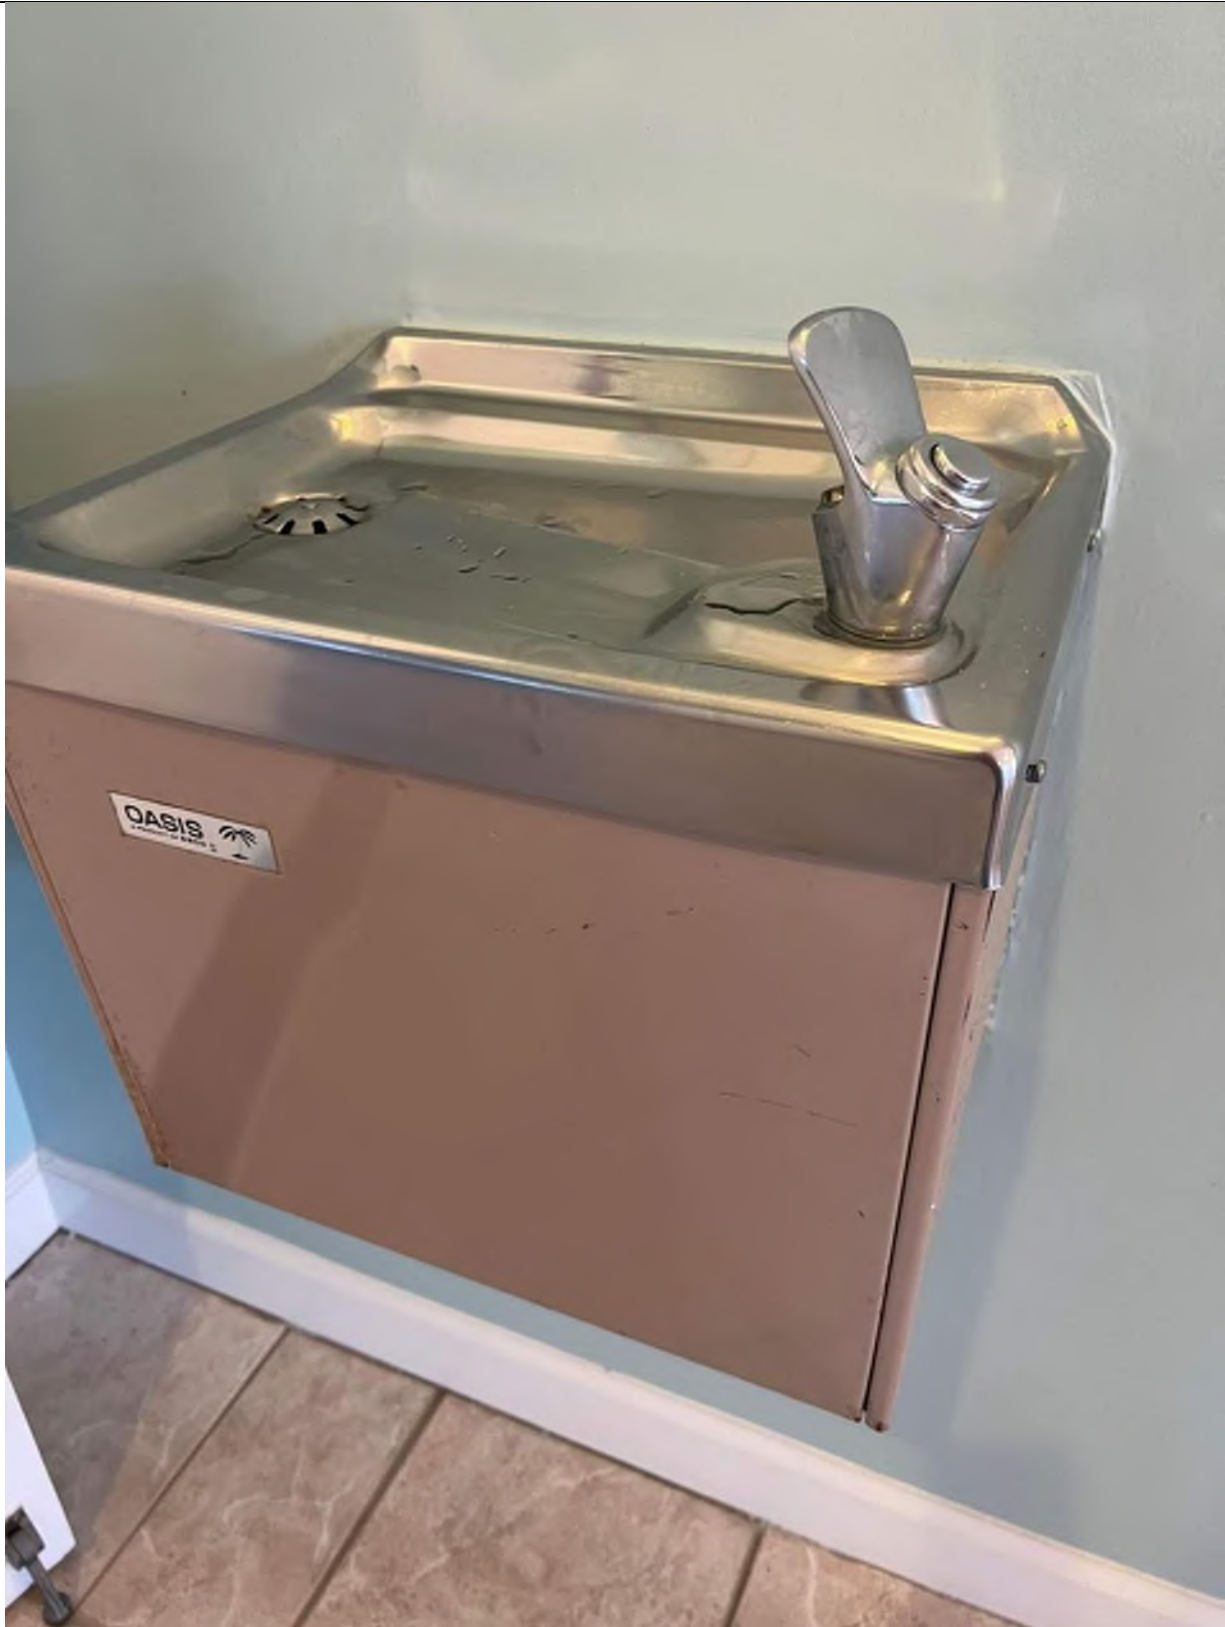
Picture 6.c.1.1

6.b.11. Signs of water staining in units due to broken fittings	No
6.c. 5055 N A1A (Building C)	
6.c.1. Water fountain	Water fountain in game room in good condition. See picture 6.c.1.1

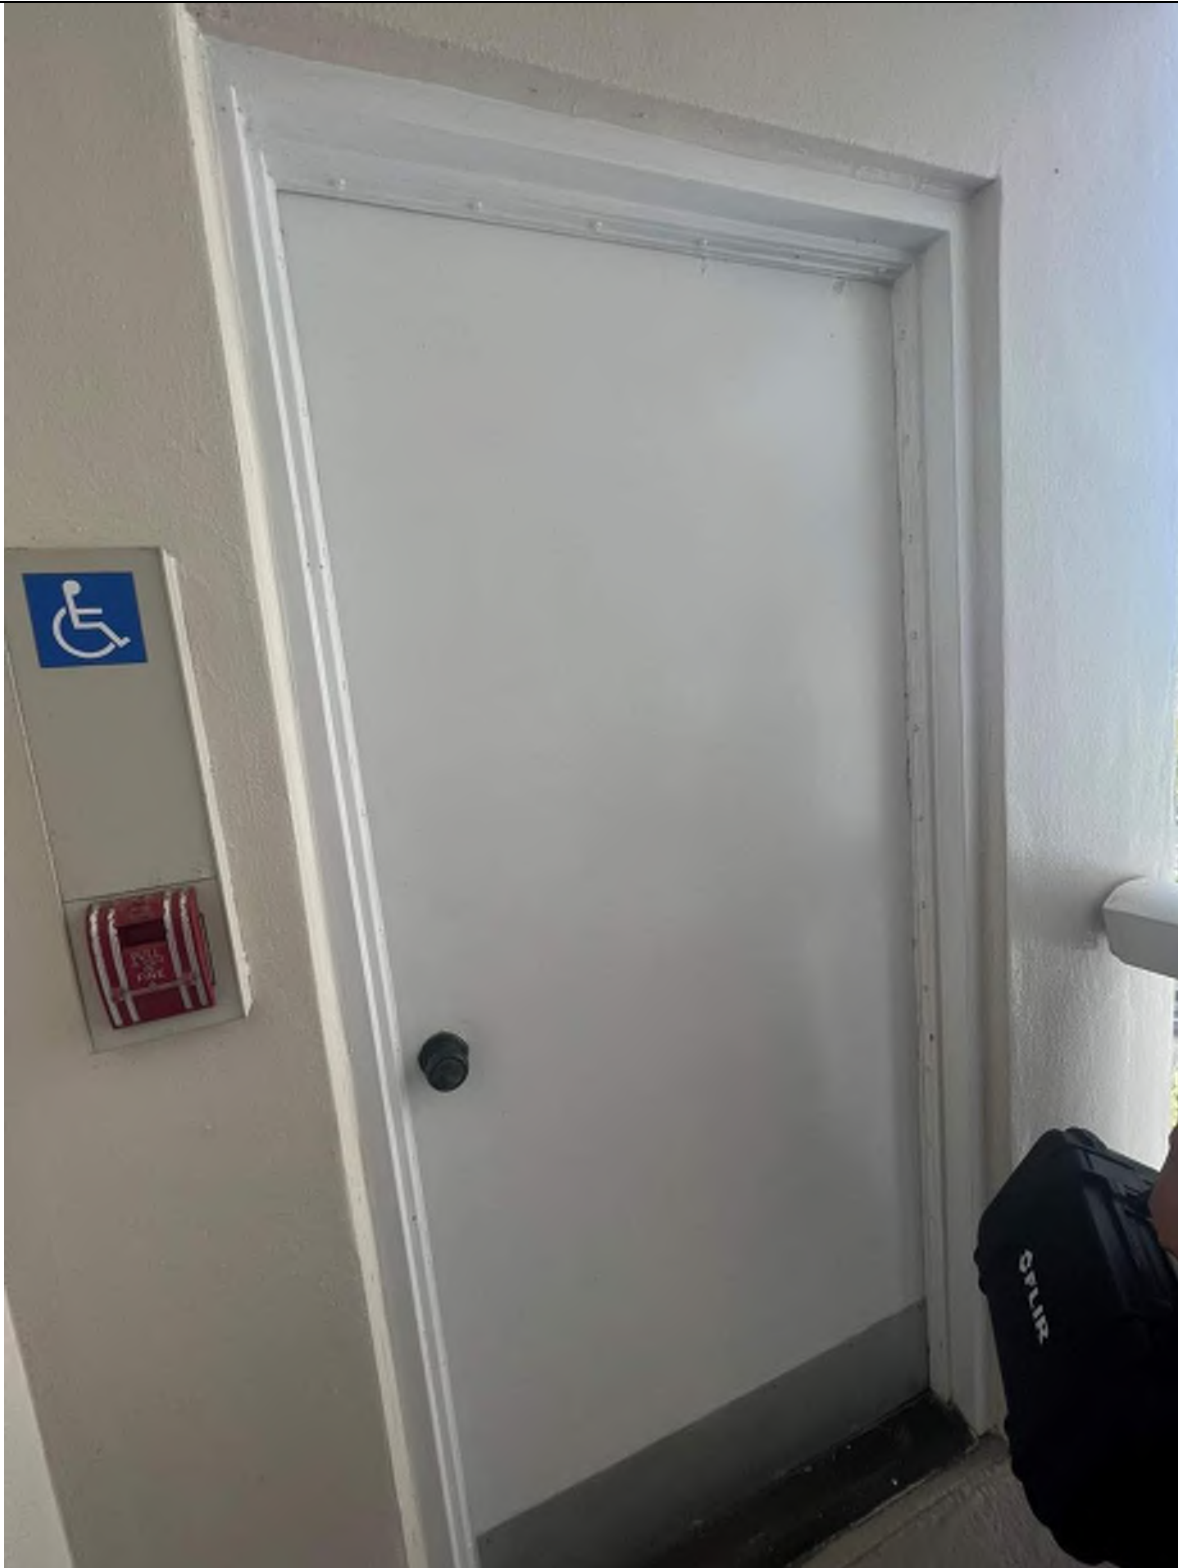
Picture 9.a.1.1

9. Doors and Windows – S.I.R.S. components	
Applicable code(s): 2020 Florida Building Code (F.B.C.) Building	
9.a. 5061 N A1A (Building A)	
9.a.1. Utility and stairwell doors	The doors to access the stairwells and the meter rooms/trash rooms are solid core masonite doors. The doors are in overall fair condition. See picture 9.a.1.1

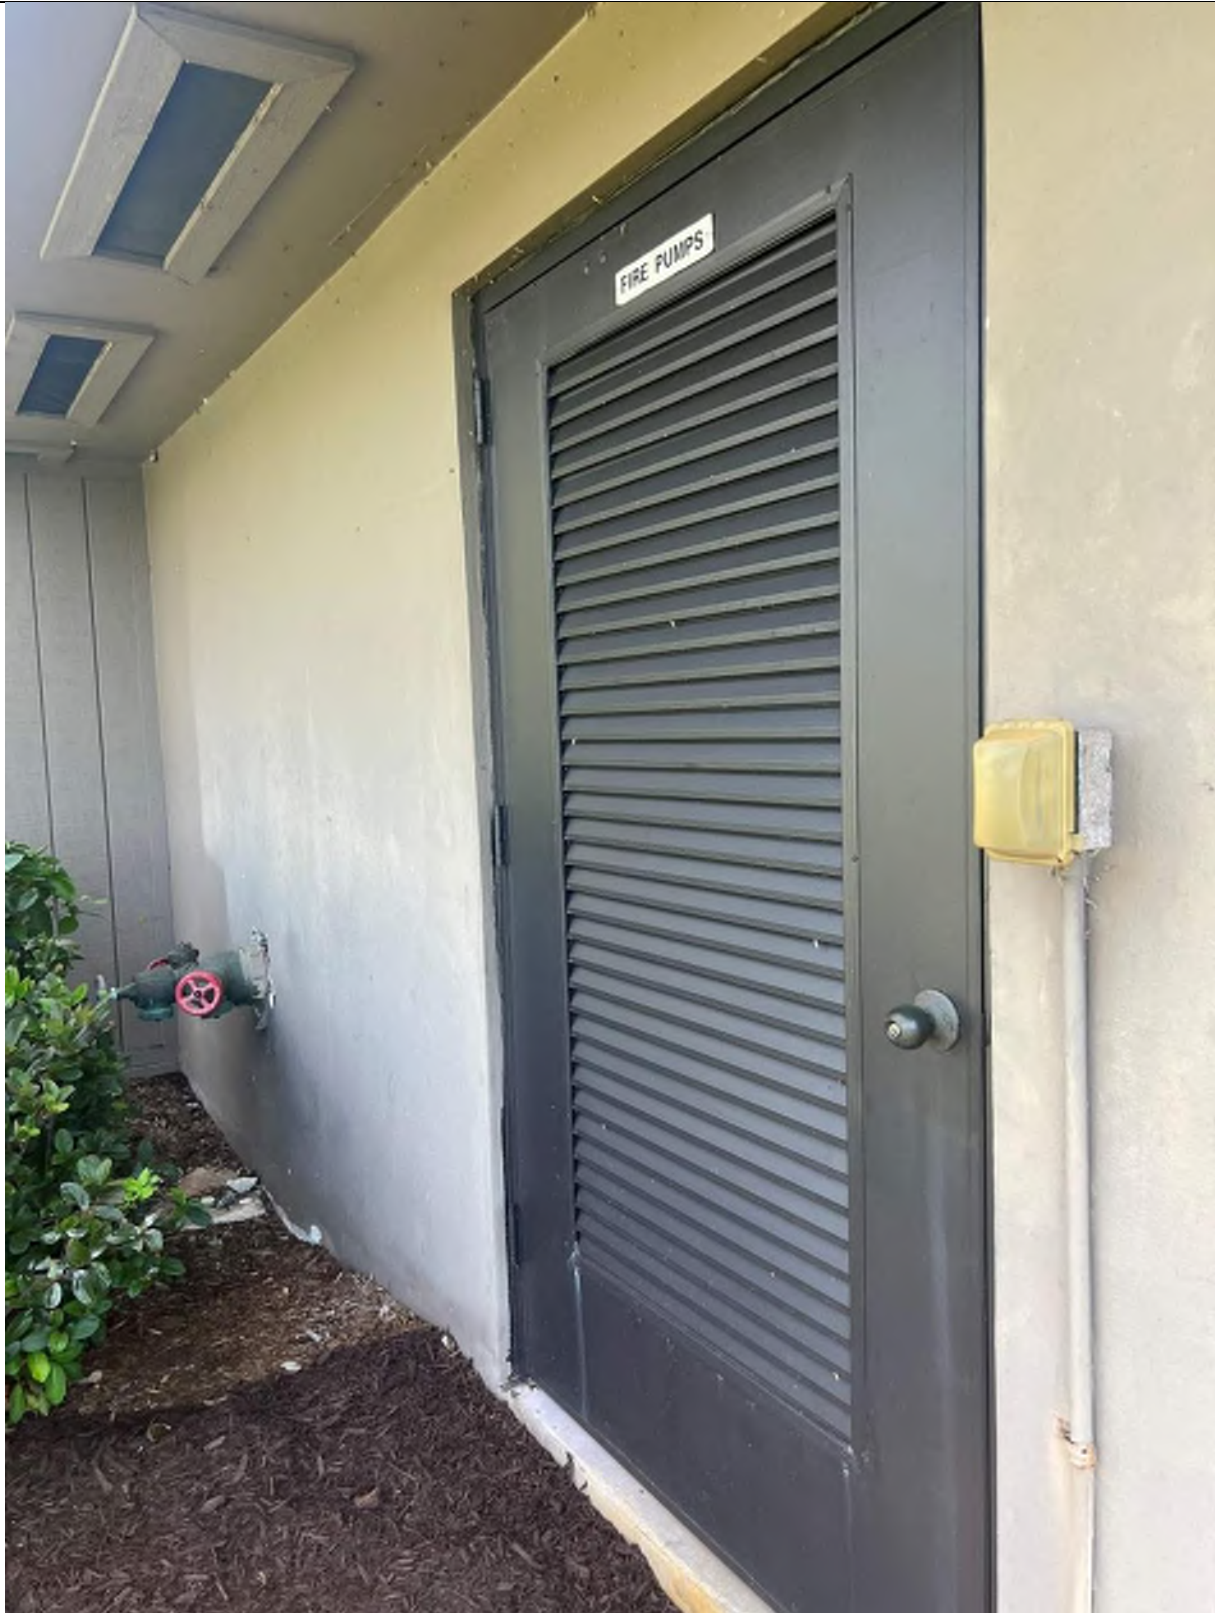
Picture 9.d.13.1

9.d.9. Sliding glass doors condition	Sliding glass triple pane doors at the guard house are in good overall condition. See picture 9.d.9.1.
9.d.10. Sliding glass doors useful life.	50 years
9.d.11. Sliding glass doors estimated remaining life	11 years
9.d.12. Sliding glass doors replacement cost	2 EA x \$7,200 EA = \$14,400
9.d.13. Aluminum louvered door condition	Aluminum louvered door at the guard house are in good overall condition. See picture 9.d.13.1
9.d.14. Aluminum louvered door useful life.	40 years
9.d.15. Aluminum louvered door estimated remaining life	1 year
9.d.16. Aluminum louvered door replacement cost	1 EA x \$2,700 EA = \$2,700
