# Pointe West Community

## Tree Infrastructure Impact Assessment

Pointe West HOA Tree Assessment

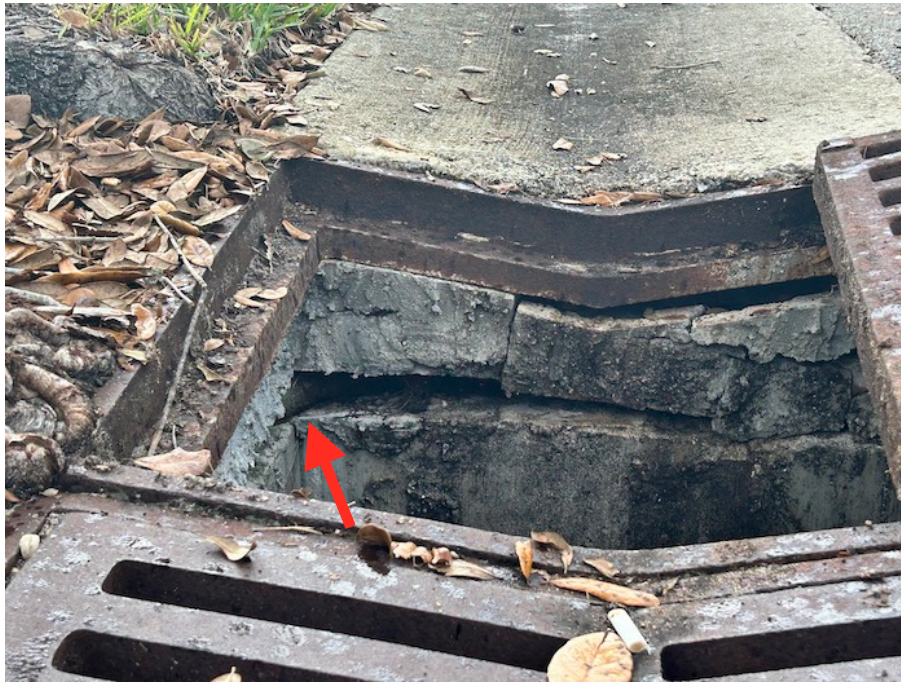
*Arrow indicates tree root lifting and separating a valley gutter in the Pointe West community.*

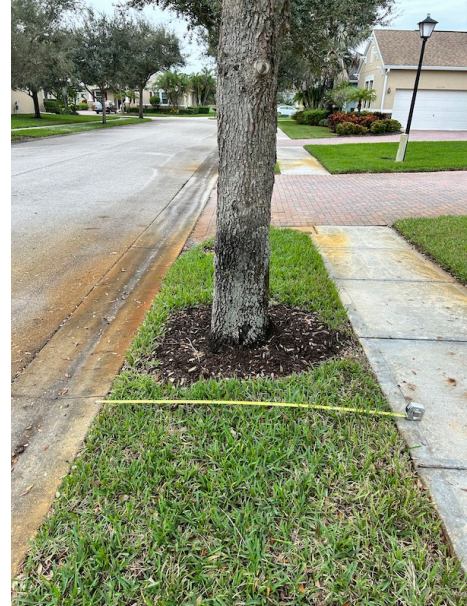
*Image 2. Live oak tree planted and growing in a 4 foot wide curb strip.*

All of the street trees we assessed are growing in curb strips that run parallel to the streets. These curb strips range in width from four feet to seven feet (image 2).

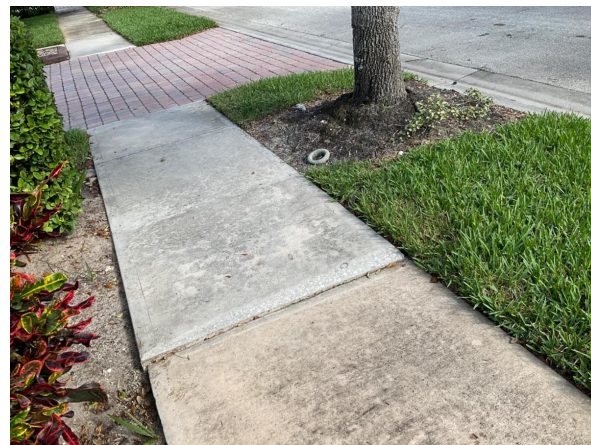
Image 3. Tree #461. Supportive lateral roots were cut to install a new sidewalk slab. This temporary fix, which has failed allowing the new roots to lift the replacement sidewalk, has also destabilized the tree.

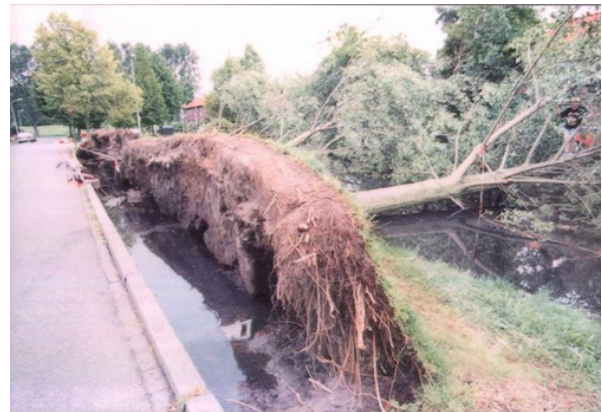
Simply removing the lifted sidewalk slab and cutting the roots before pouring a new slab will not last long. In our experience, in Florida, new roots from the same tree will grow back under the new sidewalk and again the lift slab in about three years. Cutting and removing roots also destabilizes trees and makes them more prone to failing during high winds events. Tree #461 (Image 3) appears to have had a new slab installed which is now lifting. In the process, all of the large lateral roots on the sidewalk side of the tree are removed. Trees are more prone to failure due to lack of root support during the years it takes to replace those roots (image 4) .

*Image 4. Lack of well developed lateral support root makes trees more susceptible to failure during high wind events. This can be a result of either cutting roots or not providing enough rooting space. Often, both go hand in hand.*

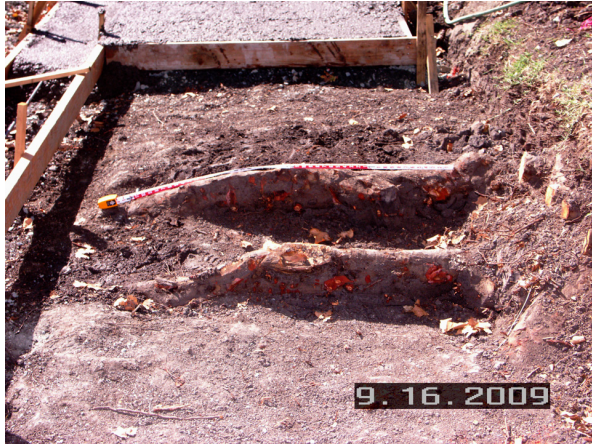
*Image 13. Prior to plate installation, two 4 to 5-inch roots were retained, bruised a bit by the construction crew who did this by hand. Notice smaller roots at the surface were cut.*

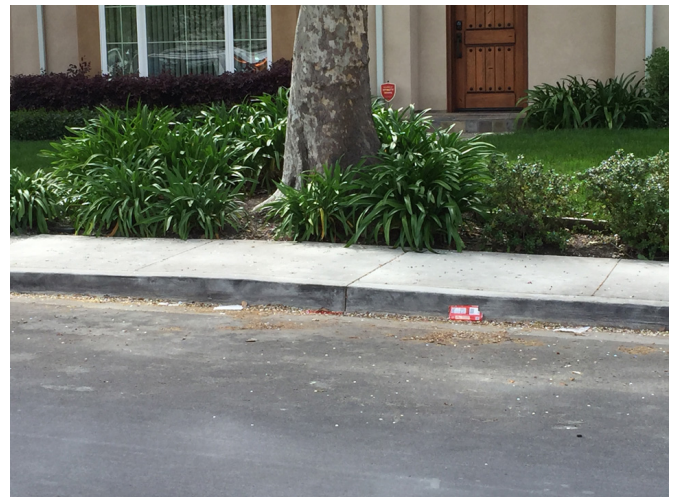
*Image 16. Joe McNeil says, "Nine years later there is no disturbance lifting or fracturing of the sidewalk above the roots. The tree has looked great since, as well." The sidewalk and curb were elevated about an inch to accommodate the required thickness of the steel plates.*

**Excavation of root and installation of a steel plate over the offending roots** - The second method of Tree-based Sidewalk Repair is to use a steel plate that is bolted over the top of the offending roots (image 15). We have not found a municipality, HOA or a contractor that has performed this technique here in Florida. We learned about it from a colleague Joe McNeil in Pleasantville, California who is an ISA Board Certified Master Arborist and an ASCA Registered Consulting Arborist. His website is: <http://www.oakperson.com/> and his company is McNeil Arboriculture Consultants LLC. The descriptions below each photo are Mr. McNeil's as are the photos. The tree in question is a London Plane (*Platanus x acerifolia*) a hybrid of the sycamore tree (*Platanus occidentalis*). According to Joe this installation was done in September, 2009 and the tree, which is located about 12 inches to the right of the sidewalk slab in image 16, is in good condition now and no sidewalk lifting has been observed.

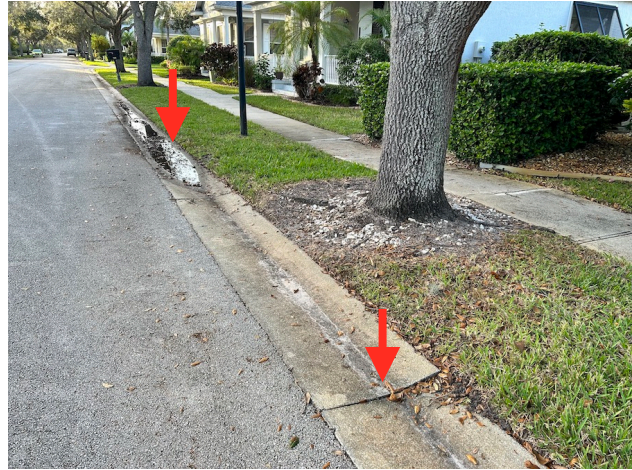
After sidewalk trip hazards, dealing with valley gutters should be a top priority. A failing drainage system will become very costly because the damage caused by standing water will increase the infrastructure damage. Many trees are observed to be heaving the valley gutters upward which affects the valley gutter flowline, and consequently the roadway drainage. This creates a break in the flowline and disrupts stormwater’s path to curb inlets. Stormwater then becomes perched in a newly created depressional area, resulting in stormwater that remains on the roadway for a prolonged duration (image 17). Continued standing water can lead to stormwater seeping into a roadway pavement’s base course, reducing the pavement’s ability to resist vehicular traffic loads. This ultimately leads to an accelerated deterioration of the pavement and an increase in maintenance costs in the future.

*Image 17. Valley gutter function is hindered as a result of impacts by tree roots. Arrows indicate lifted valley gutter and pooling water.*

The street trees in Pointe West are planted too close to the valley gutters in order to recommend cutting of roots. While the trees may survive root cutting, they immediately lose lateral structural root support and become more susceptible to blowing over in a storm or other high loading event (image 4). Due to the highly restricted rooting area, there are no viable mitigation options that do not cause severe loss of health or structural integrity to the trees. For these reasons, we have recommended removal of any tree that is actively lifting a valley gutter. This number will likely increase as the trees grow.

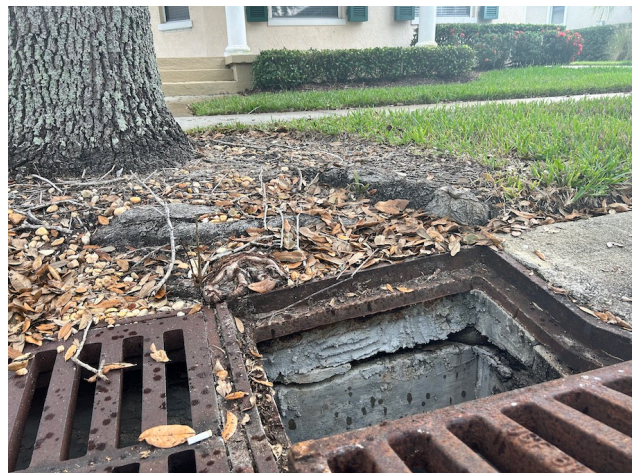
*Image 18. A tree root is seen growing between and slowly separating the spaces in the engineered valley gutter.*

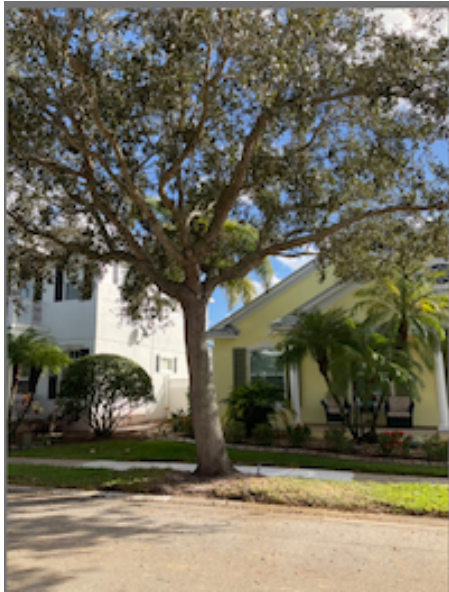
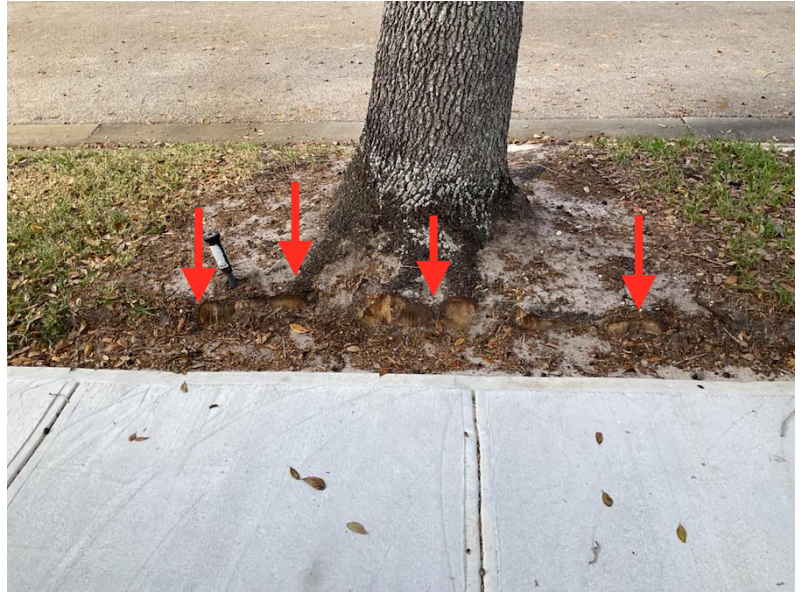
*Images 19 (left), 20 (right). Tree #256 has suffered significant root loss (arrows) during sidewalk slab removal and replacement. This large tree is currently more susceptible to structural failure during wind events and should be removed.*

Other trees recommended for removal are larger trees that have recently suffered serious root damage as a result of recent sidewalk slab removal and replacement. These trees are currently at high risk of structural failure during wind events and should not be retained. Trees #108 and 267 are examples of this dangerous situation.

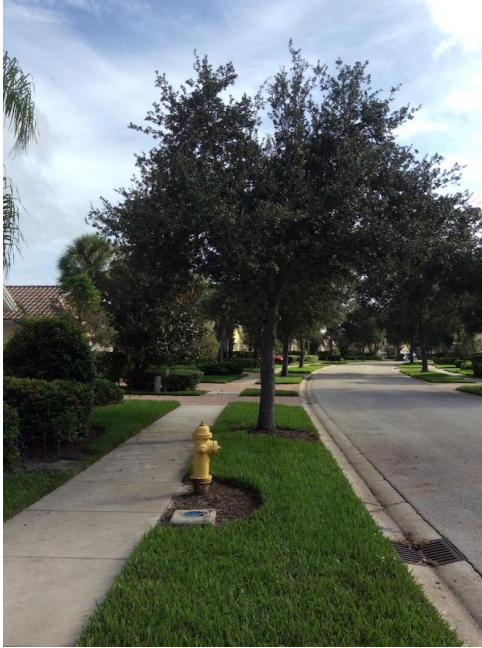
Tree roots often impact fire hydrants as they are attracted to the presence of water in the underground tubes. As an example from a similar community in Florida, a four inch diameter root can be seen growing toward and around a fire hydrant located approximately fifteen away (images 21, 22).

*Image 21. A young live oak tree approximately 15 feet from a fire hydrant and water utility line.*

A total of 92 trees are recommended for removal. Eighty seven trees are recommended for removal due to impacts to valley gutters. Four trees are recommended for removal because they are located within 20 feet of a fire hydrant. One newly installed tree was recommended for removal due to it's poor health and structural damage.

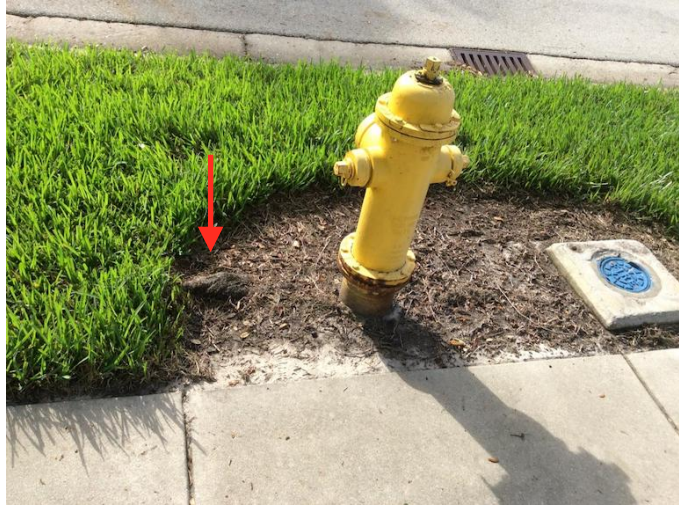
*Image 22. A tree root approximately 4 inches in diameter impacting a fire hydrant.*
