**Milestone Phase I Report  
River Run Condominium Association, Inc.**

Report Date: 🕒 1/25/2025

Inspection Date: 🕒 9/18/2024

Building A - 5956 River Run Drive, Sebastian, Florida 32958, USA

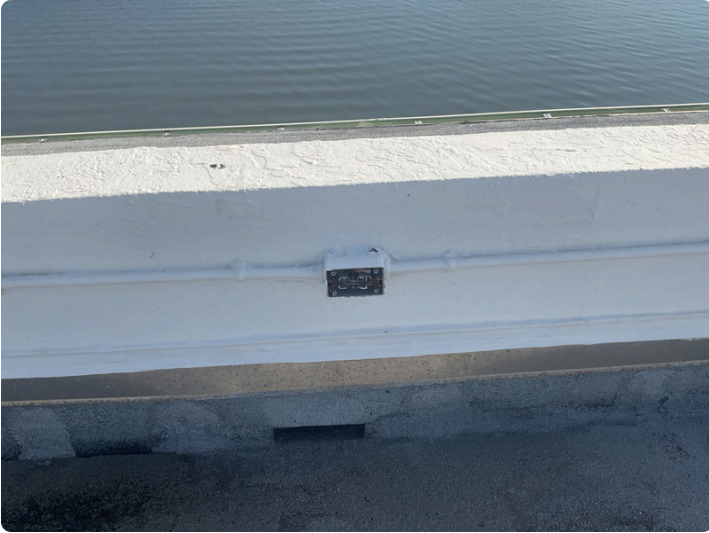
Exposed electrical outlet on roof. Install a new plate covering.

Exposed electrical outlet on parapet wall

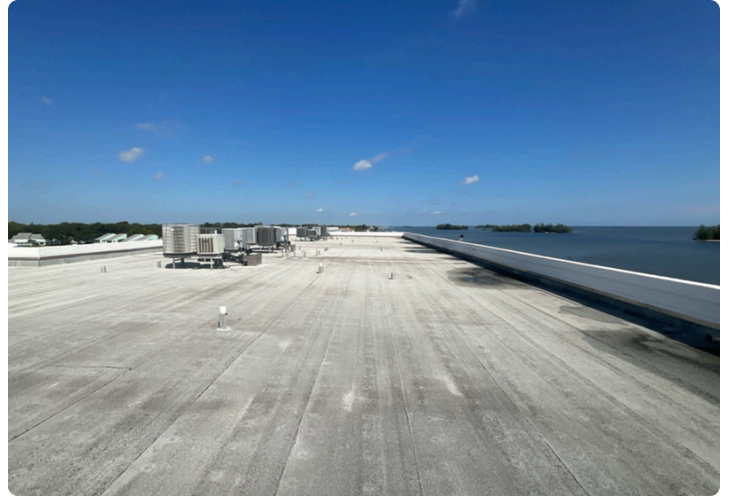
Roof was in average condition for its age.

Roof overview

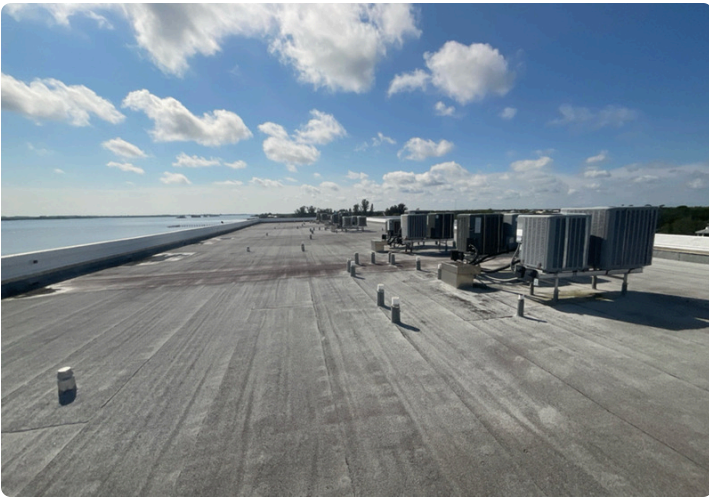
Roof overview

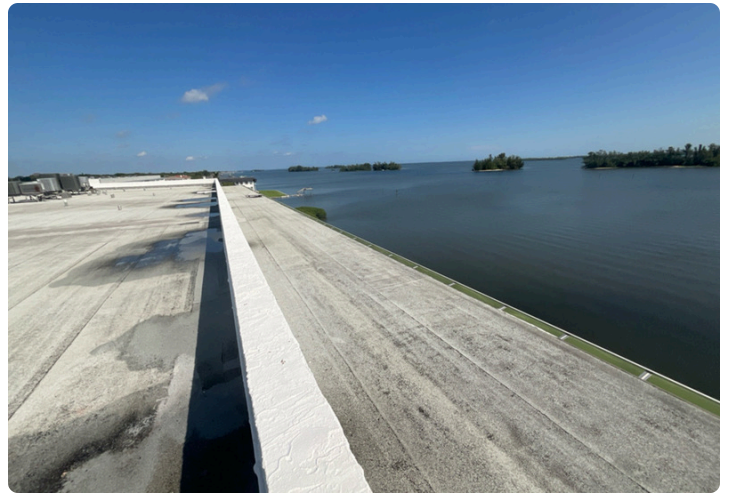
Roof overview

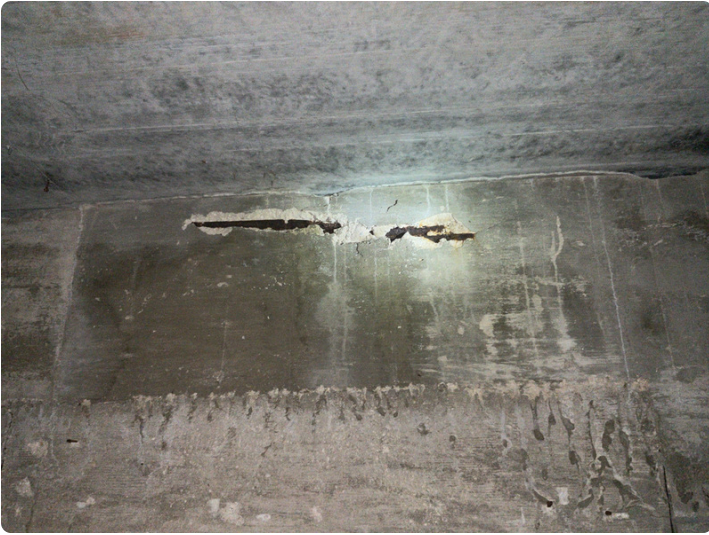
Deficiencies	Spalling/exposed metal and cracking running along the basement walls were observed. All concrete with exposed metal and cracks must be further inspected to determine the level or rebar and metal deterioration in the basement. Non-destructive testing will be used primarily but some destructive testing may be required, including chipping out any spalled concrete and taking samples of the rebar.
Condition	Poor

Spalling/exposed metal in basement

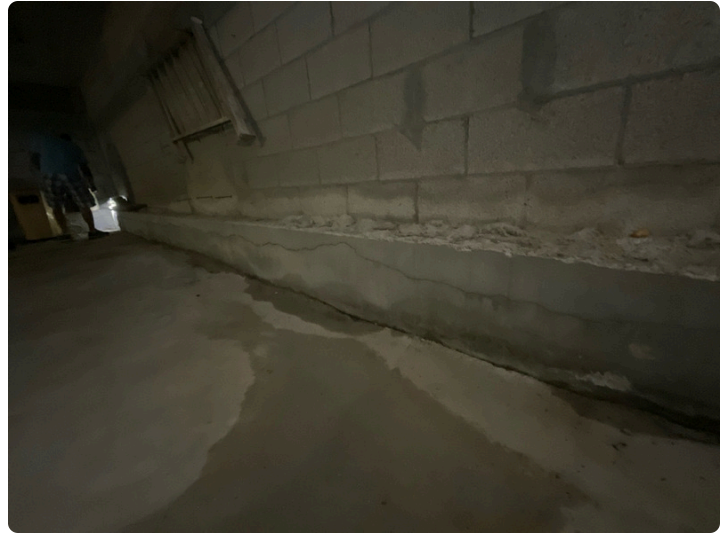
Spalling/crack running along length of room

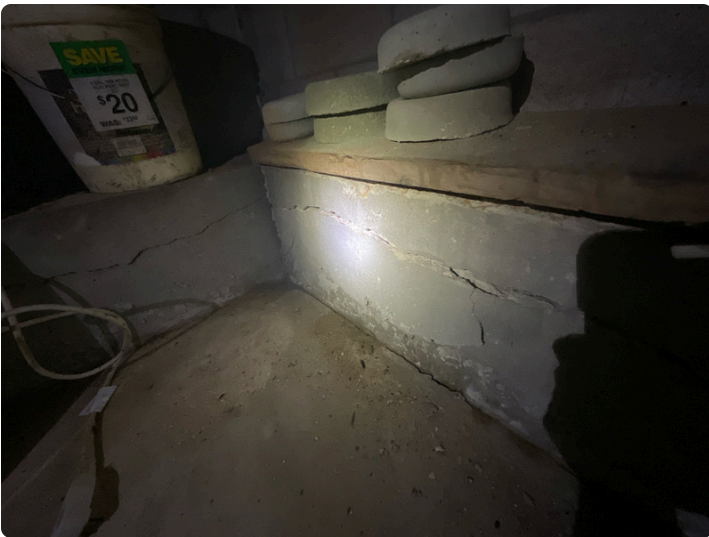
Spalled/cracking concrete

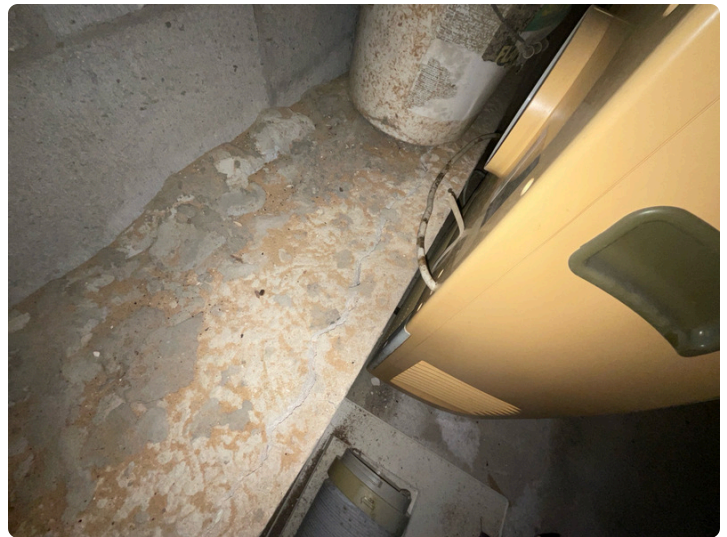
Crack/spall running along of wall

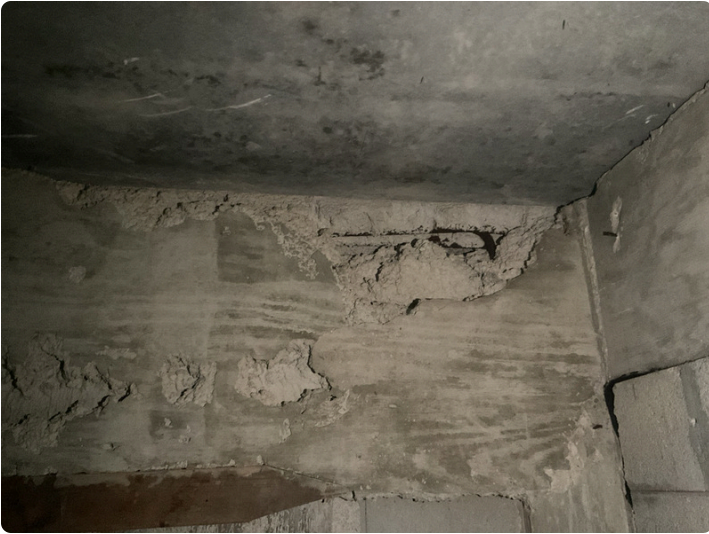
Potential spalling concrete

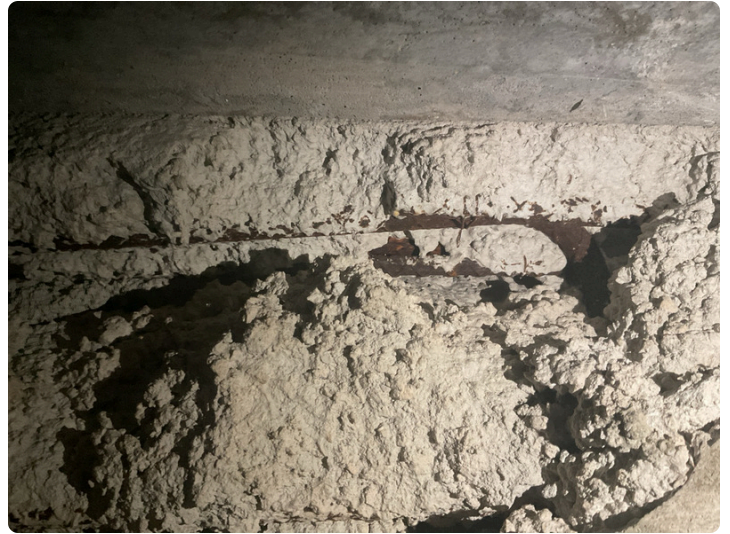
Exposed rebar

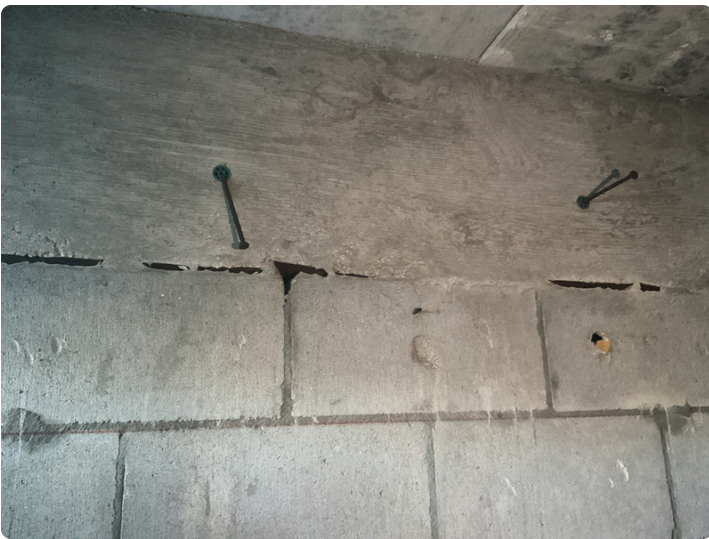
Spalling concrete/exposed metal

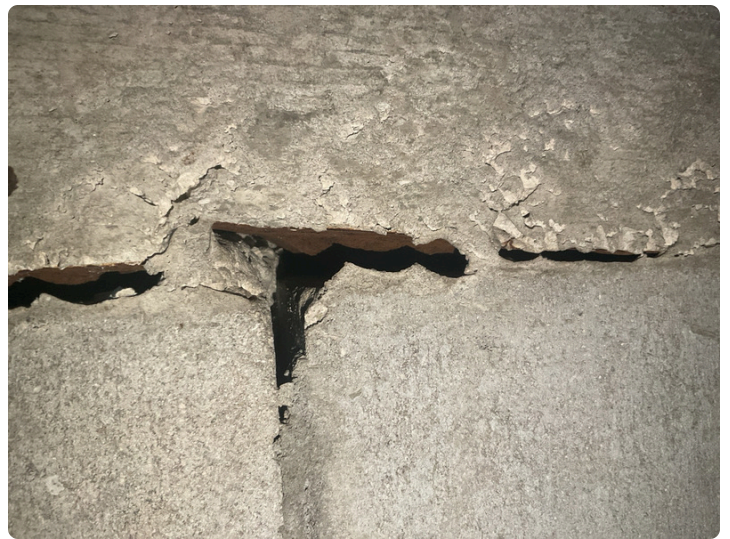
Spalling concrete/exposed metal in basement wall

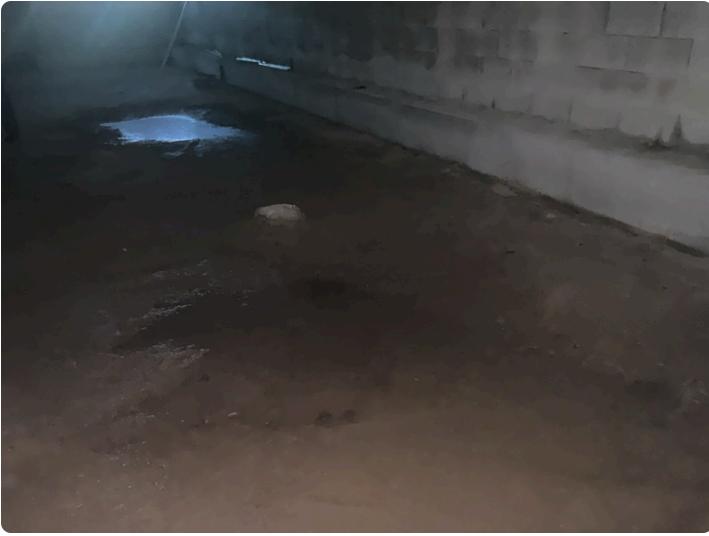
Sediment buildup in basement

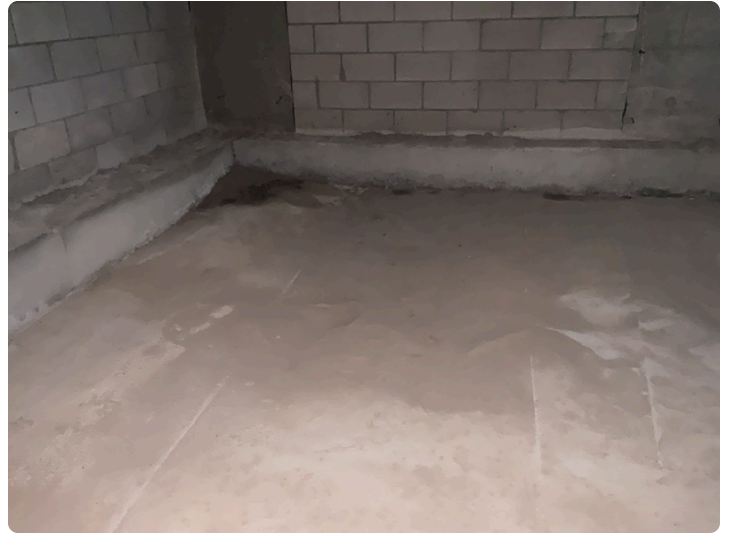
Sediment building in basement sediment buildup in basement

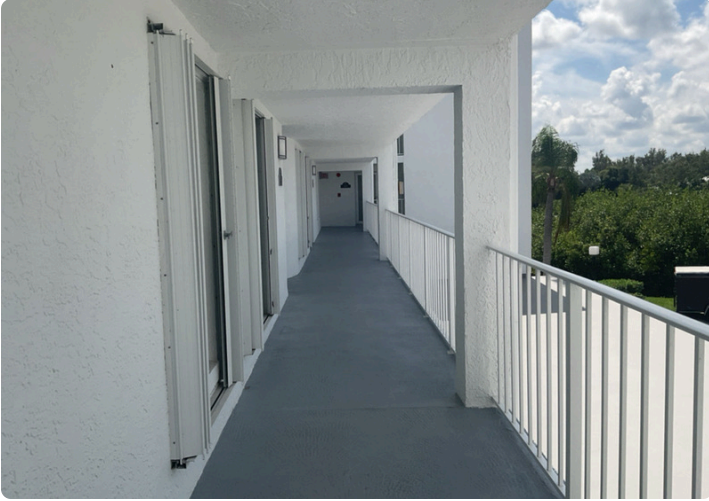
Walkway overview

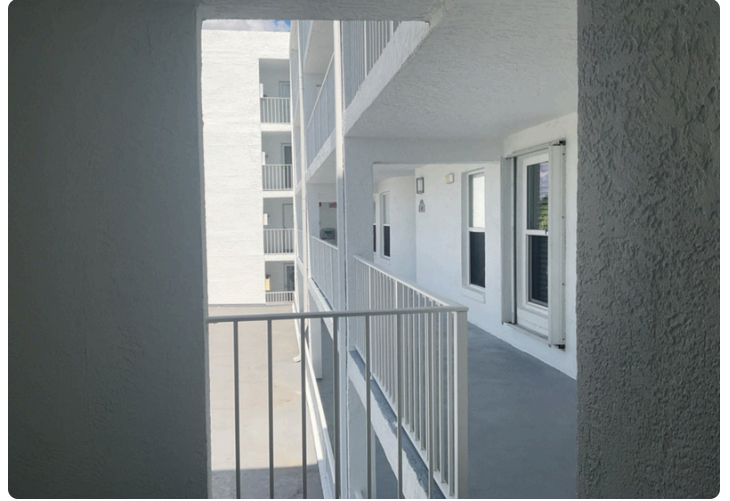
Walkway overview

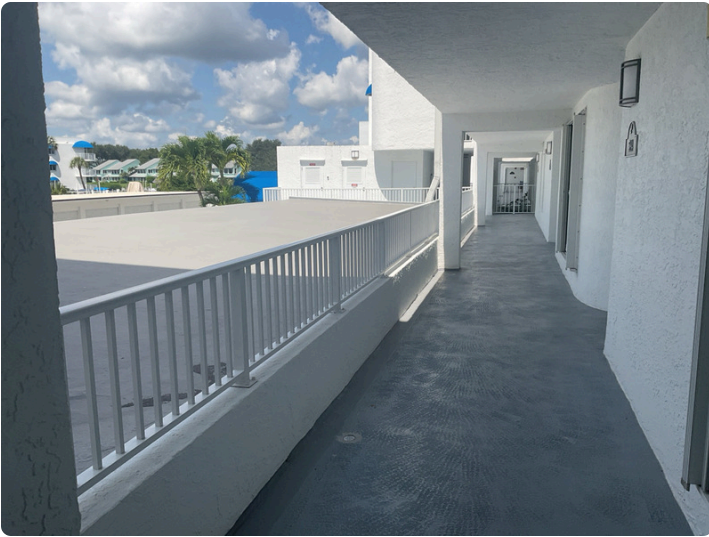
Walkway overview

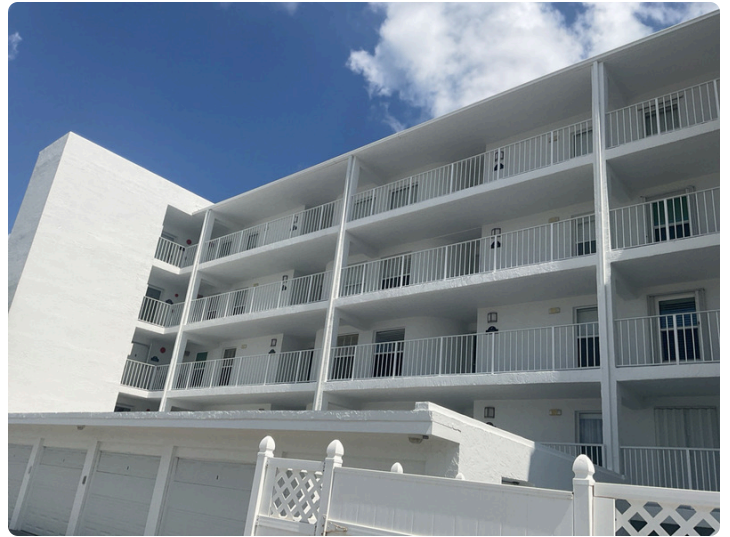
Walkway overview

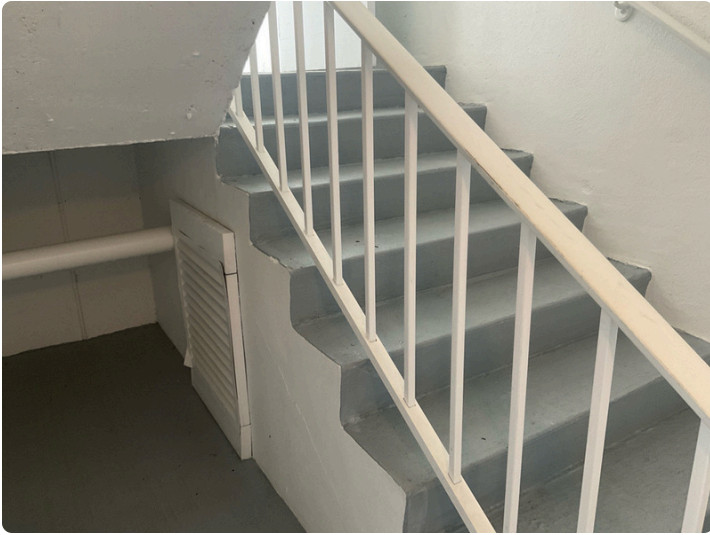
Typical stairway

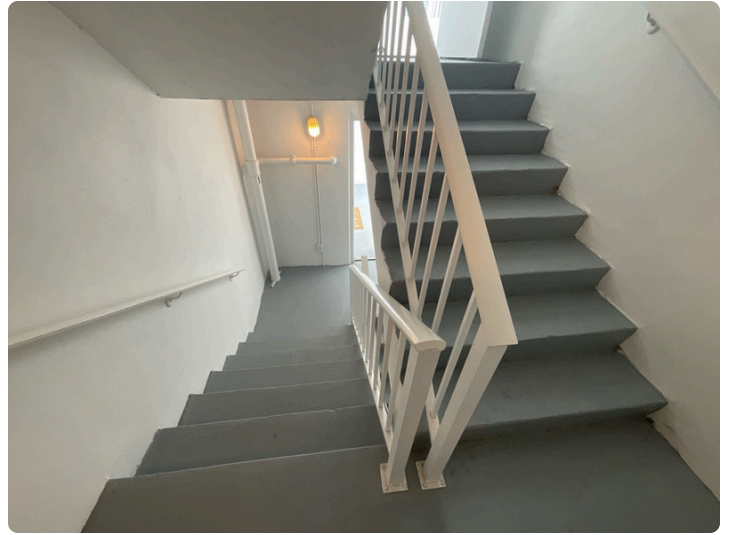
Typical stairway

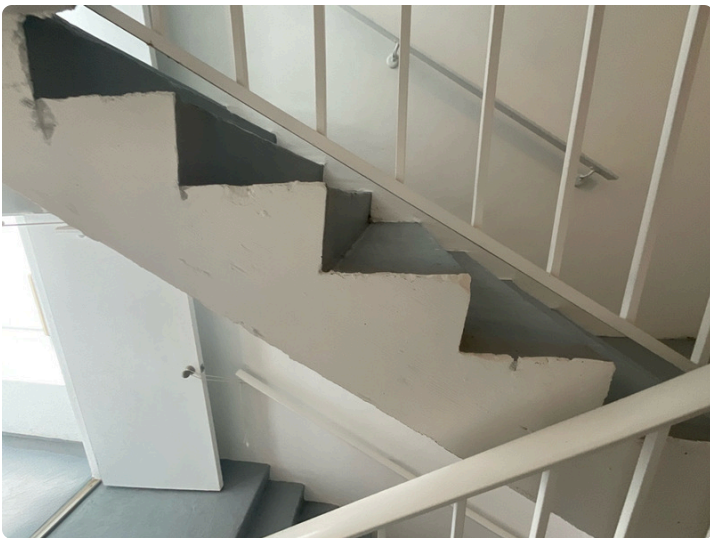
Typical tread

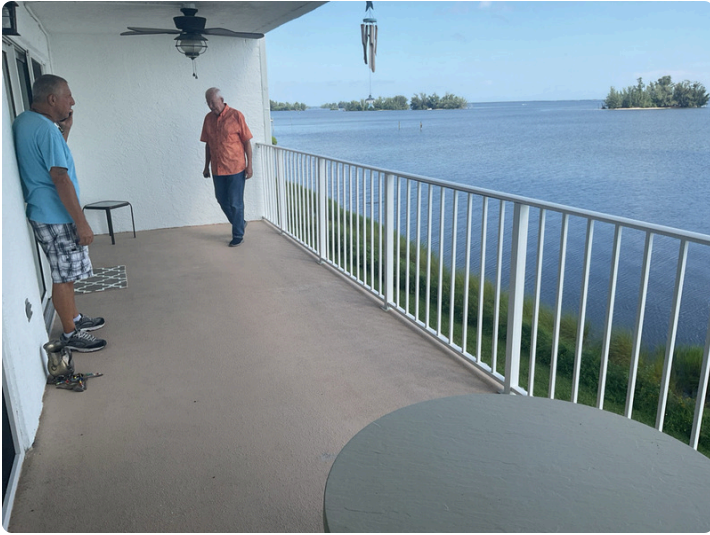
Typical balcony railing

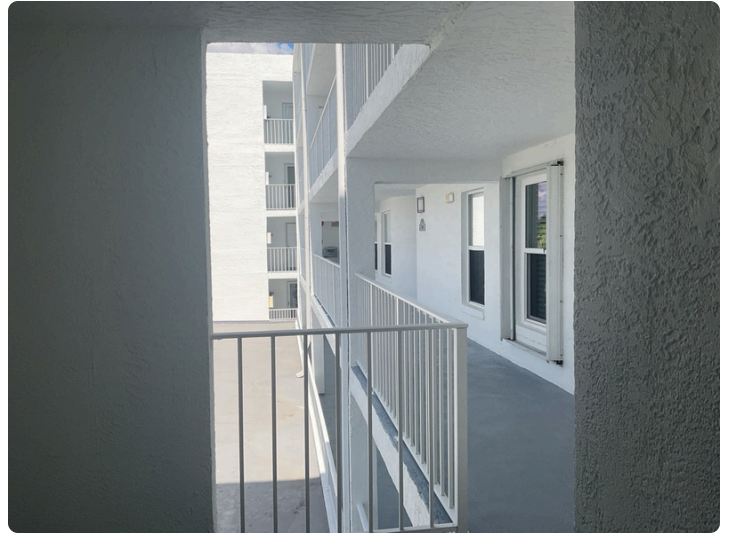
Typical walkway railing

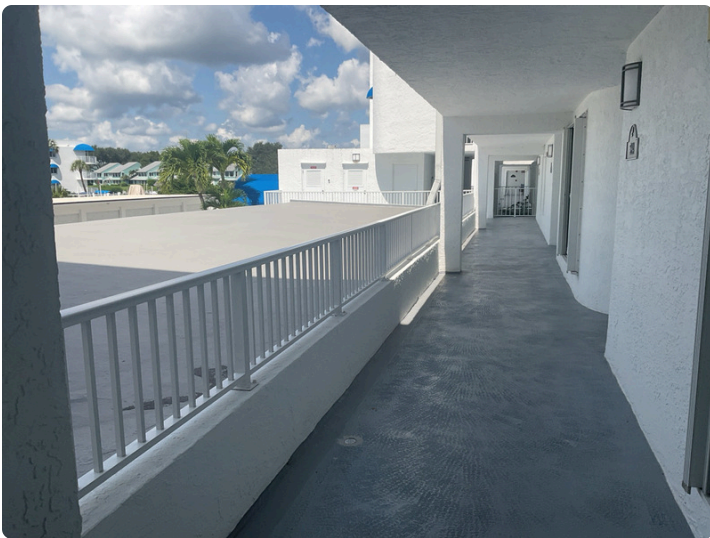
Typical walkway railing

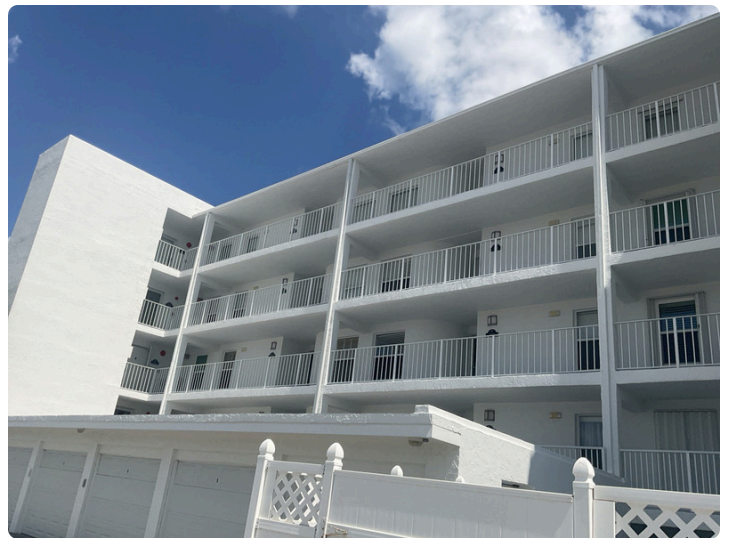
Railing overview

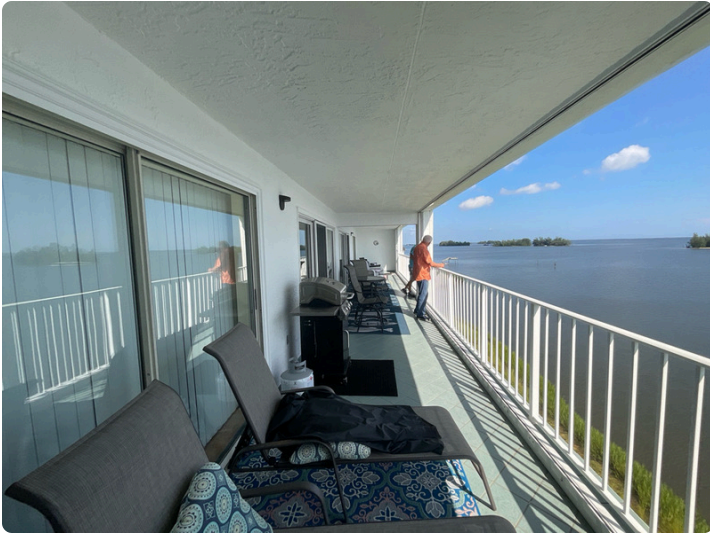
Typical balcony

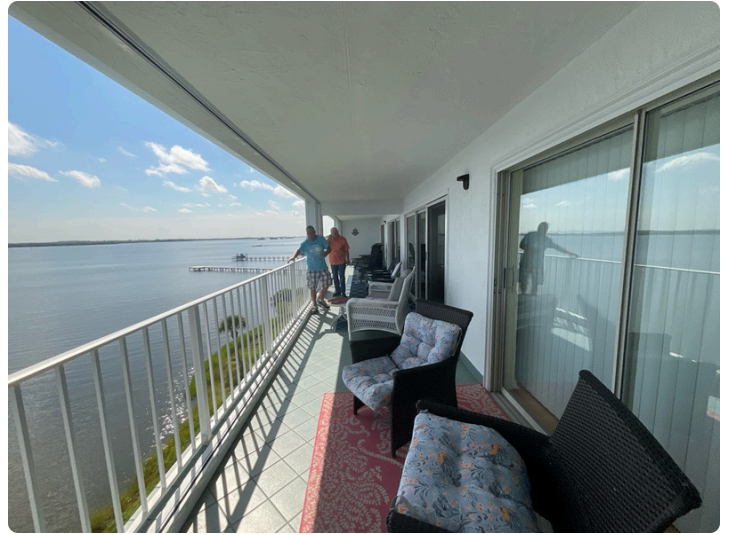
Typical balcony

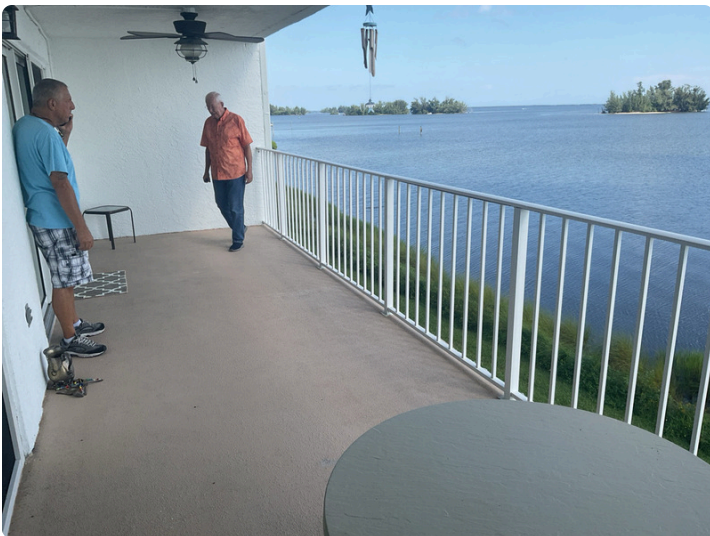
Typical balcony

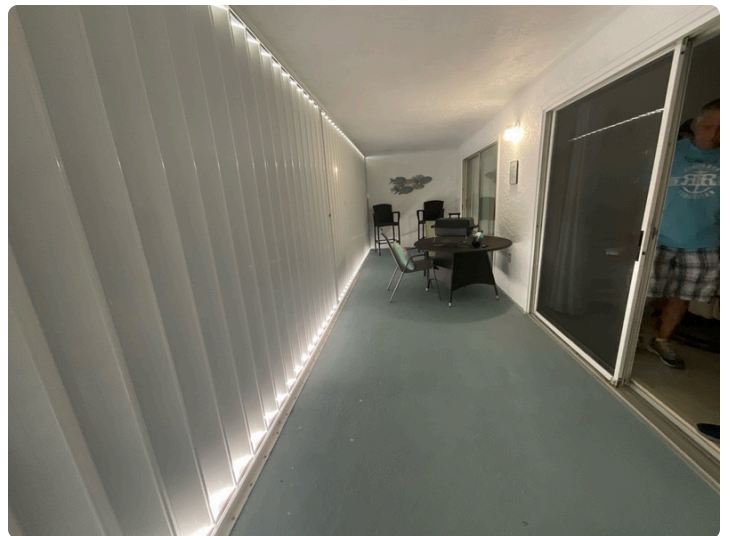
Typical balcony

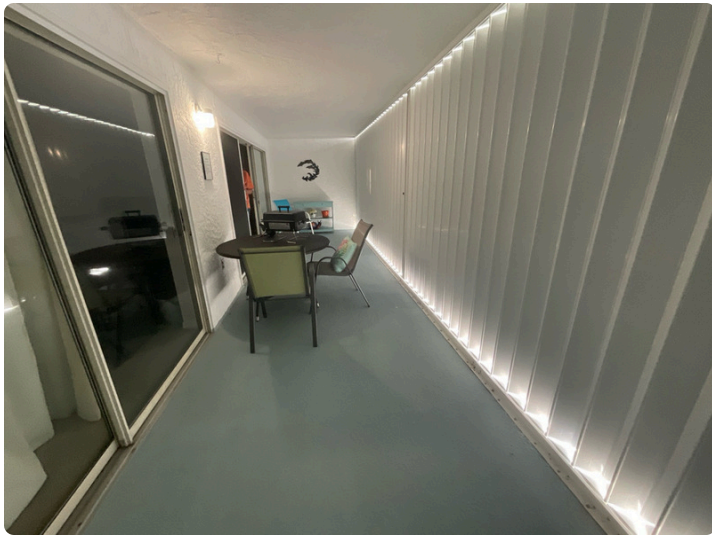
Typical balcony

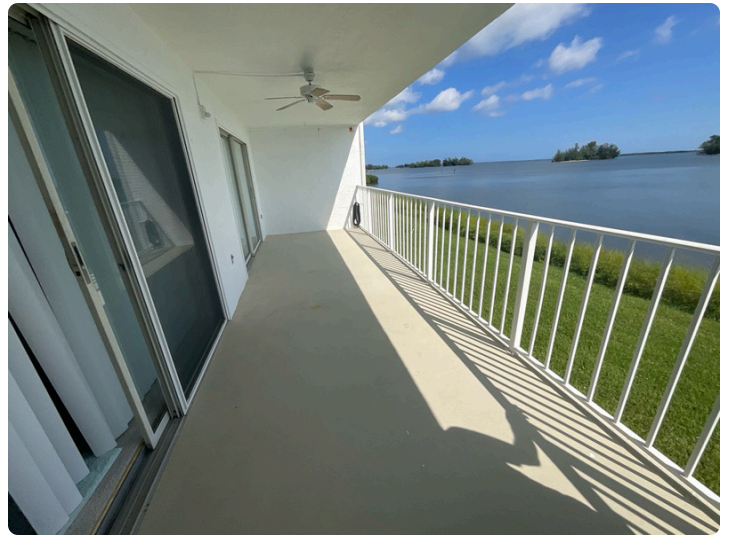
Typical balcony

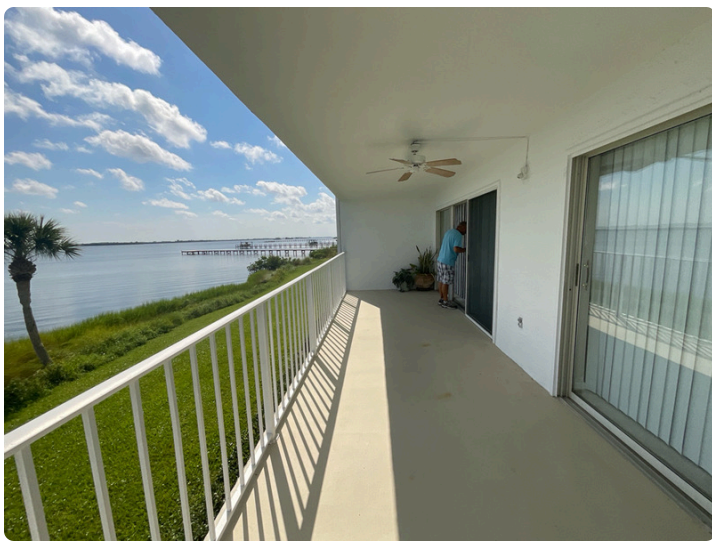
Typical balcony

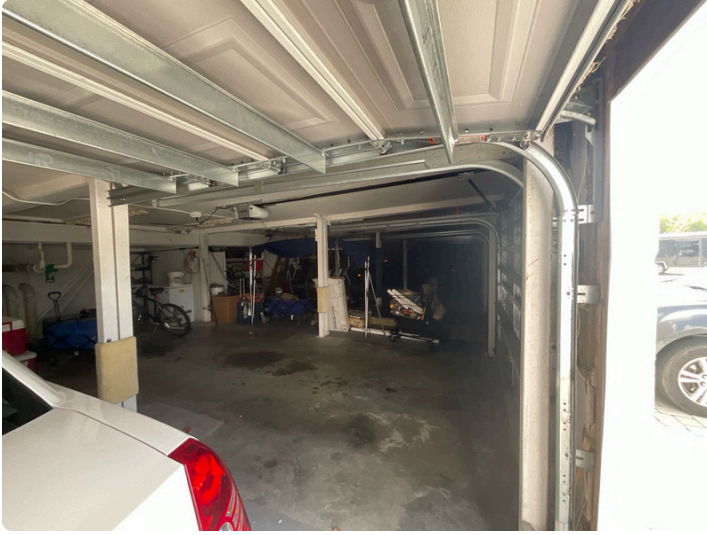
Carport overview

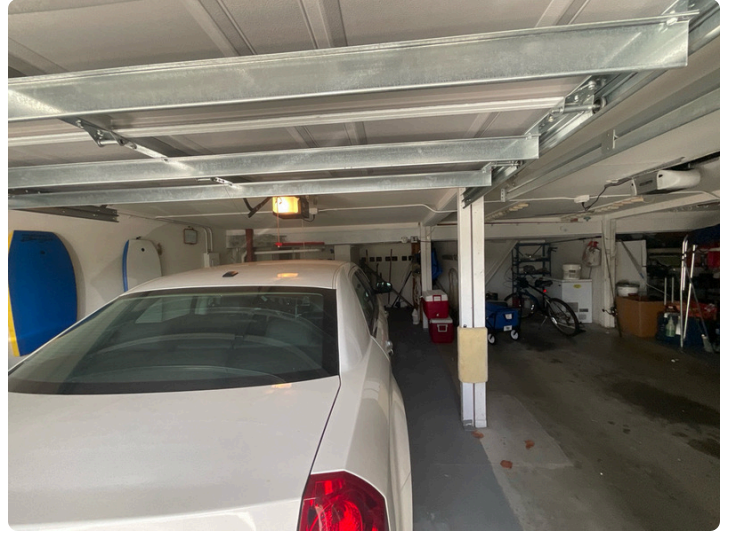
Carport overview

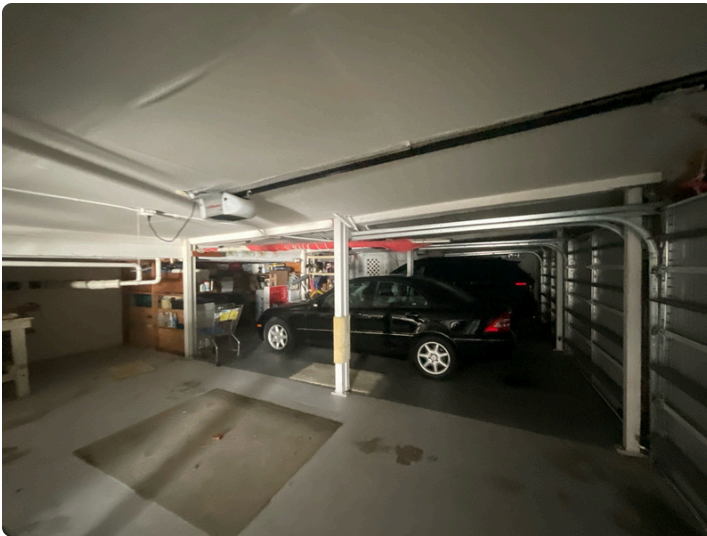
Carport overview

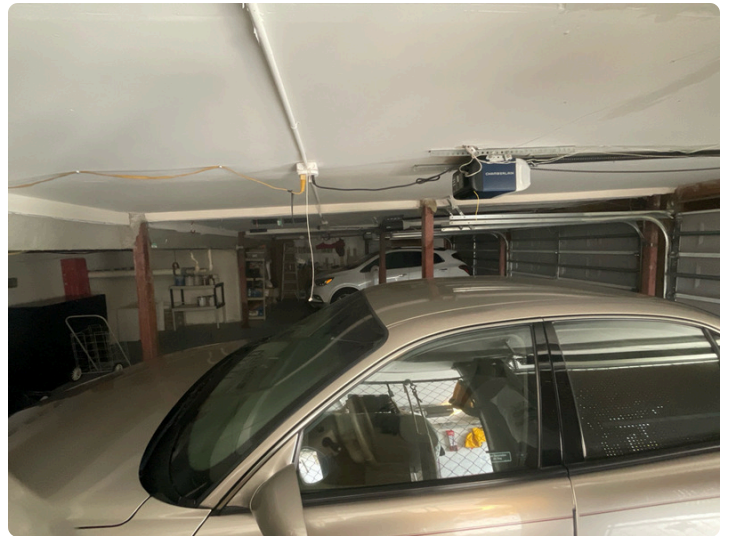
Carport overview

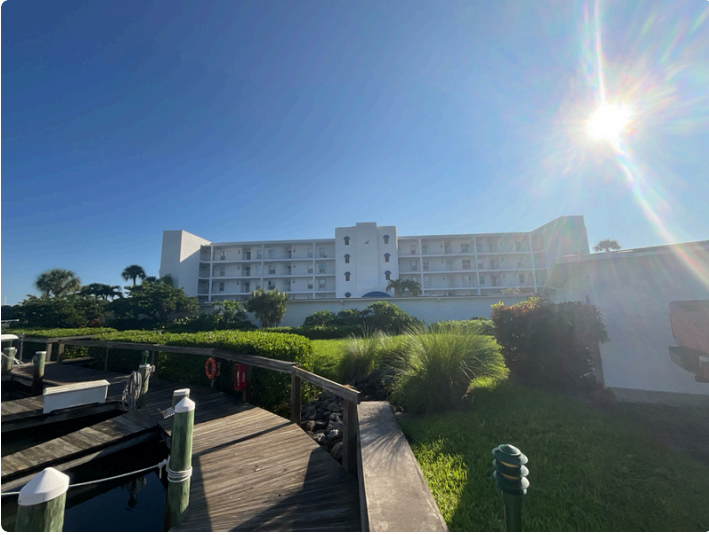
Front elevation
