Milestone Phase I Report
River Run Condominium Association, Inc. Building B

Report Date: 🕒 1/25/2025

Inspection Date: 🕒 9/18/2024

Building B - 6100 River Run Drive, Sebastian, Florida 32958, USA

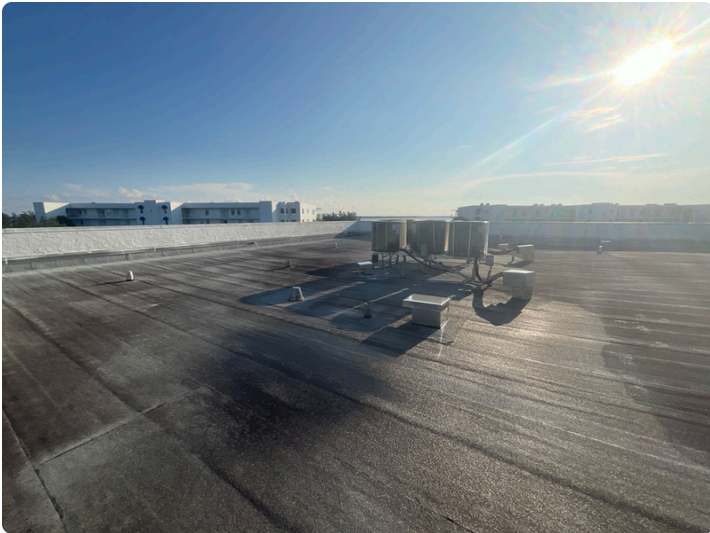
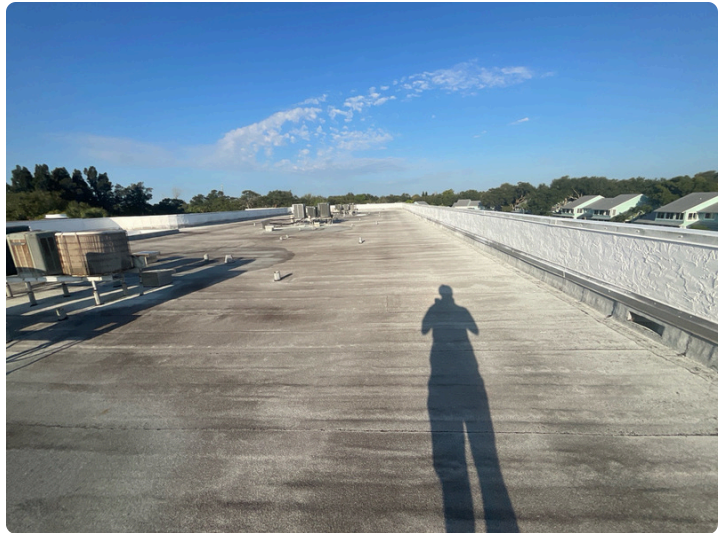
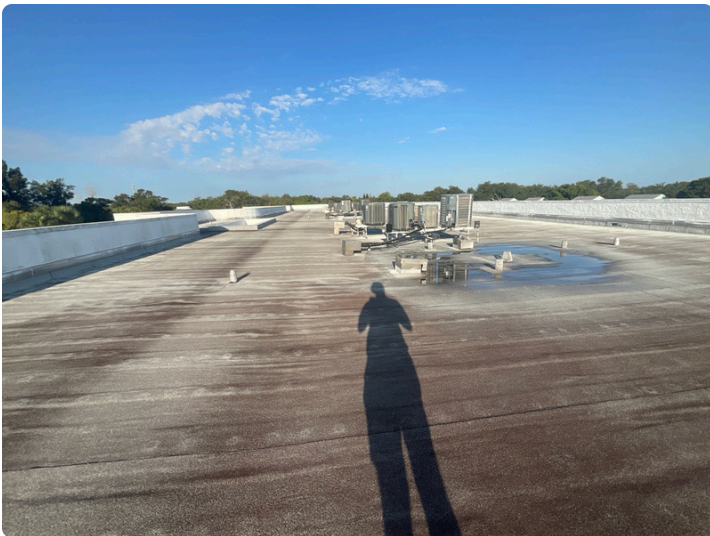
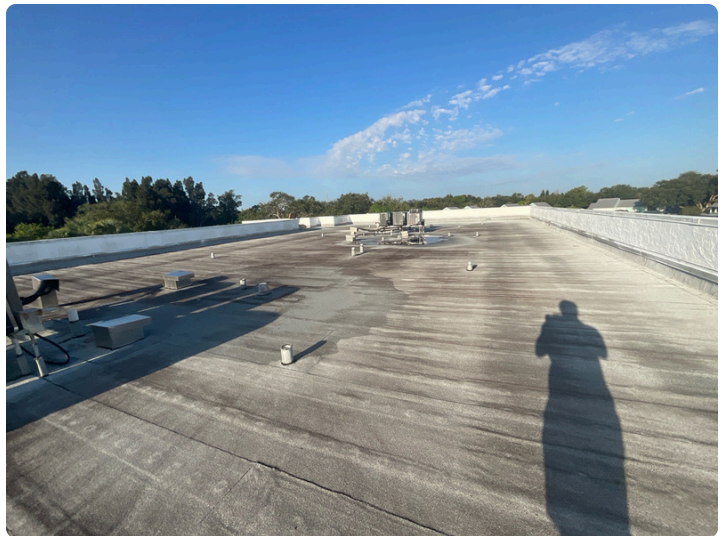
The roof is in good condition for its age. Some ponding was observed, which was expected as it rained the night before the inspection. Monitor to ensure all ponding evaporates after 48-72 hours.

Roof overview

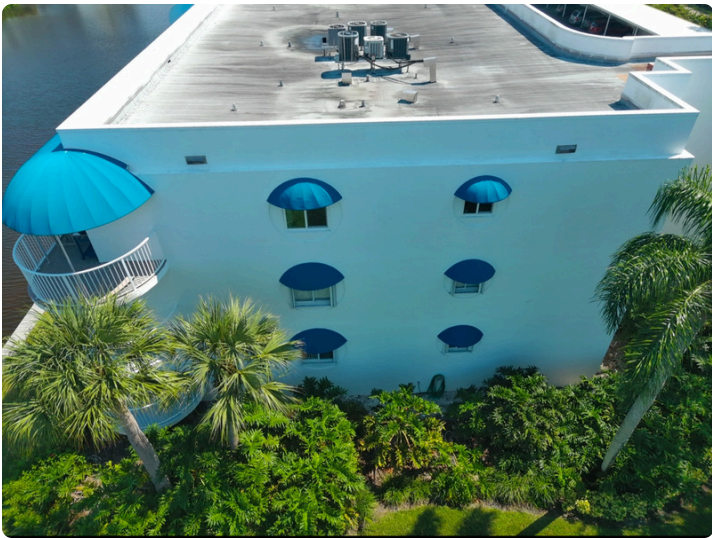
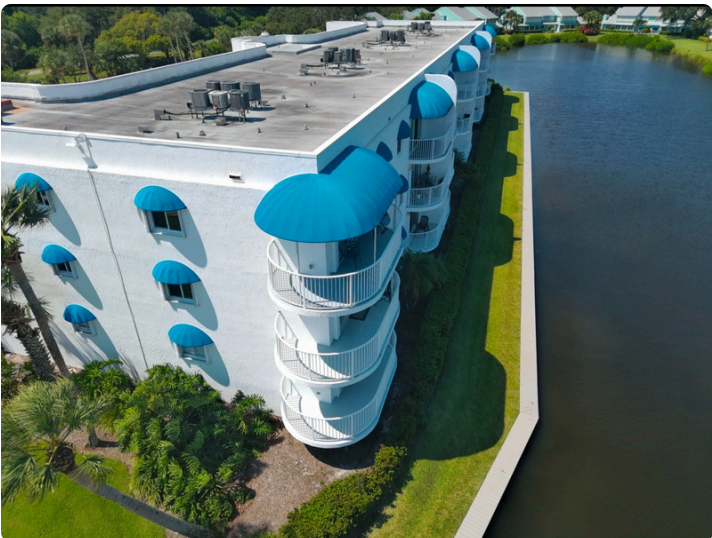
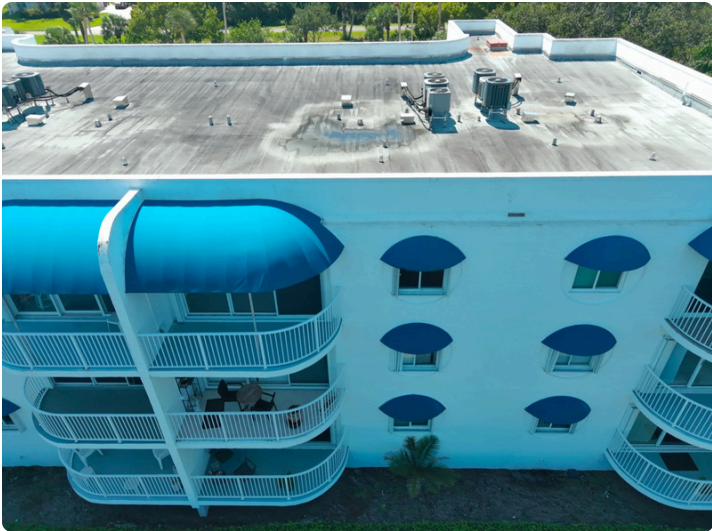
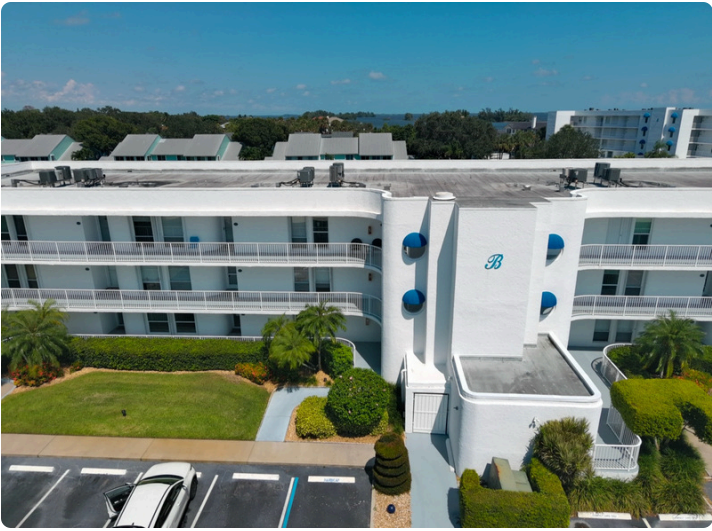
The exterior walls are in good condition for their age.

Exterior wall overview

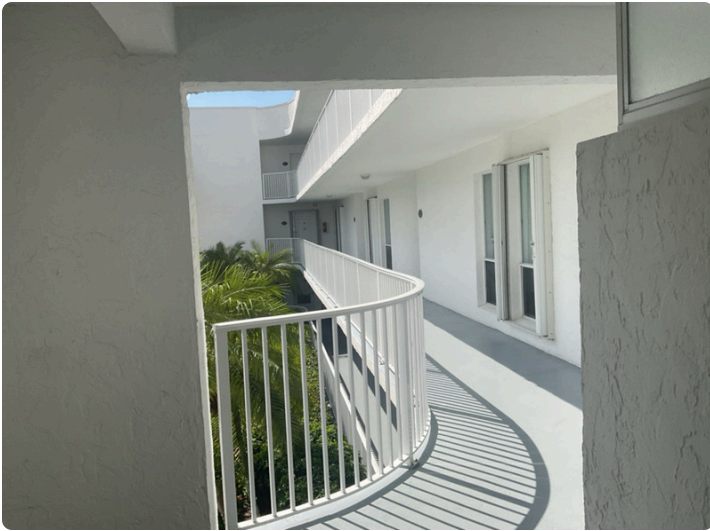
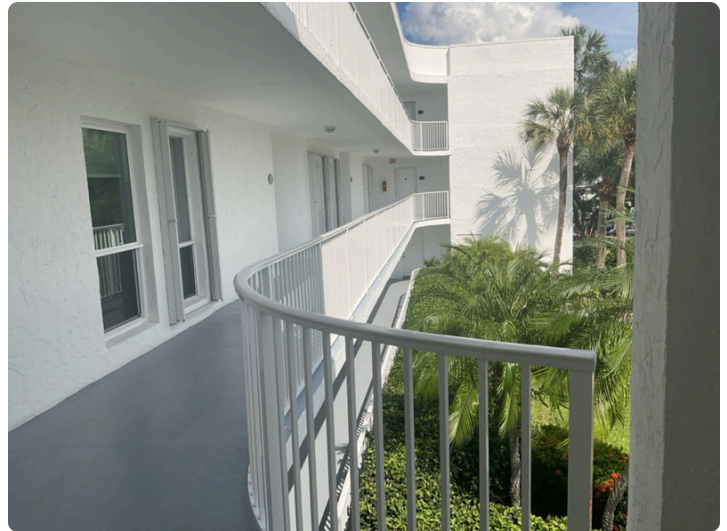
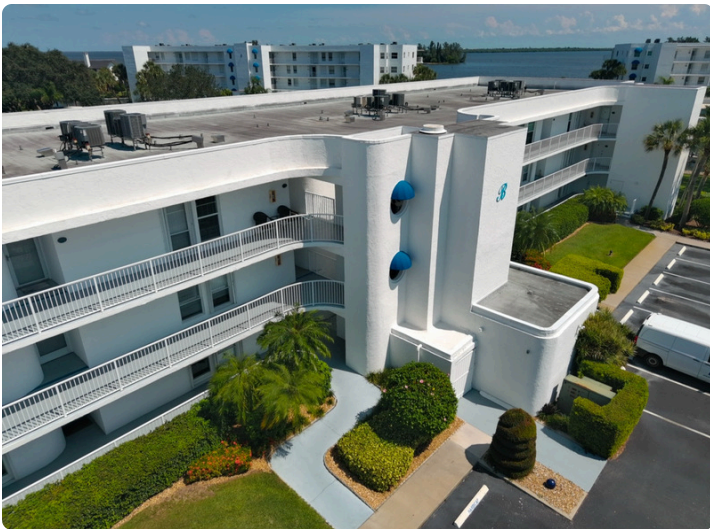
Walkway overview

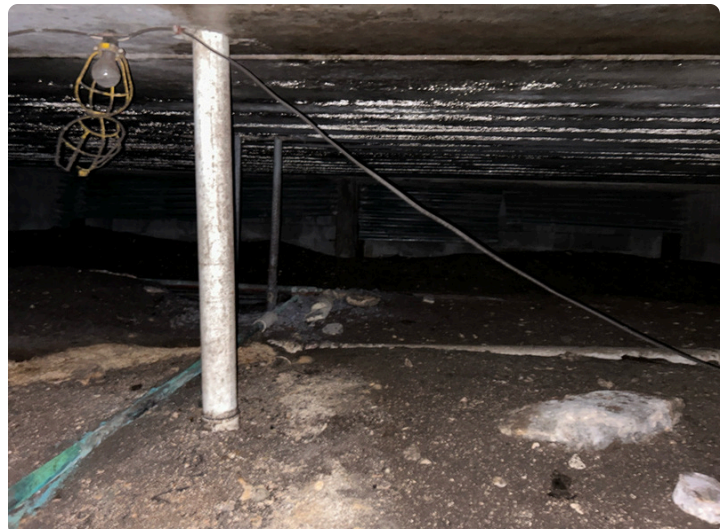
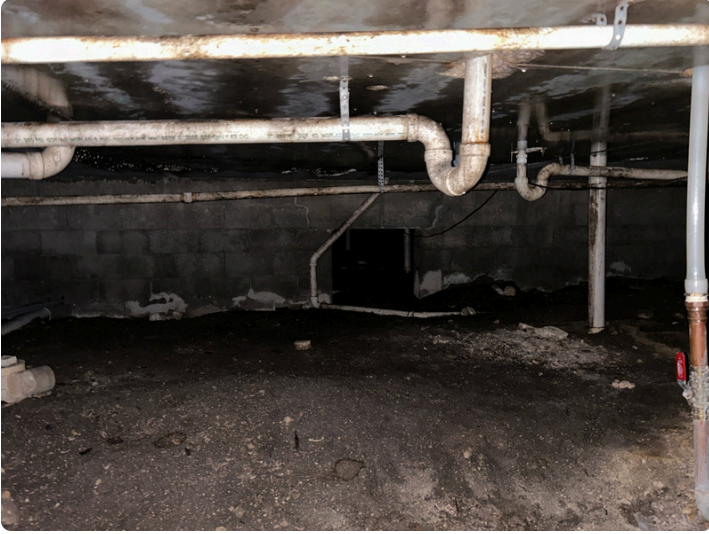
Walkways and floors were generally in good condition. Some condensation was forming under one unit towards the middle of the building. That section was noticeably cooler than the rest of the crawlspace. Continue monitoring to ensure no future issues arise.

Condensation in crawlspace

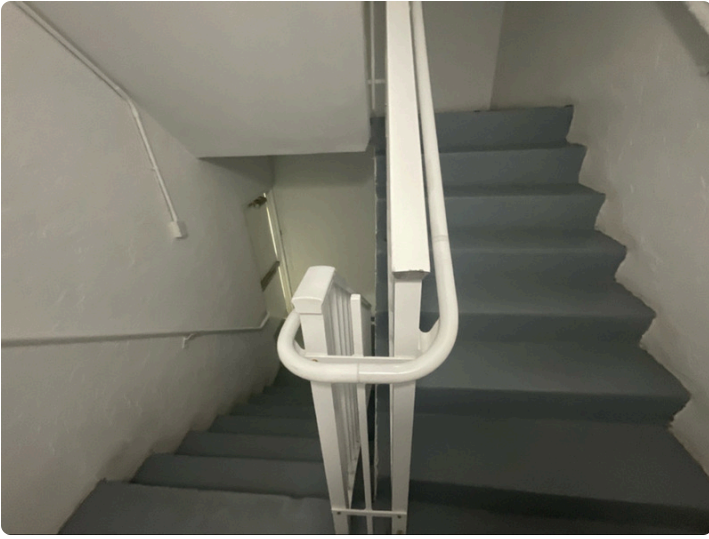
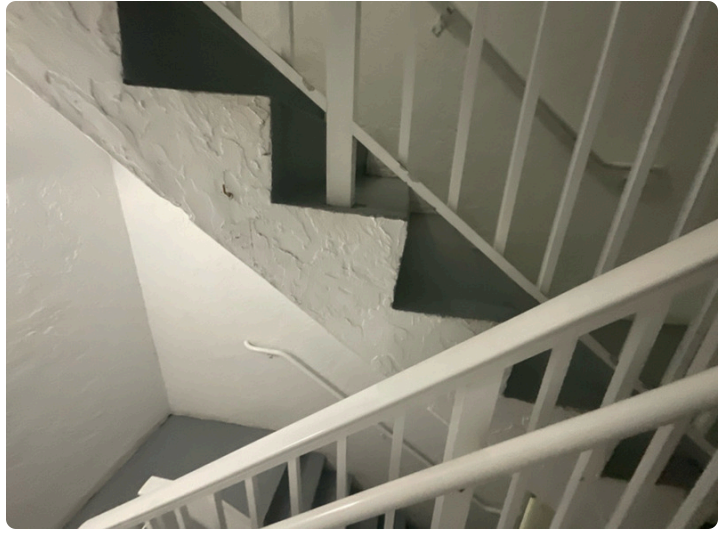
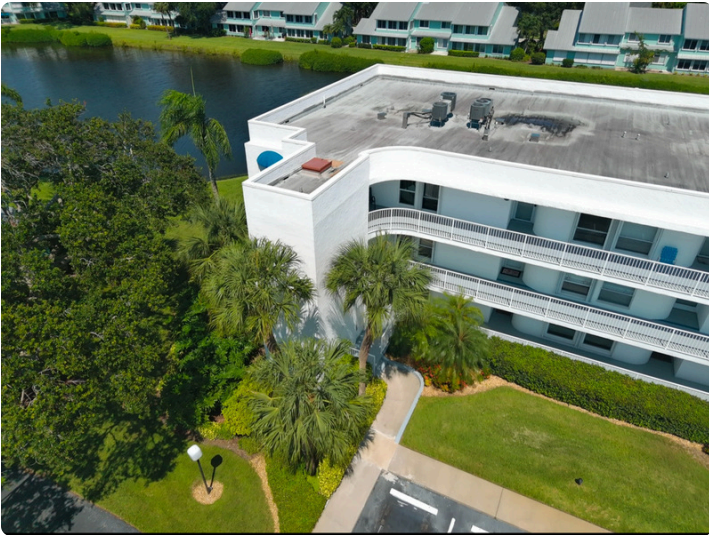
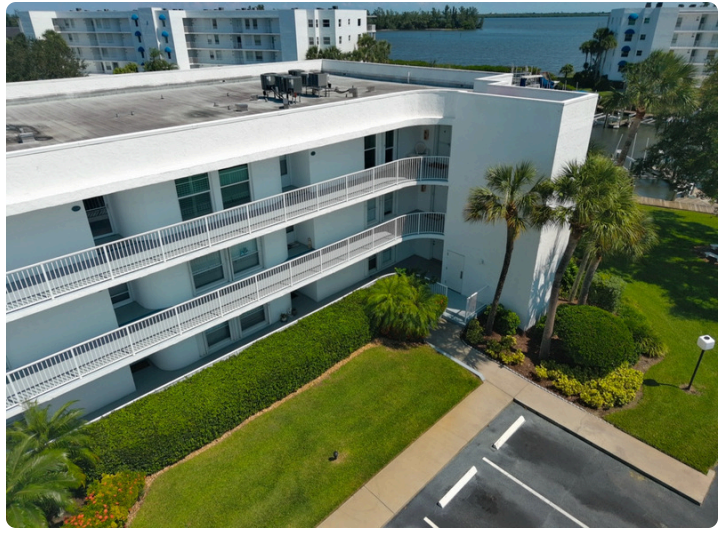
Stairs were in good condition

Typical stairway

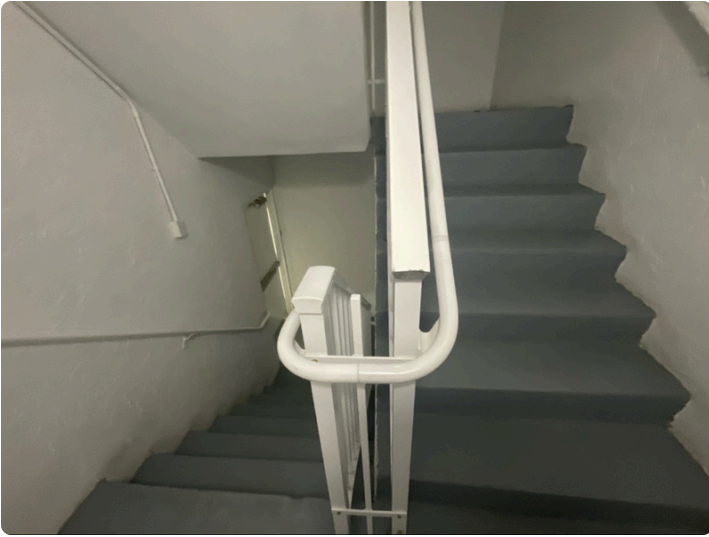
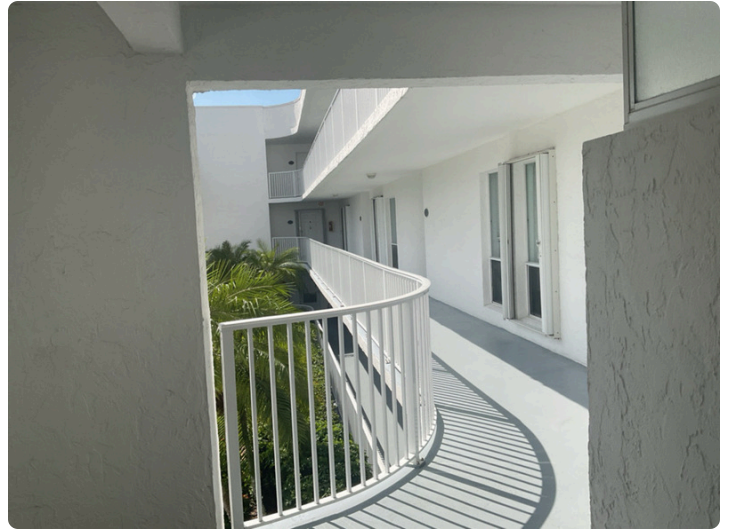
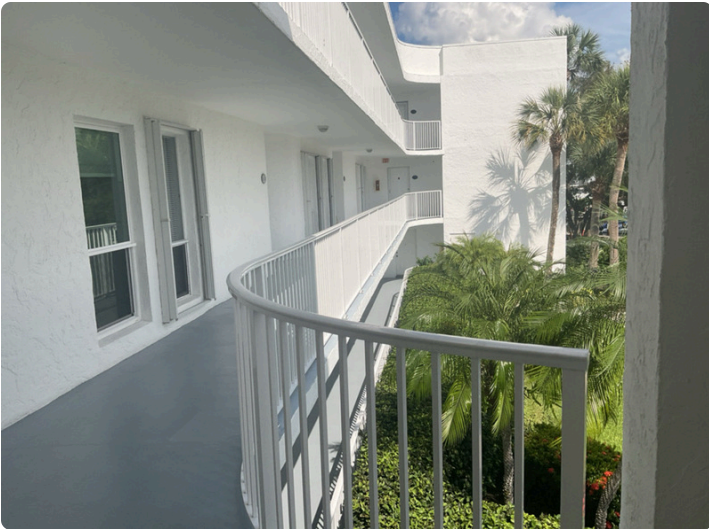
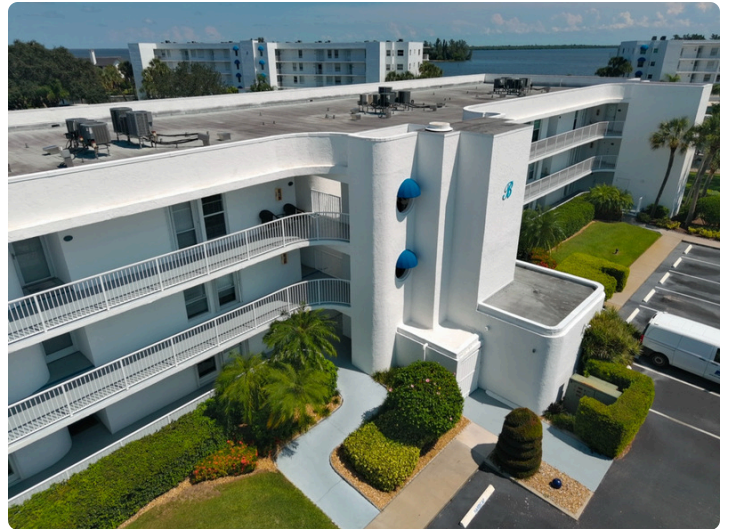
Railings were in good condition

Typical stairway railing

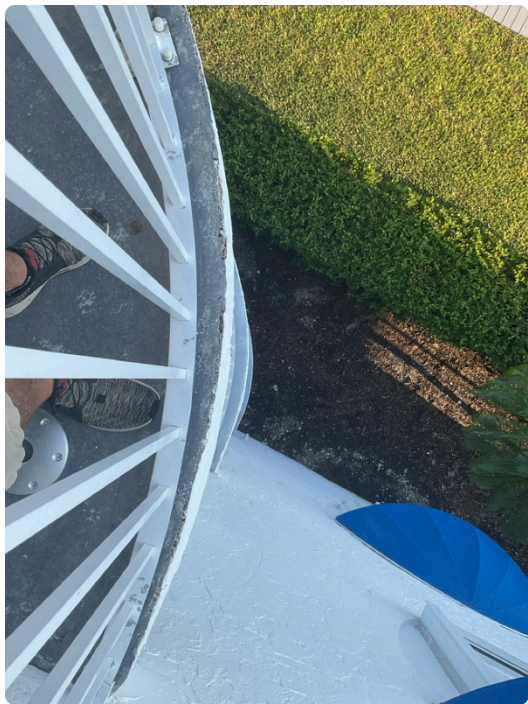
Cracking along balcony edge of Unit 6146

Maintenance	Chips were observed along some balcony edges. Inspect all balconies and patch any similar issues with mortar. Cut out in balcony of 6146 observed. Fill with non shrink grout and coat with a waterproofing coating.
Condition	Average

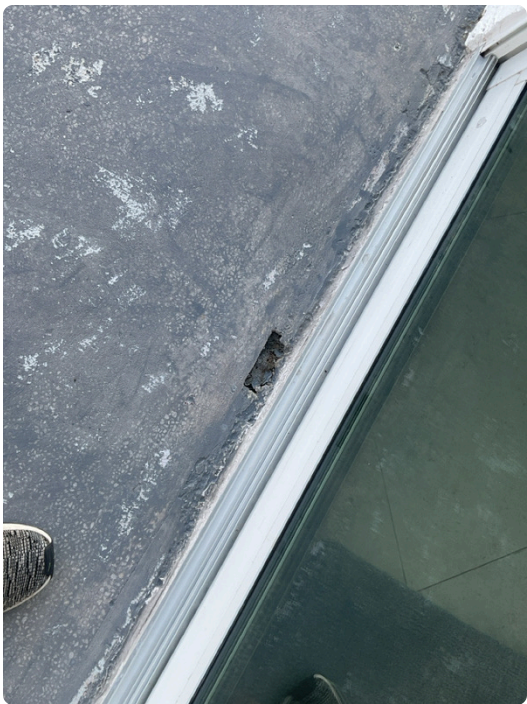
Cut out in balcony of Unit 6146

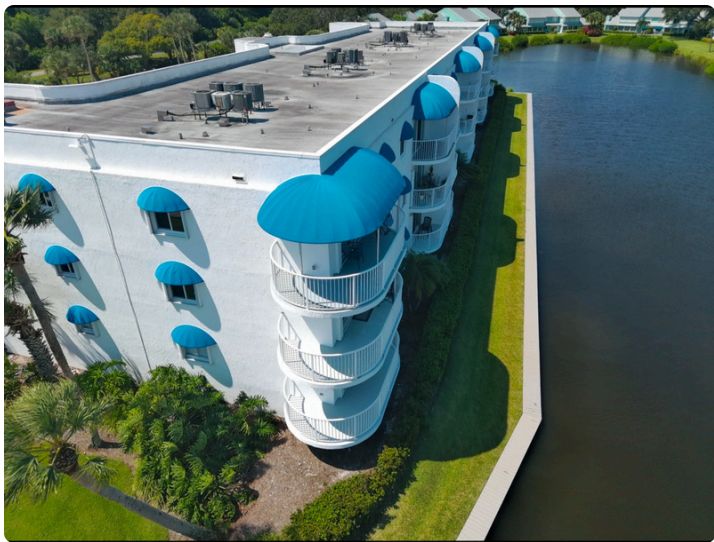
Balcony overview
