**Milestone Phase I Report
River Run Condominium Association, Inc. Building E**

1/16/2025

9/18/2024

Building E - 6000 River Run Drive, Sebastian, Florida 32958, USA

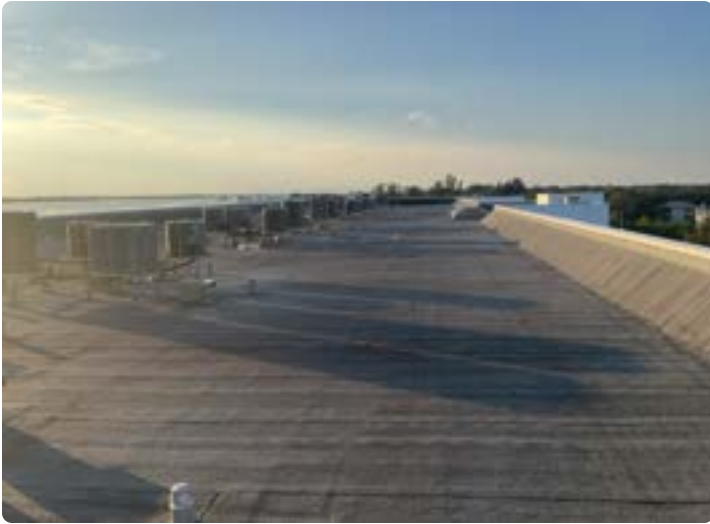
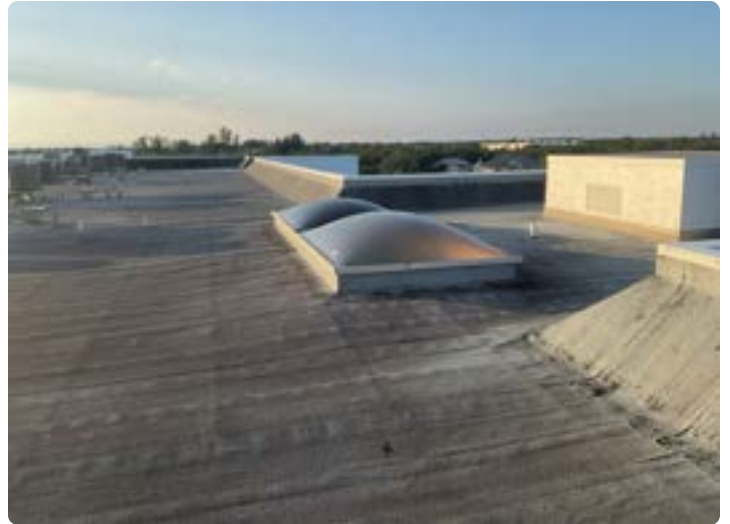
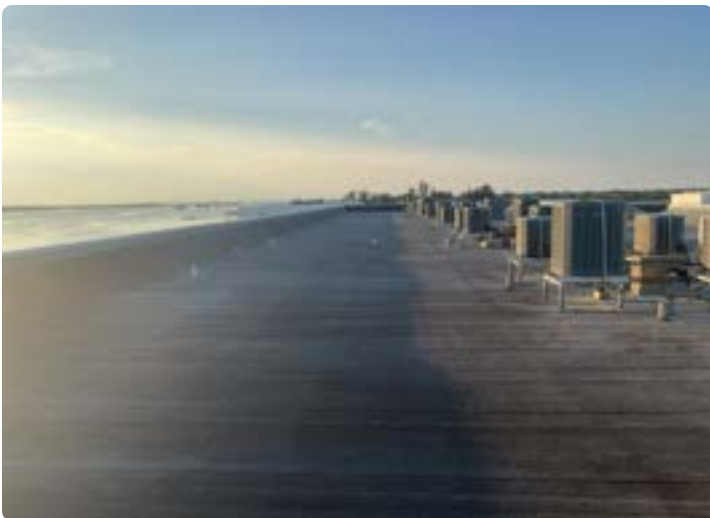
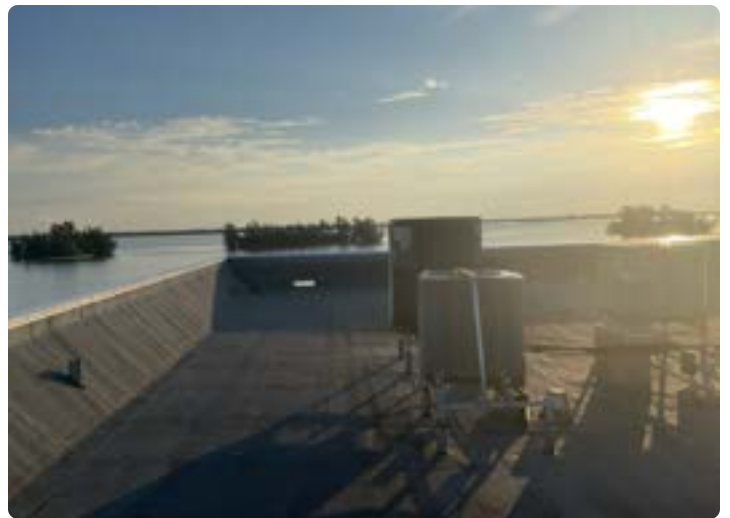
The roof is in good condition for its age.

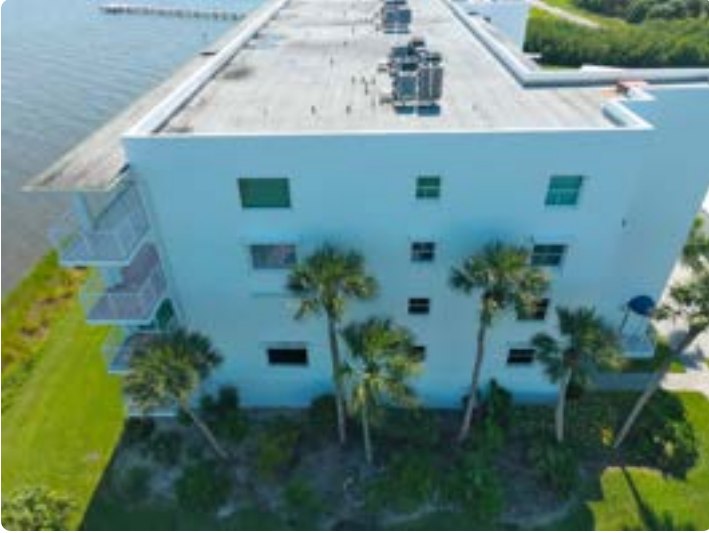
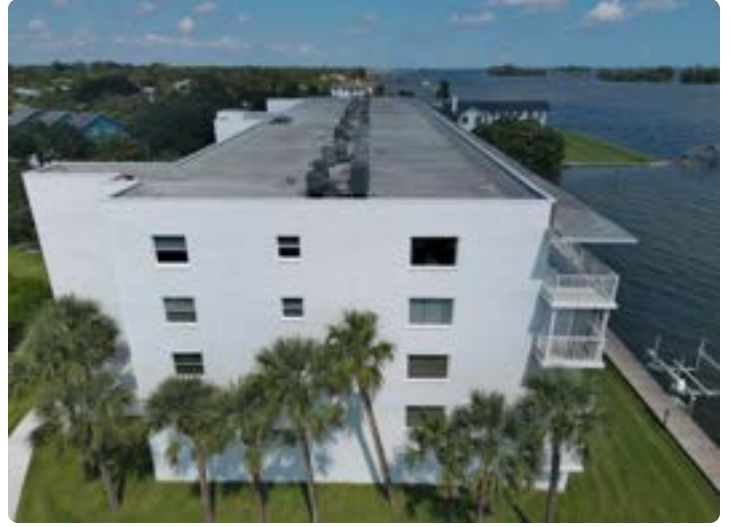
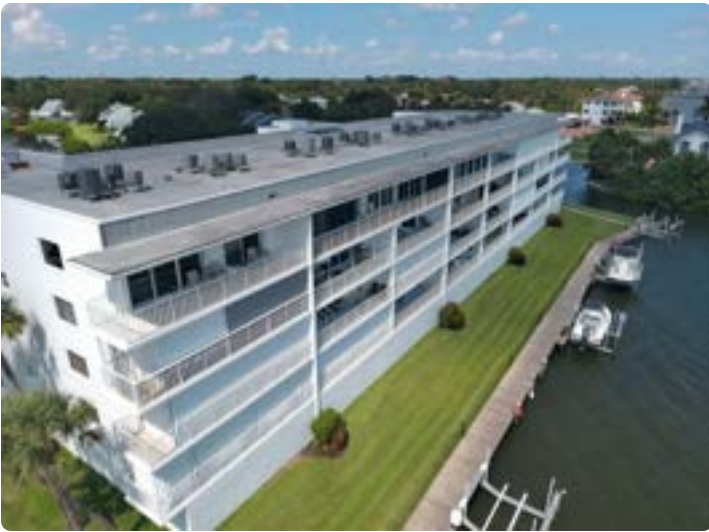
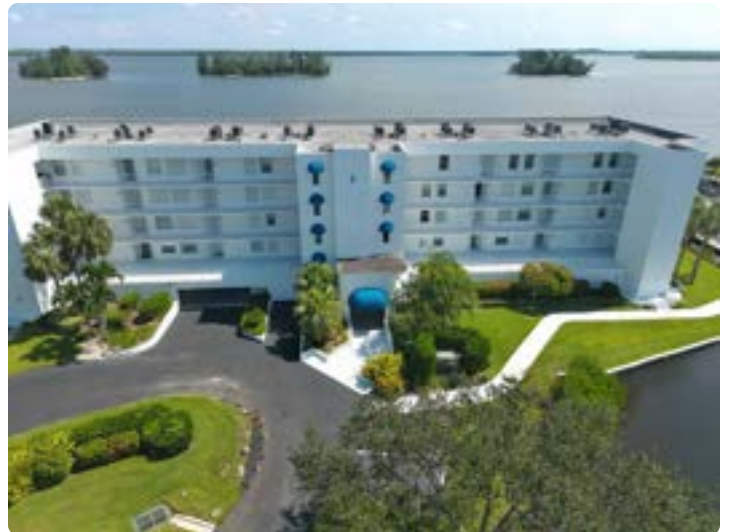
Exterior walls are in good condition for their age.

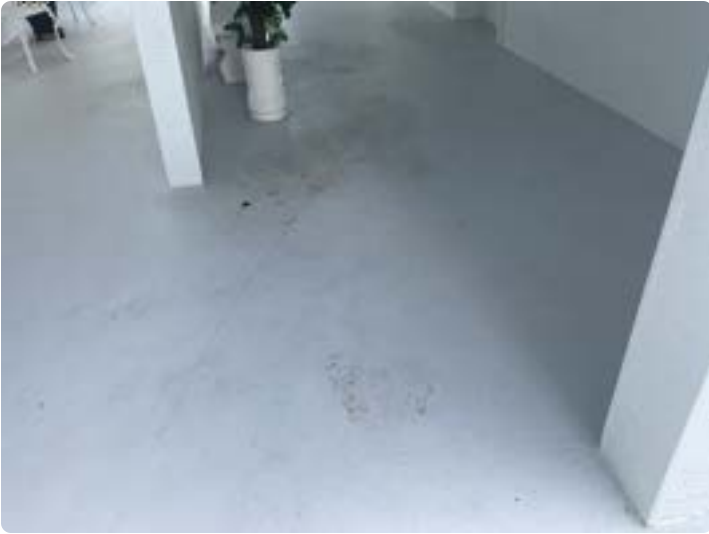
Maintenance	Delamination and debonded coating observed on walkways. Remove any coating that has become debonded, coat all affected after. Sealant cracking and failing along walkway-to-wall connections. Patch with new sealant.
Condition	Walkways are in average condition for their age. Some delamination and debonded coating were observed, along with sealant failure along the walkway-to-wall connection.

Delamination on first floor walkway

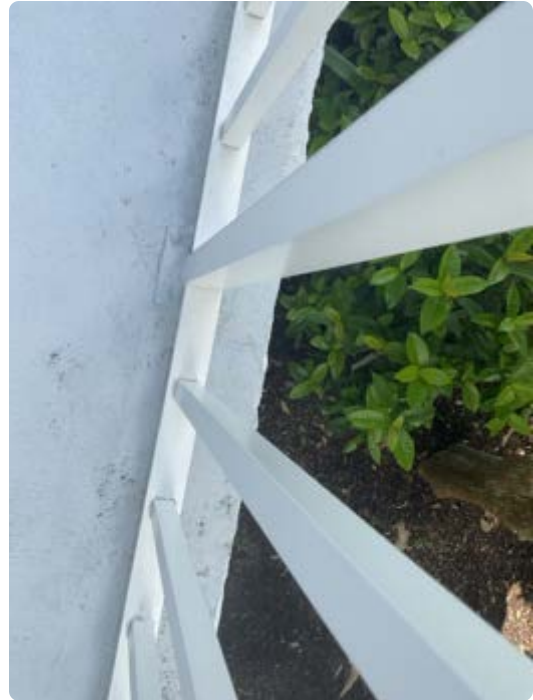
Coating cracking outside unit 6011

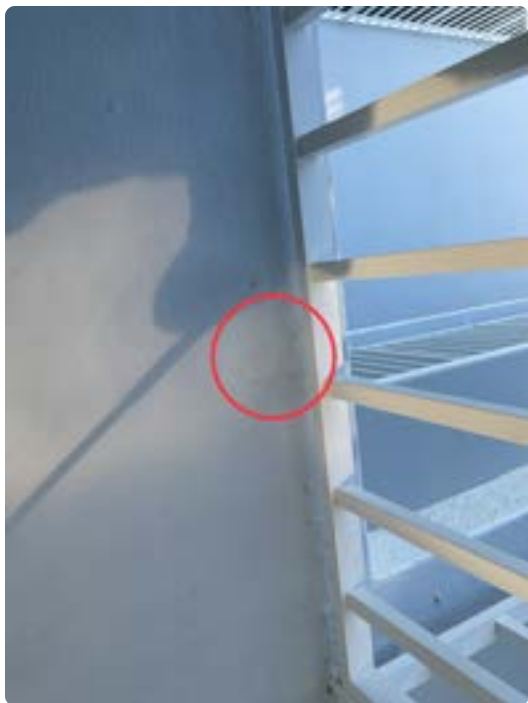
Debonded coating on walkway outside unit 6039

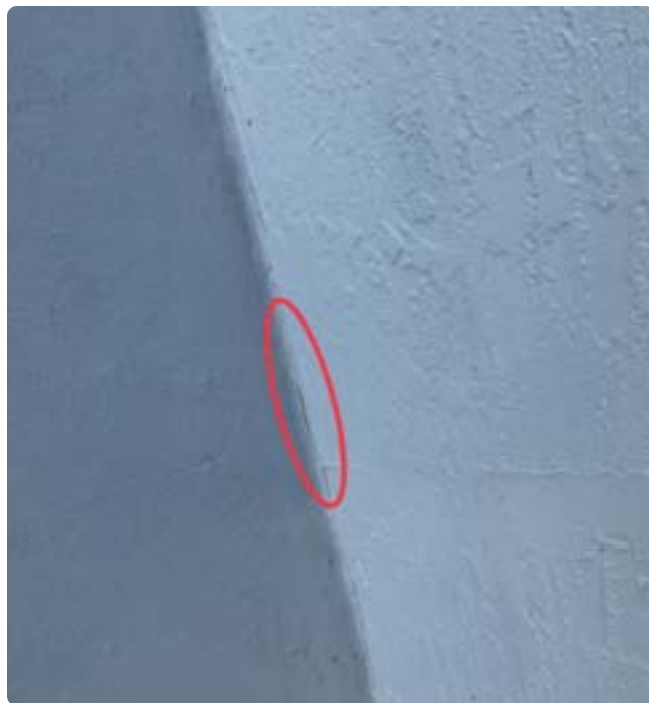
Cracking at walkway to wall connection outside unit 6023

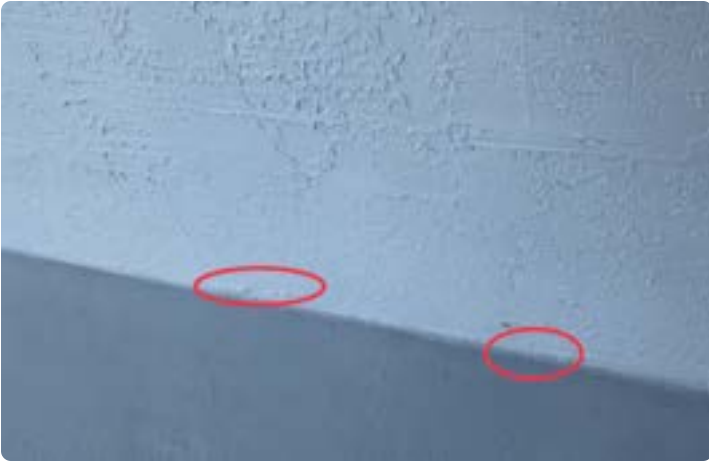
Cracking at walkway to wall connection outside unit 6023

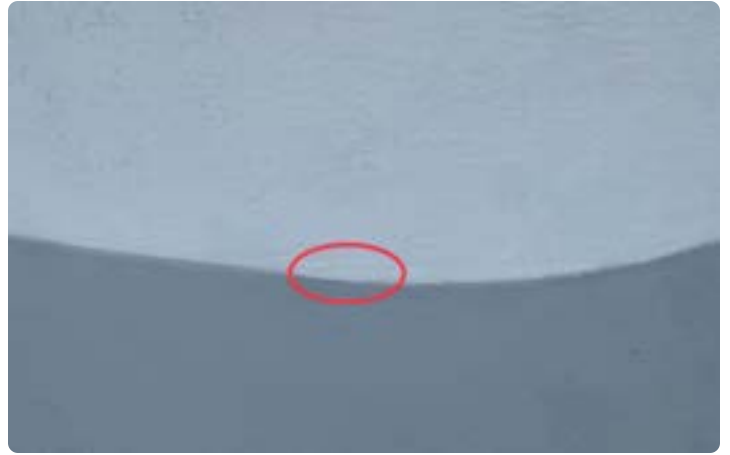
Cracking at walkway to wall connection outside unit 6021

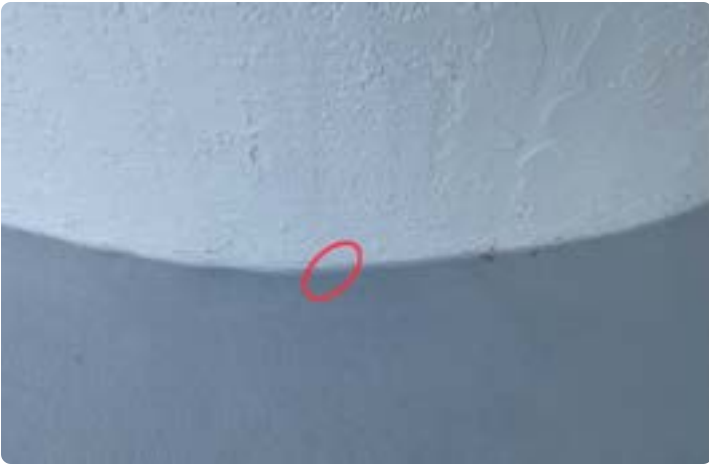
Cracking at walkway to wall connection outside unit 6037

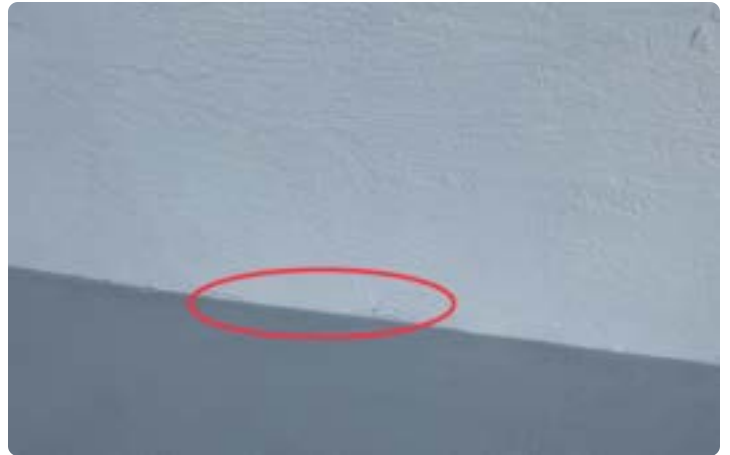
Cracking at walkway to wall connection outside unit 6041

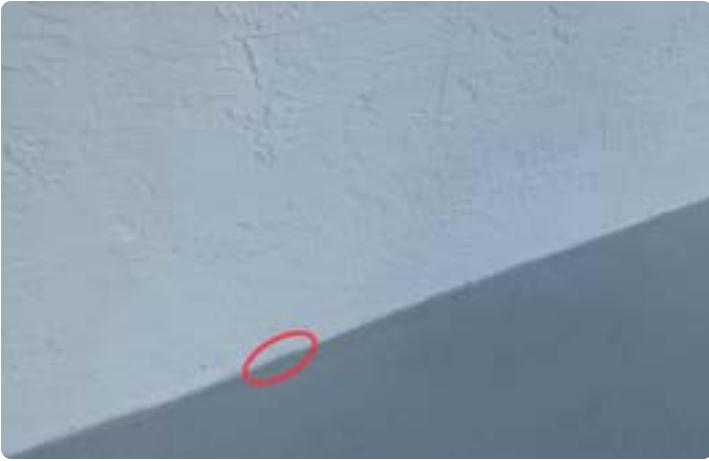
Cracking at walkway to wall connection outside unit 6041

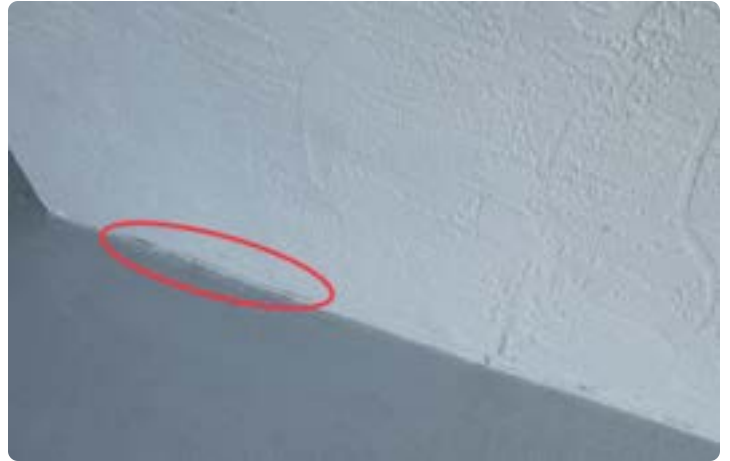
Cracking at walkway to wall connection outside unit 6041

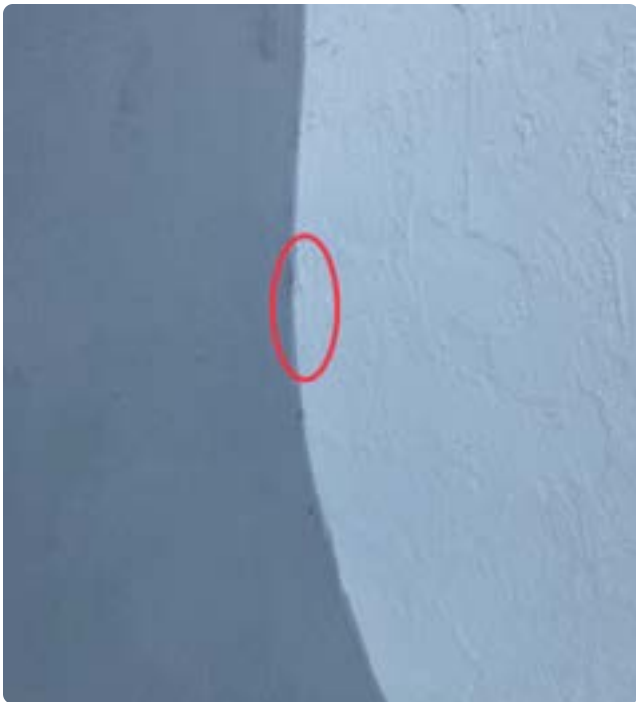
Cracking at walkway to wall connection outside unit 6045

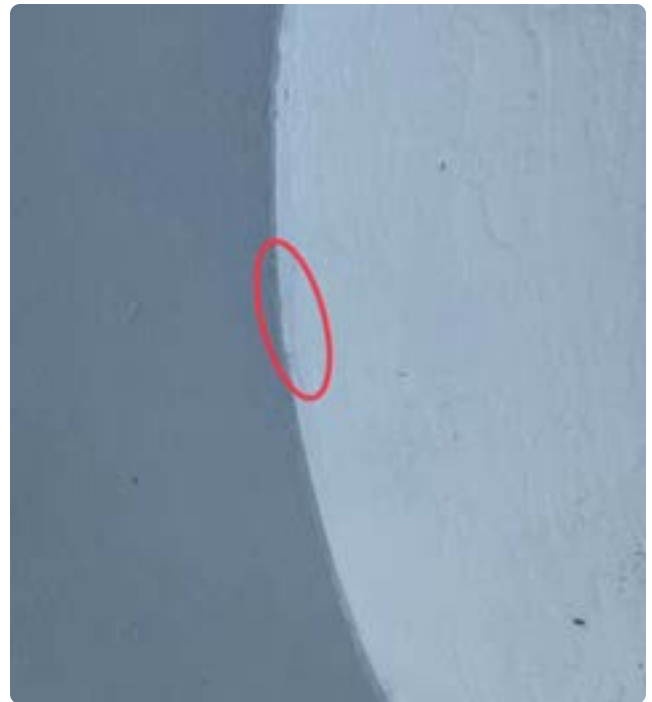
Cracking at walkway to wall connection outside unit 6059

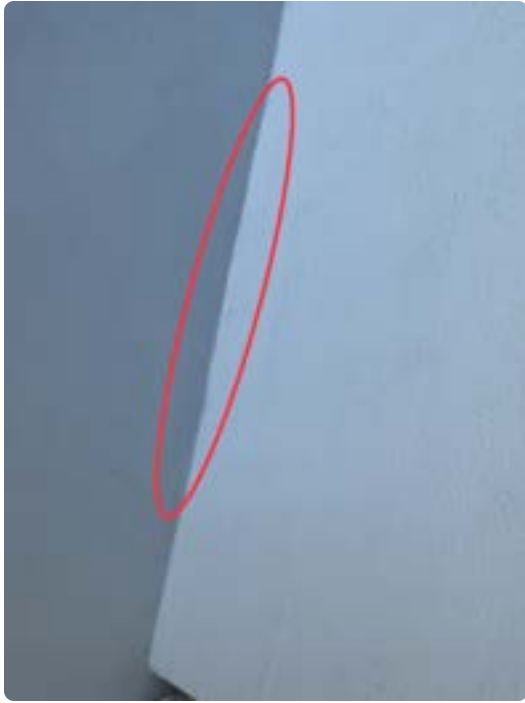
Cracking at walkway to wall connection outside unit 6055

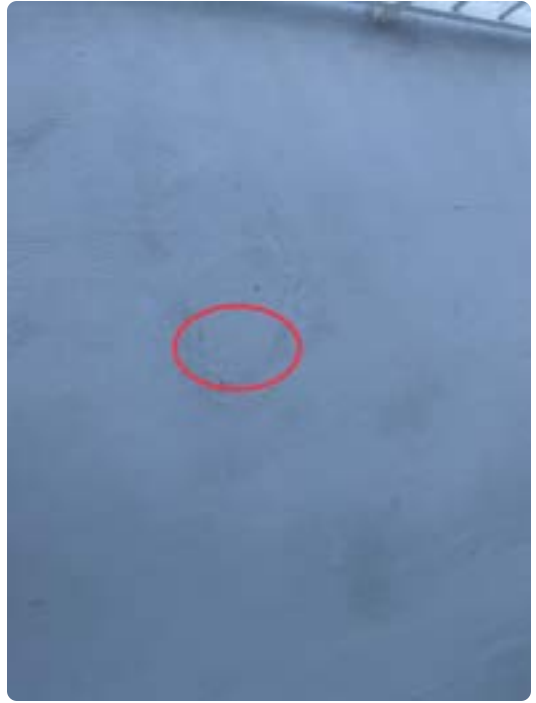
Debanded coating outside unit 6027

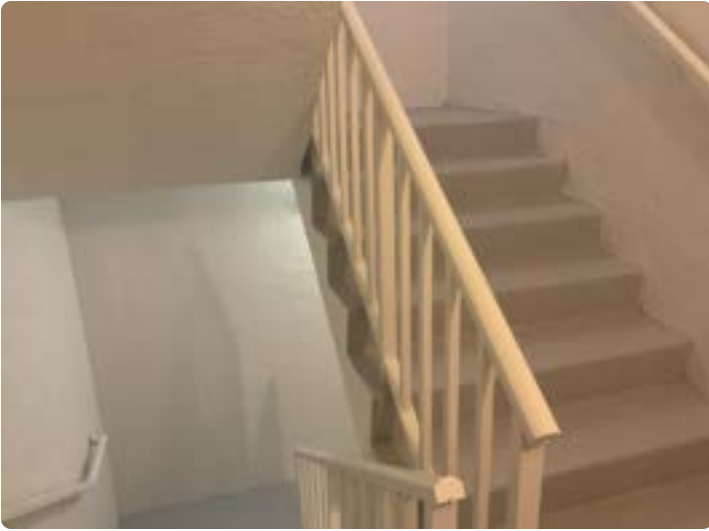
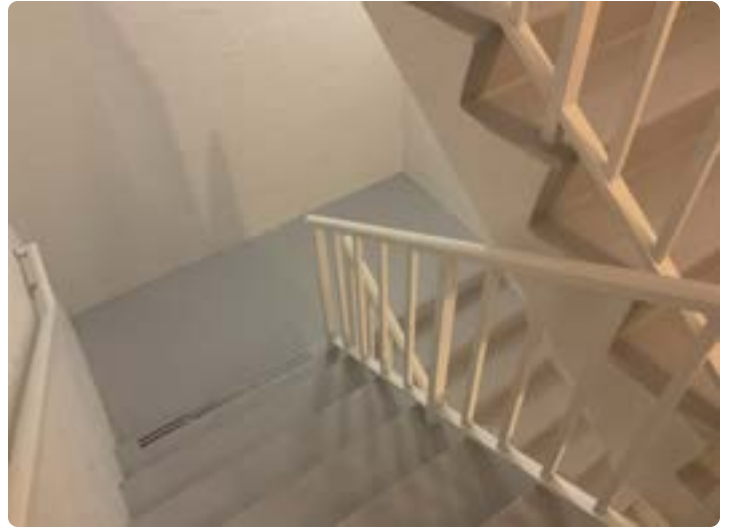
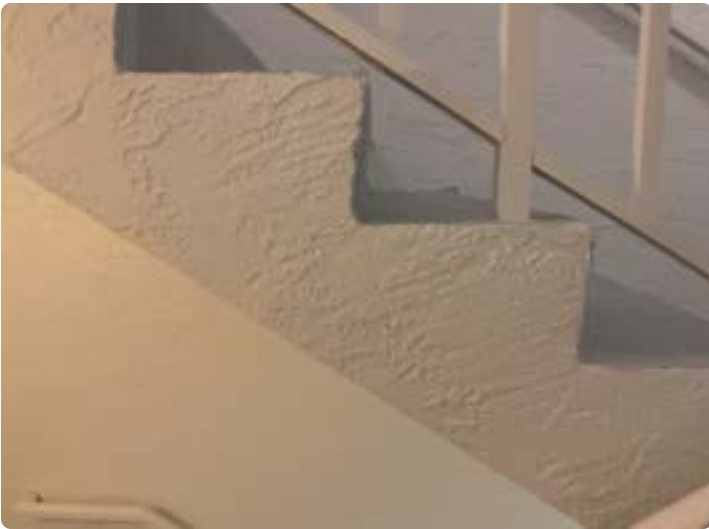
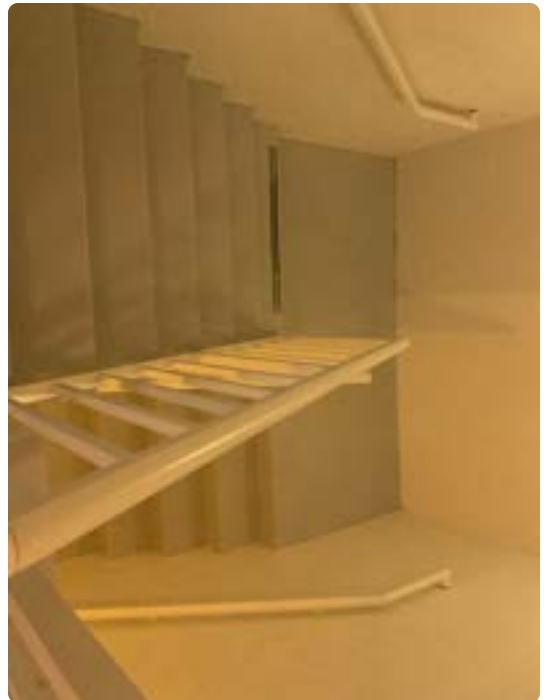
Stairways are in good condition for their age.

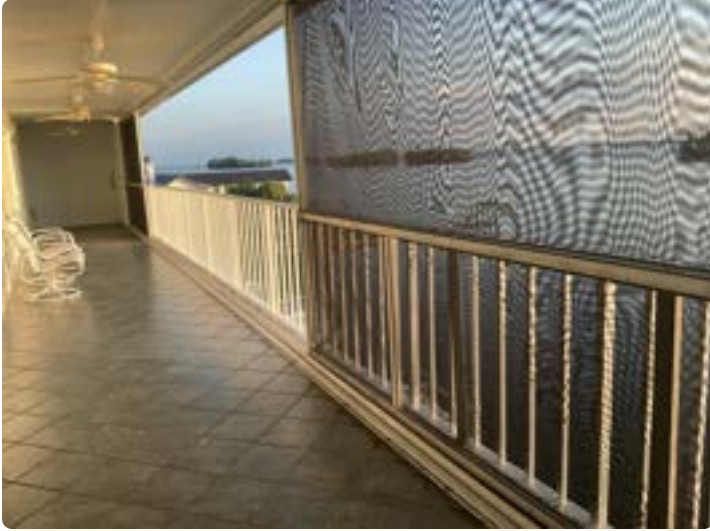
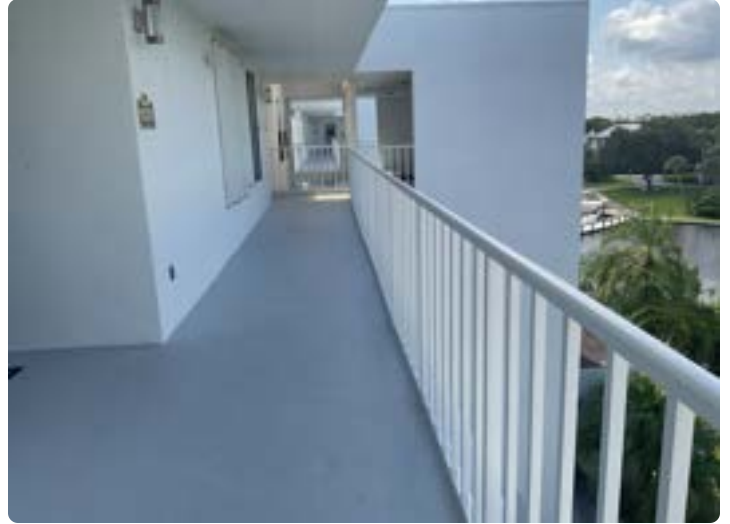
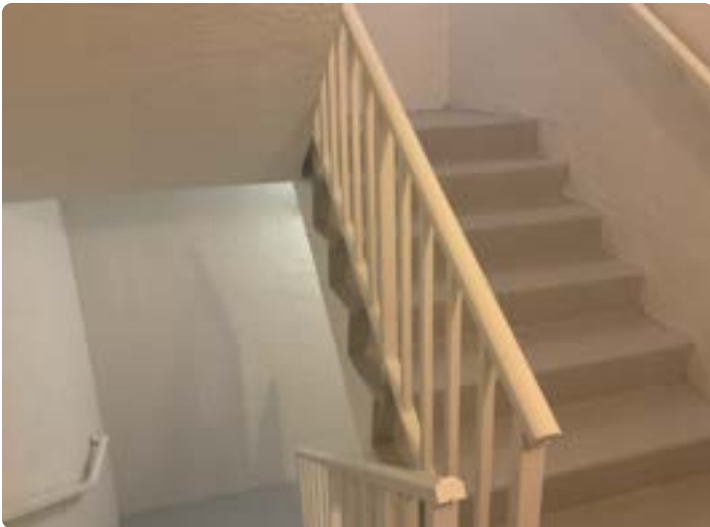
Railings are in good condition for their age.

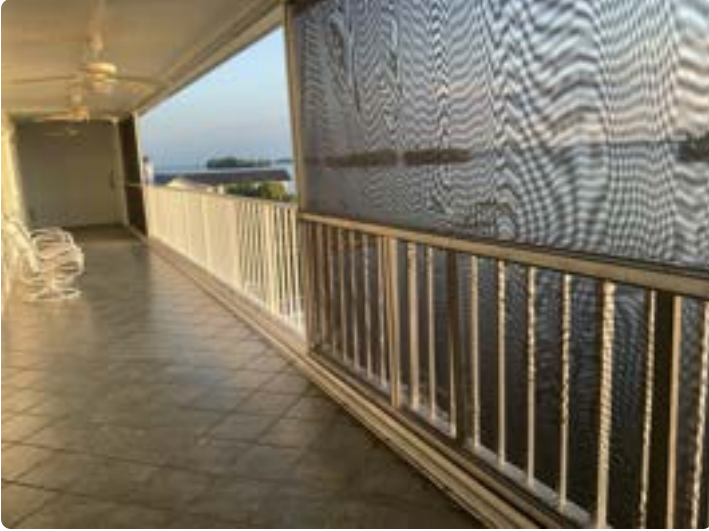
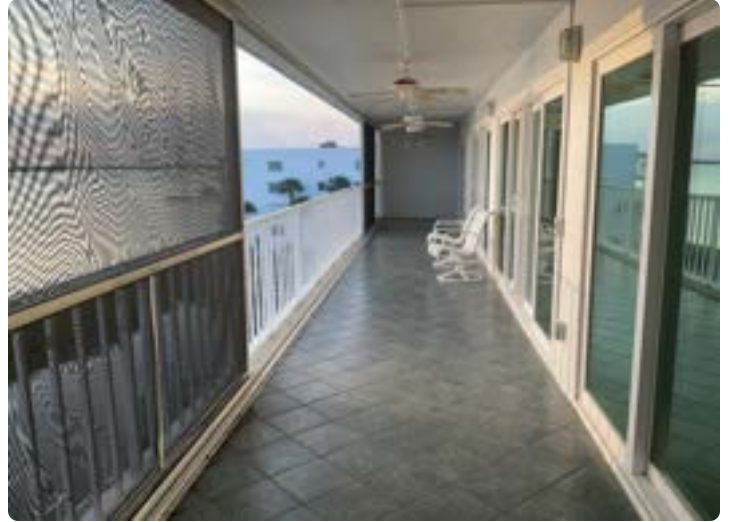
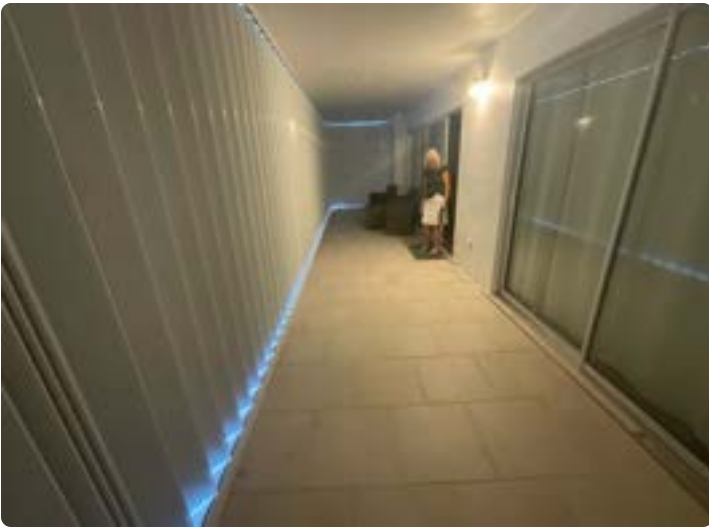
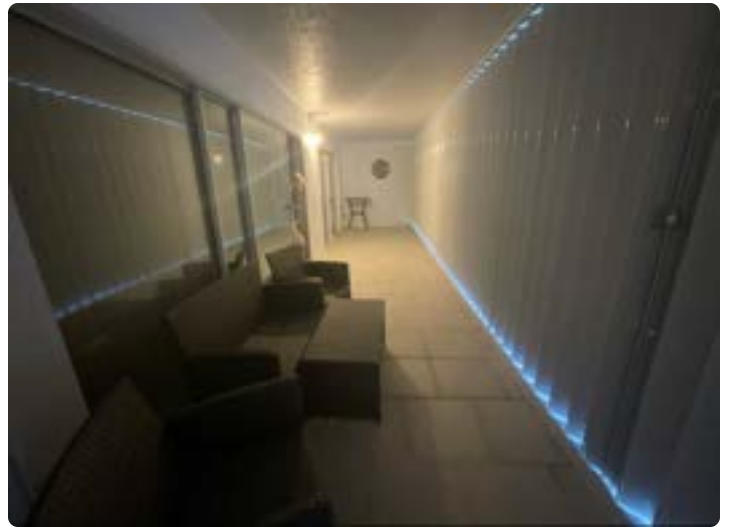
Balconies are in good condition for their age.

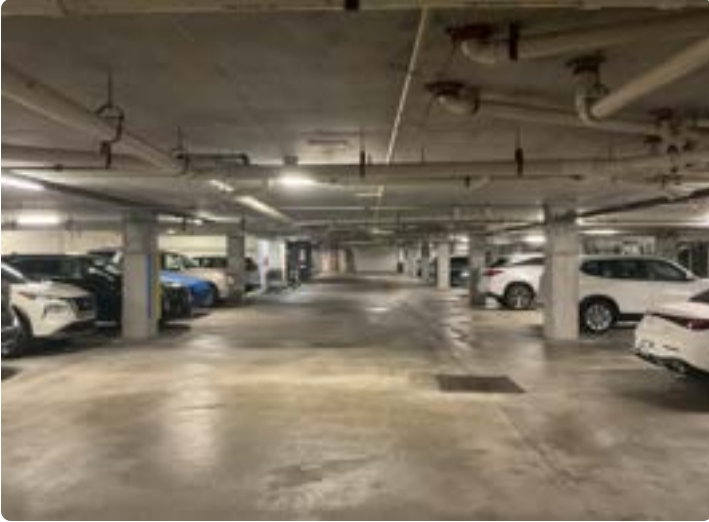
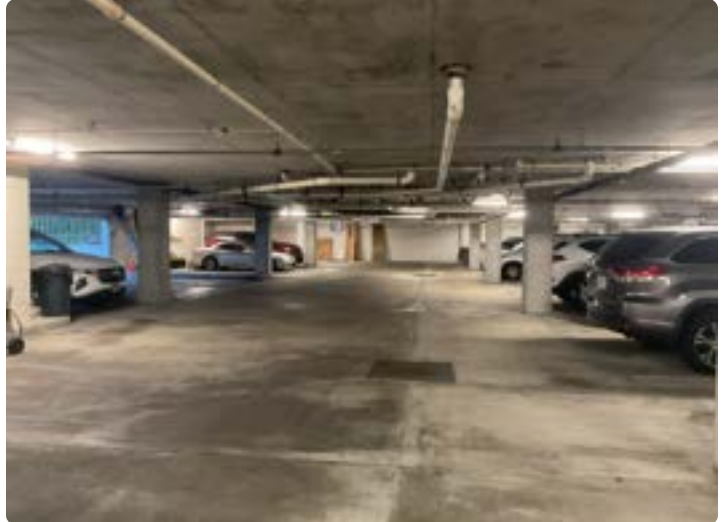
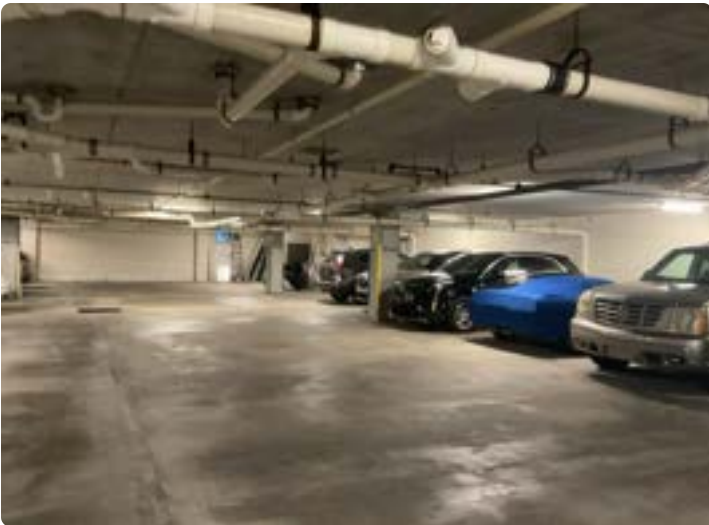
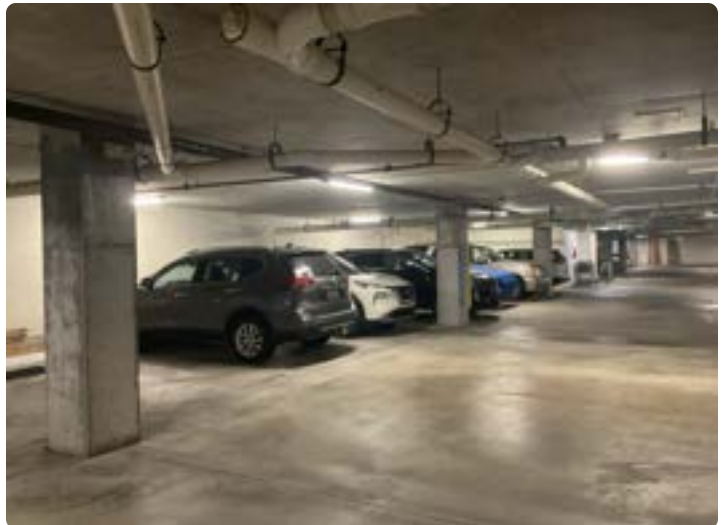
Parking garage is in average condition for its age.
