Uniform Mitigation Verification Inspection Form

Inspection Date 11/10/2011		
Owner Information		
Owner Name: Ocean Villas III	Building 1100	Contact Person:
Address: 2400 S. Ocean Drive		Home Phone:
City: Ft. Pierce	Zip: 34949	Work Phone:
County: St. Lucie		Cell Phone:
Insurance Company:		Policy #:
Year of Home : 1977	# of Stories: 3	Email:

Uniform Mitigation Verification Inspection Form - Pictures

Owner Name: Ocean Villas III Building 1100

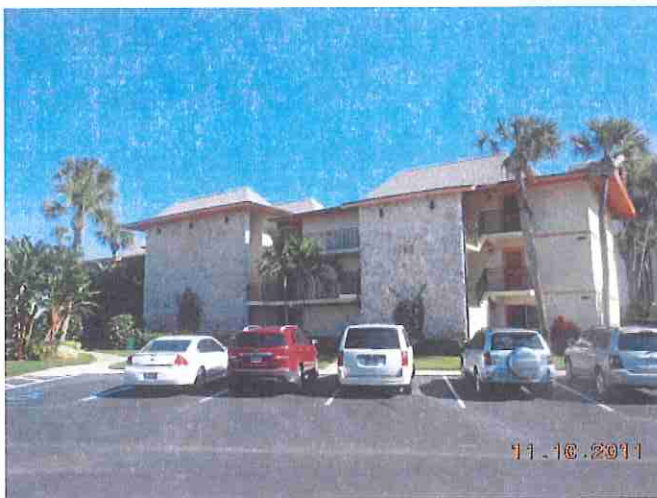
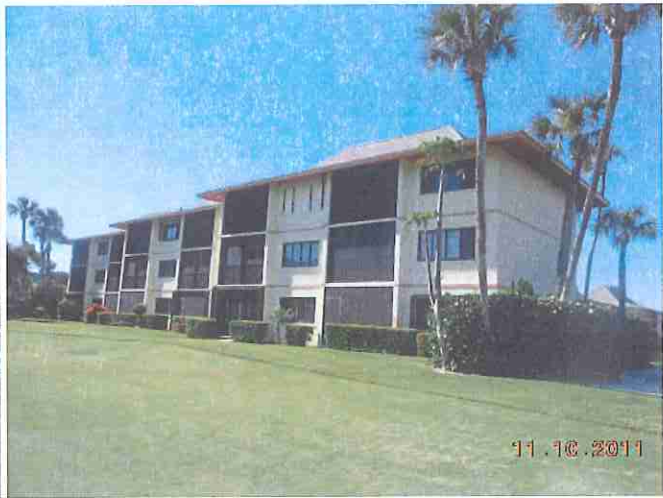
5. Roof Geometry A

- A. Hip Roof Hip roof with no other roof shapes greater than 10% of the total building perimeter.
- B. Non-Hip Roof Any other roof shape or combination of roof shapes including hip, gable, gambrel, mansard and other roof shapes not including flat roofs.
- C. Flat Roof Flat roof shape greater than 100 square feet or 10% of the entire roof, whichever is greater.

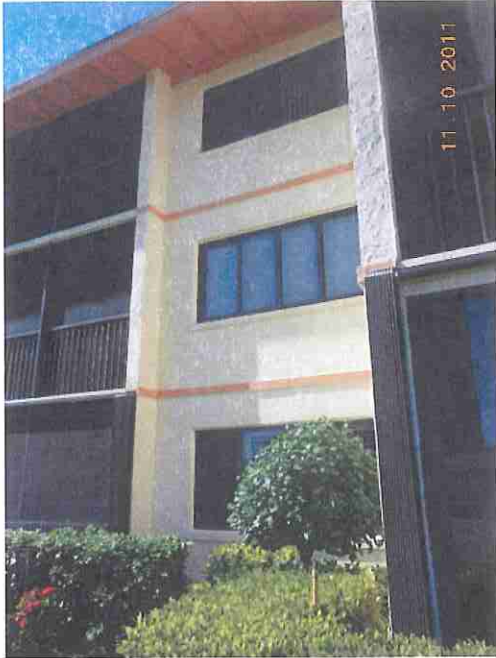
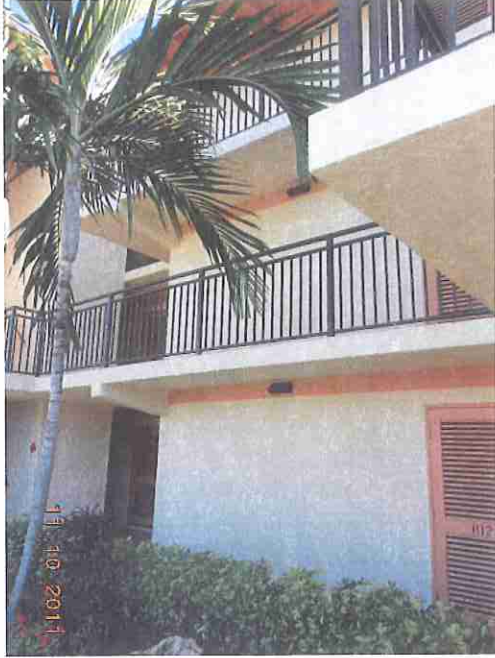
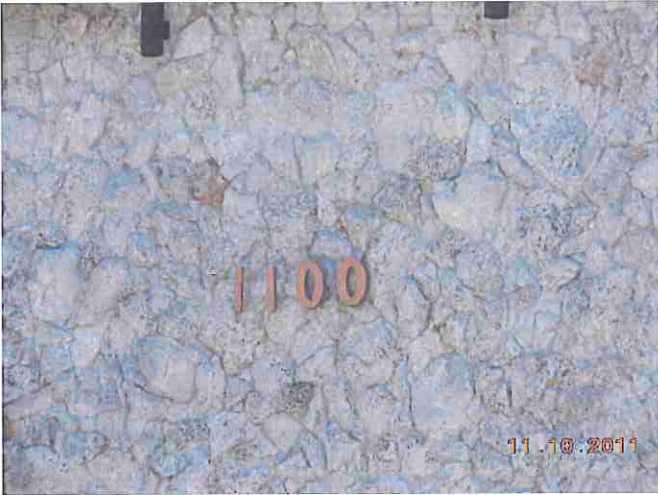
7. Wall Construction C

- A. Wood Frame %
- B. Un-Reinforced Masonry %
- C. Reinforced Masonry 100%
- D. Poured Concrete %
- E. Other: _____ %

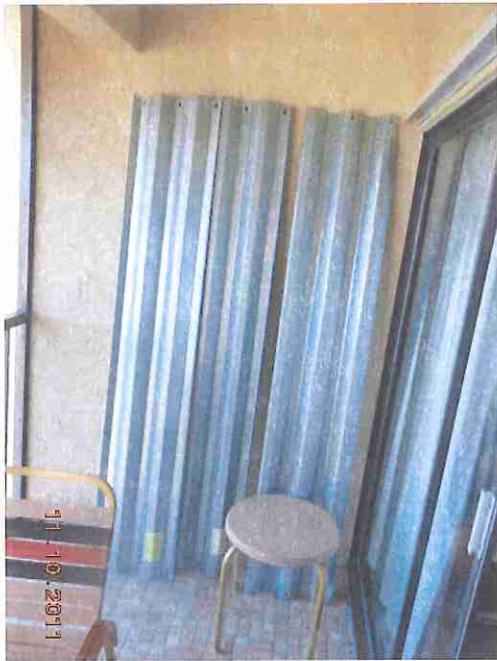
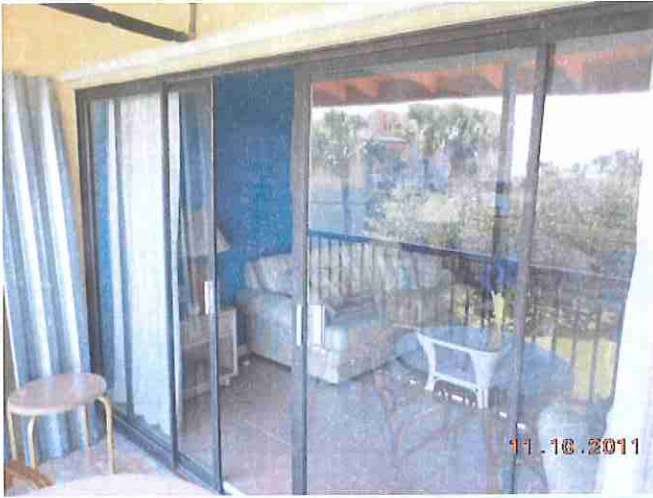
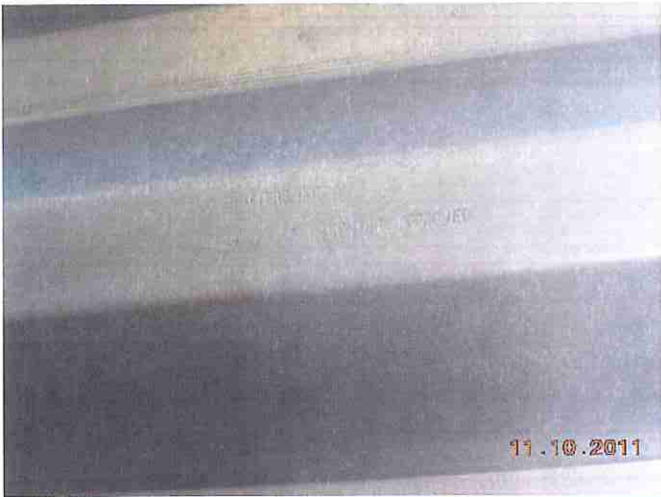
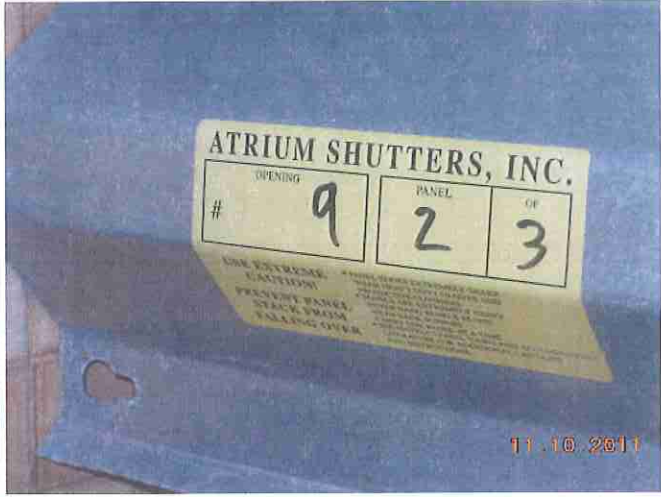
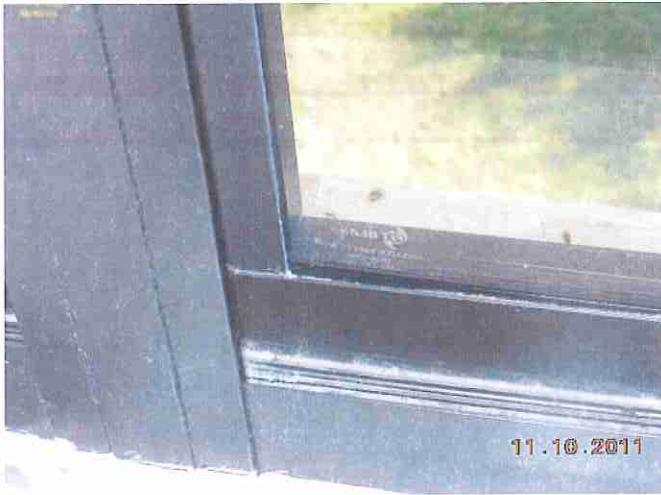
9. Opening Protection A

- A. All Exterior Openings (Glazed and Unglazed) All exterior openings are fully protected at a minimum with impact resistant coverings, impact resistant doors and/or impact resistant window units that are listed as wind borne debris protection devices in the product approval system of the State of Florida or Miami-Dade County and meet the requirements of one of
