## Wind Mitigation Report

Park Shores of Indian River Shores Condominium Association

131 Park Shores Circle, Indian River Shores, FL 32963

# Uniform Mitigation Verification Inspection Form

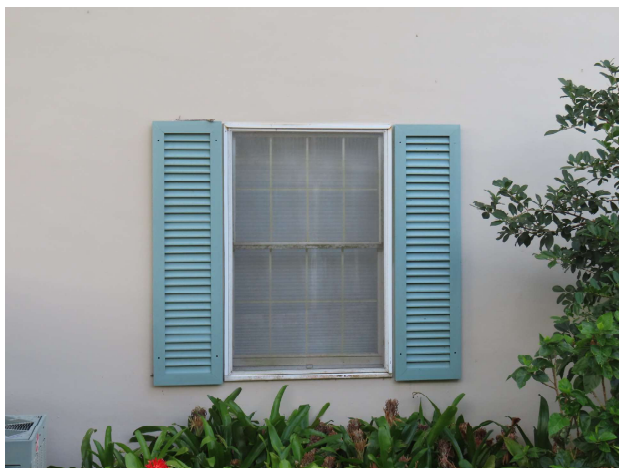
| Opening Protection Level Chart<br>Place an "X" in each row to identify all forms of protection in use for each opening type. Check only one answer below (A thru X), based on the weakest form of protection (lowest row) for any of the Glazed openings and indicate the weakest form of protection (lowest row) for Non-Glazed openings. | | Glazed Openings | | | | Non-Glazed Openings | |
|---|---|---|---|---|---|---|---|
| X | No Windborne Debris Protection | <input checked="" type="checkbox"/> | <input type="checkbox"/> | <input type="checkbox"/> | <input type="checkbox"/> | <input checked="" type="checkbox"/> | <input type="checkbox"/> |

No protection

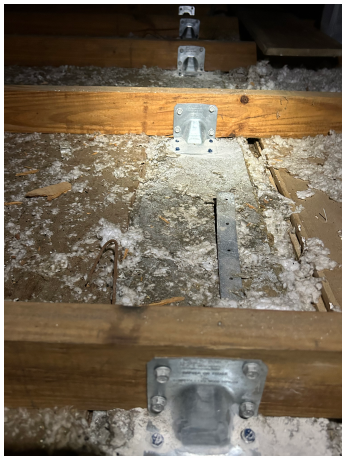
- ☒ Secured to truss/rafter with a minimum of three (3) nails, **and**
- ☒ Attached to the wall top plate of the wall framing, or embedded in the bond beam, with less than a ½" gap from the blocking or truss/rafter **and** blocked no more than 1.5" of the truss/rafter, **and** free of visible severe corrosion.

- ☒ B. Clips
  - ☒ Metal connectors that do not wrap over the top of the truss/rafter, **or**
  - ☐ Metal connectors with a minimum of 1 strap that wraps over the top of the truss/rafter and does not meet the nail position requirements of C or D, but is secured with a minimum of 3 nails.

Roof to Wall - Clips

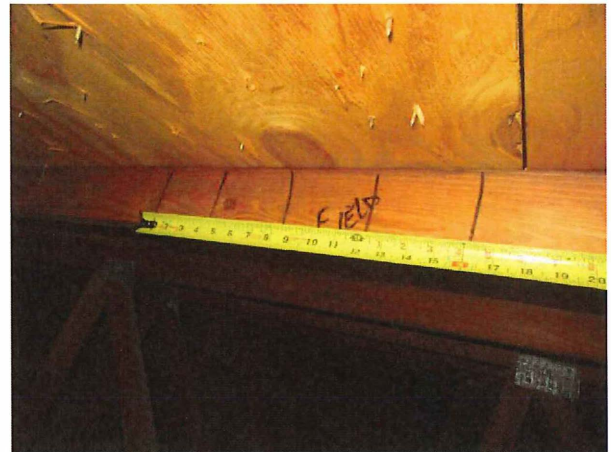
Roof Deck Nail Spacing - Field

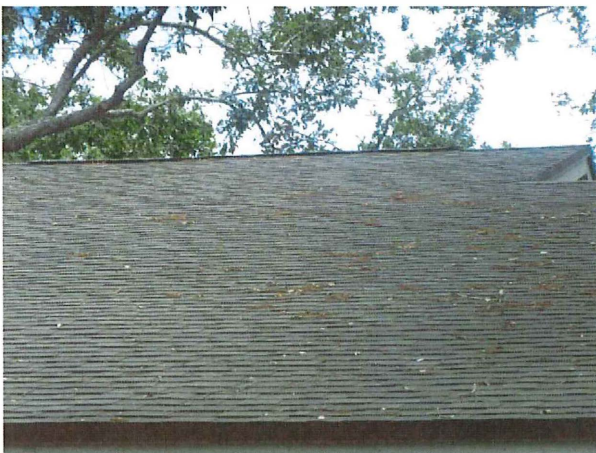
| 2.1 Roof Covering Type: | Permit Application Date | FBC or MDC Product Approval # | Year of Original Installation or Replacement | No Information Provided for Compliance |
|---|---|---|---|---|
| <input checked="" type="checkbox"/> 1. Asphalt/Fiberglass Shingle | 5/17/16 | #17769 | 2016 | <input type="checkbox"/> |

Re-Roof 5/17/16, Permit ##17769

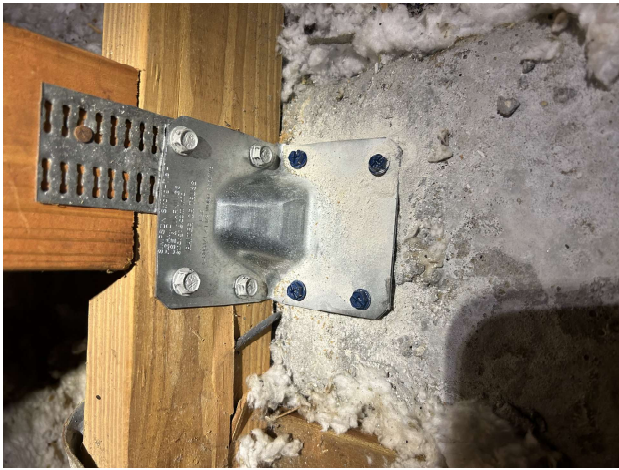
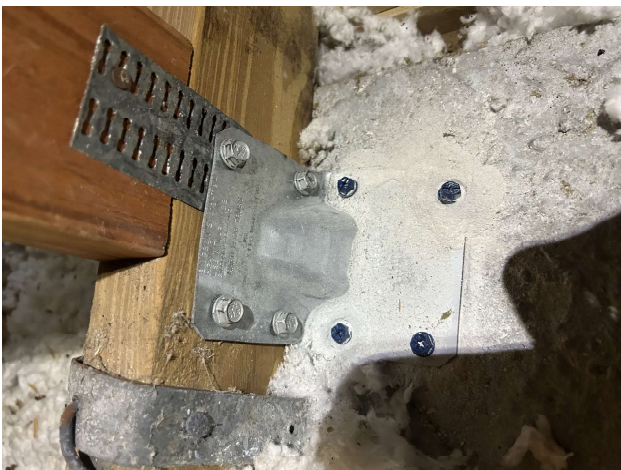
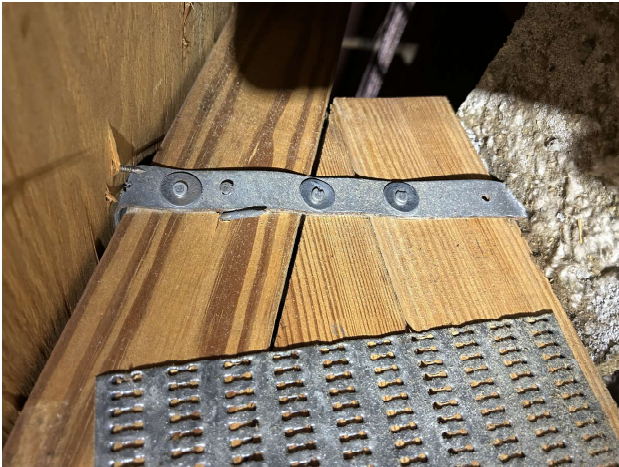
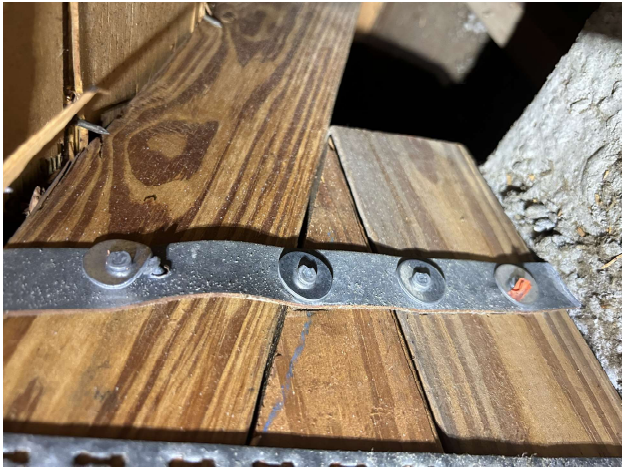
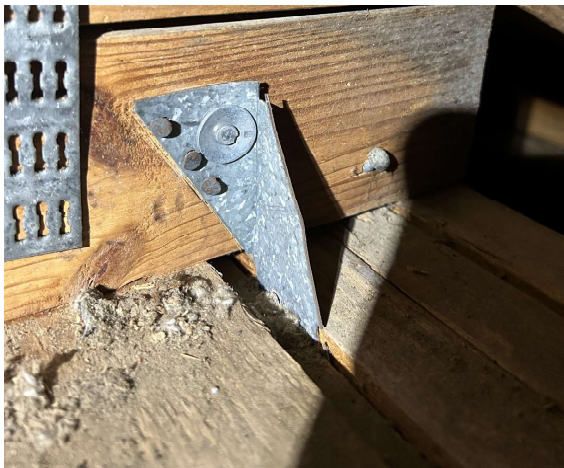
Roof to wall attachment - Clips
