## Wind Mitigation Report

Park Shores of Indian River Shores Condominium Association

123 Park Shores Circle, Indian River Shores, FL 32963

# Uniform Mitigation Verification Inspection Form

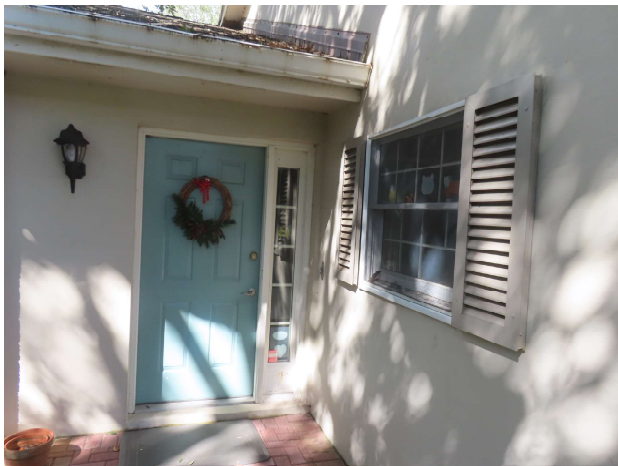
| Opening Protection Level Chart<br>Place an "X" in each row to identify all forms of protection in use for each opening type. Check only one answer below (A thru X), based on the weakest form of protection (lowest row) for any of the Glazed openings and indicate the weakest form of protection (lowest row) for Non-Glazed openings. | | Glazed Openings | | | | Non-Glazed Openings | |
|---|---|---|---|---|---|---|---|
| X | No Windborne Debris Protection | <input checked="" type="checkbox"/> | <input type="checkbox"/> | <input type="checkbox"/> | <input type="checkbox"/> | <input checked="" type="checkbox"/> | <input type="checkbox"/> |

Non rated door - No protection

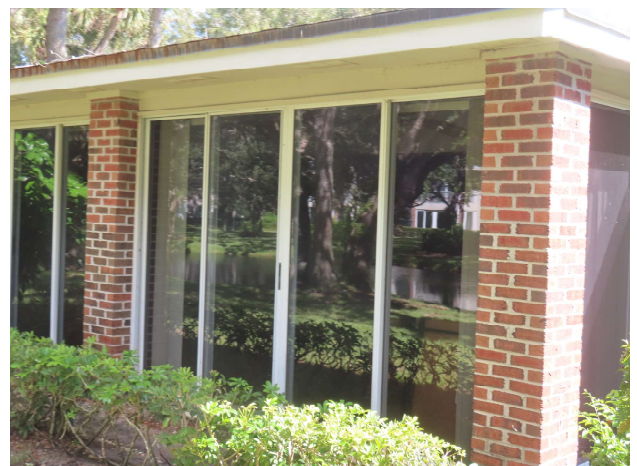
No protection

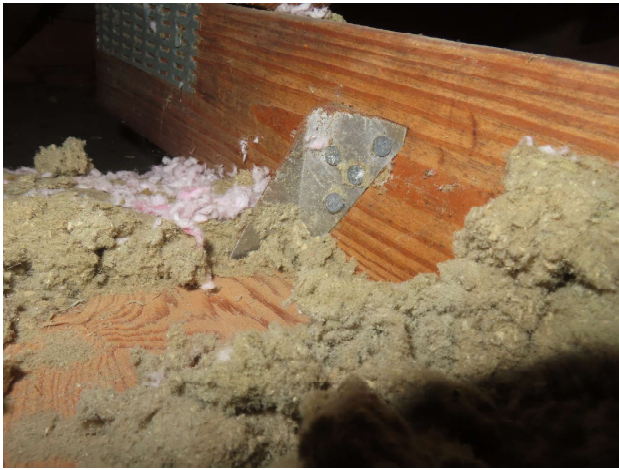
- ☒ Secured to truss/rafter with a minimum of three (3) nails, **and**
- ☒ Attached to the wall top plate of the wall framing, or embedded in the bond beam, with less than a ½" gap from the blocking or truss/rafter **and** blocked no more than 1.5" of the truss/rafter, **and** free of visible severe corrosion.
- ☒ B. Clips
  - ☒ Metal connectors that do not wrap over the top of the truss/rafter, **or**
  - ☐ Metal connectors with a minimum of 1 strap that wraps over the top of the truss/rafter and does not meet the nail position requirements of C or D, but is secured with a minimum of 3 nails.
- ☐ C. Single Wraps

Roof to wall attachment - Clips

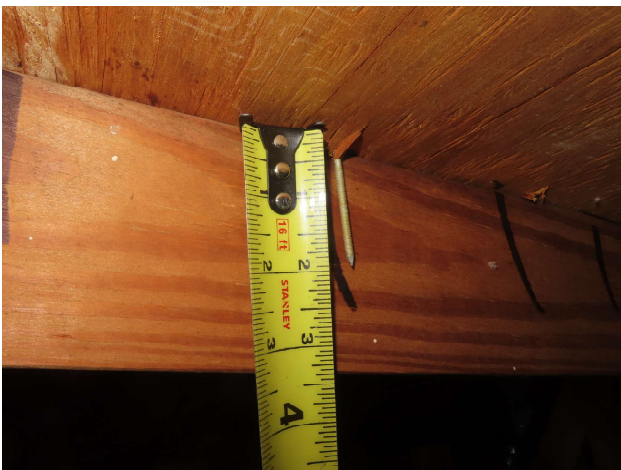
- ☒ C. Plywood/OSB roof sheathing with a minimum thickness of 7/16" inch attached to the roof truss/rafter (spaced a maximum of 24" inches o.c.) by 8d common nails spaced a maximum of 6" inches in the field. -OR- Dimensional lumber/Tongue & Groove decking with a minimum of 2 nails per board (or 1 nail per board if each board is equal to or less than 6 inches in width). -OR-

Roof deck attachment - 8d nails

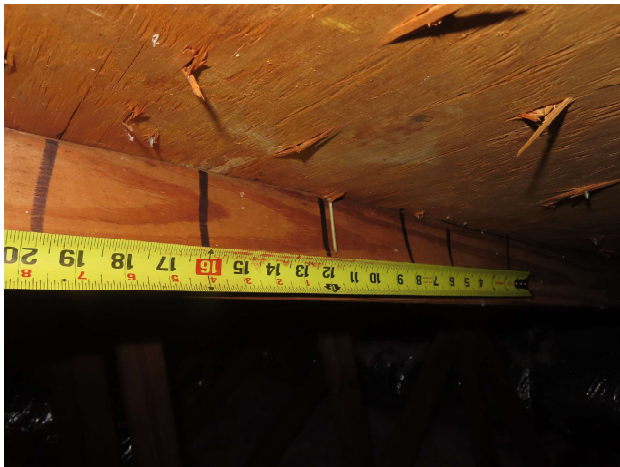
Roof deck nail spacing - Field

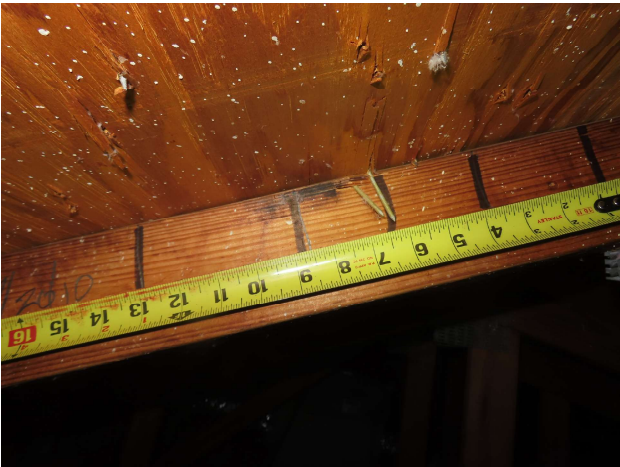
Roof deck nail spacing - Edge
