## Wind Mitigation Report

Park Shores of Indian River Shores Condominium Association

133 Park Shores Circle, Indian River Shores, FL 32963

# Uniform Mitigation Verification Inspection Form

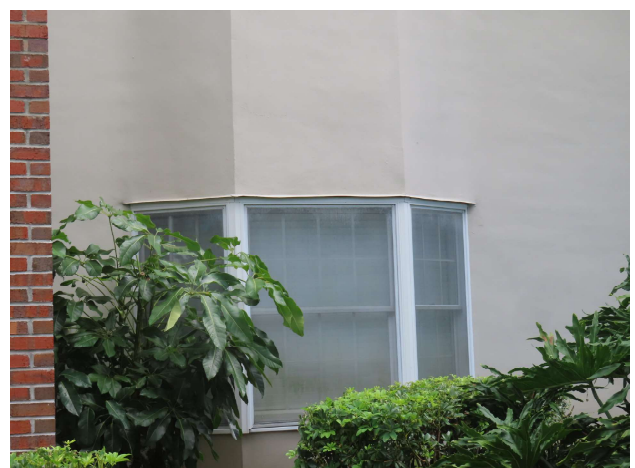
| Opening Protection Level Chart<br>Place an "X" in each row to identify all forms of protection in use for each opening type. Check only one answer below (A thru X), based on the weakest form of protection (lowest row) for any of the Glazed openings and indicate the weakest form of protection (lowest row) for Non-Glazed openings. | | Glazed Openings | | | | Non-Glazed Openings | |
|---|---|---|---|---|---|---|---|
| X | No Windborne Debris Protection | <input checked="" type="checkbox"/> | <input type="checkbox"/> | <input type="checkbox"/> | <input type="checkbox"/> | <input checked="" type="checkbox"/> | <input type="checkbox"/> |

No protection

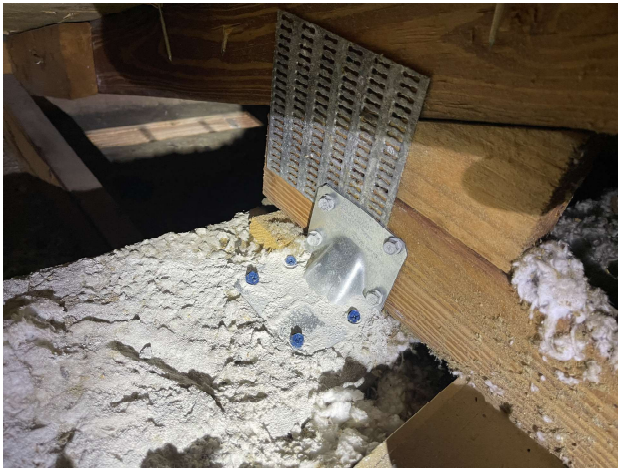
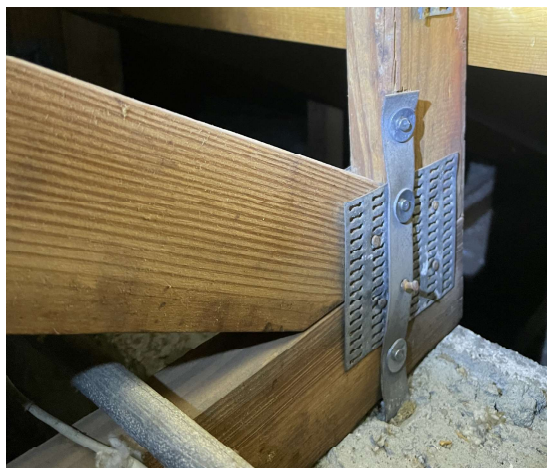
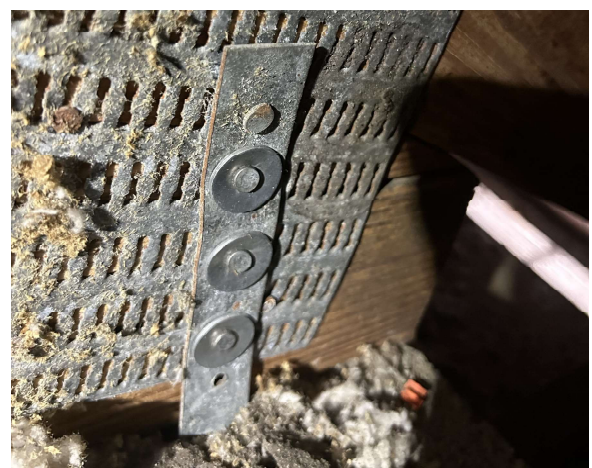
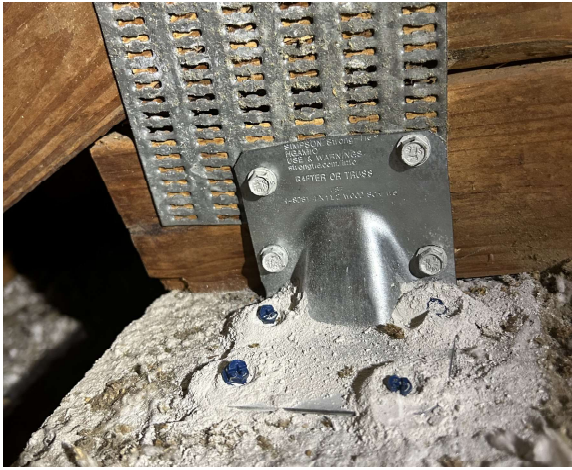
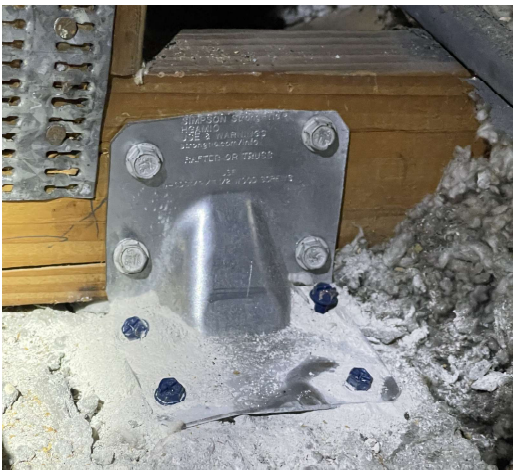
- ☒ Secured to truss/rafter with a minimum of three (3) nails, **and**
- ☒ Attached to the wall top plate of the wall framing, or embedded in the bond beam, with less than a ½" gap from the blocking or truss/rafter **and** blocked no more than 1.5" of the truss/rafter, **and** free of visible severe corrosion.

- ☒ B. Clips
  - ☒ Metal connectors that do not wrap over the top of the truss/rafter, **or**
  - ☐ Metal connectors with a minimum of 1 strap that wraps over the top of the truss/rafter and does not meet the nail position requirements of C or D, but is secured with a minimum of 3 nails.

Roof to wall attachment - Clips

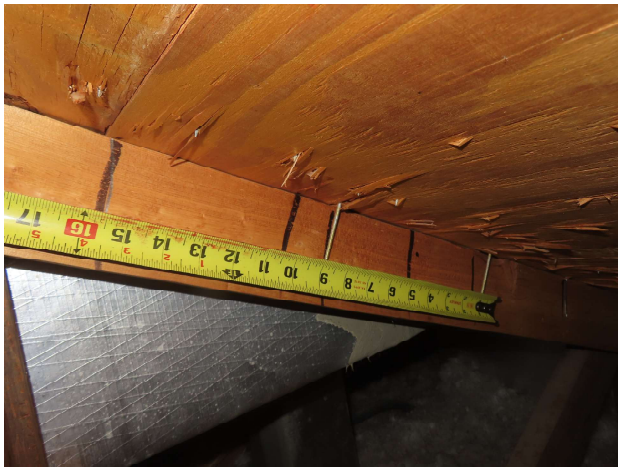
Roof deck nail spacing - Field

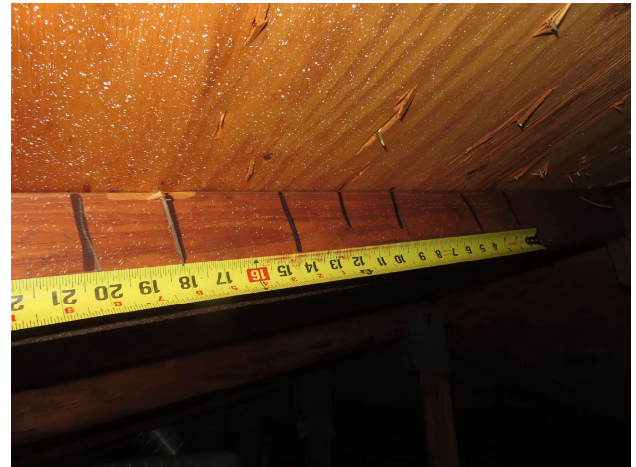
Roof deck nail spacing - Edge
