## Wind Mitigation Report

Park Shores of Indian River Shores Condominium Association

125 Park Shores Circle, Indian River Shores, FL 32963

# Uniform Mitigation Verification Inspection Form

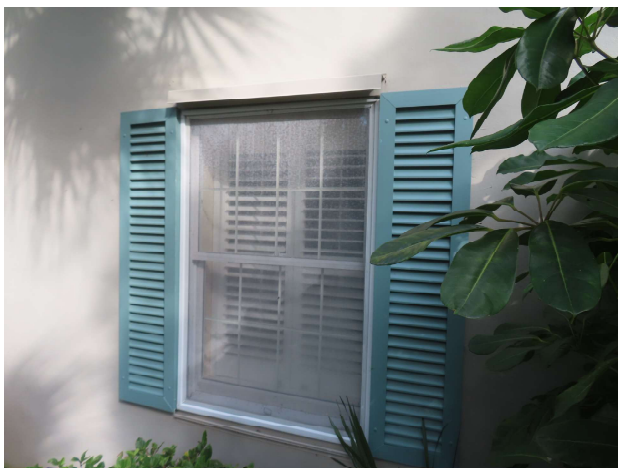
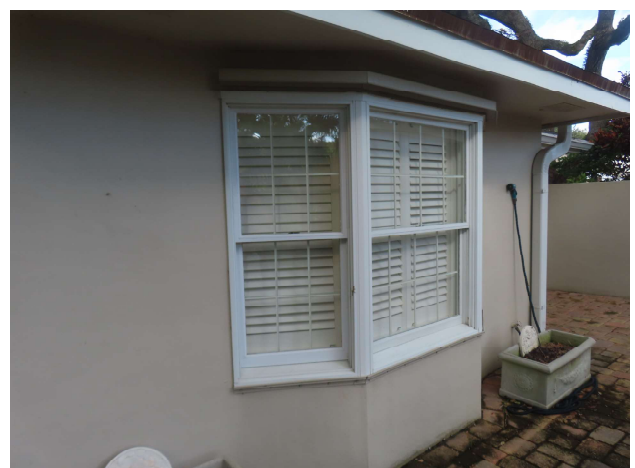
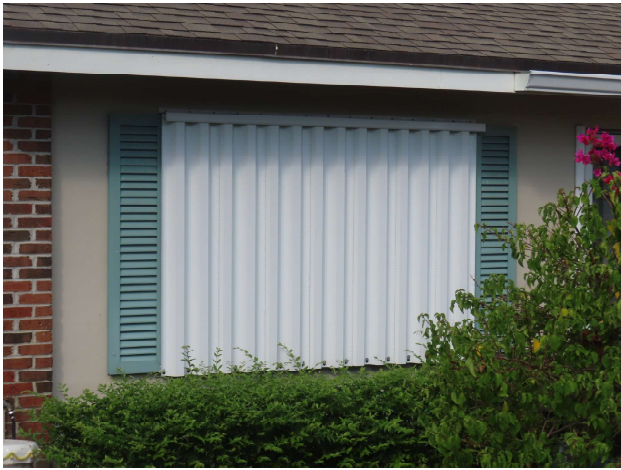
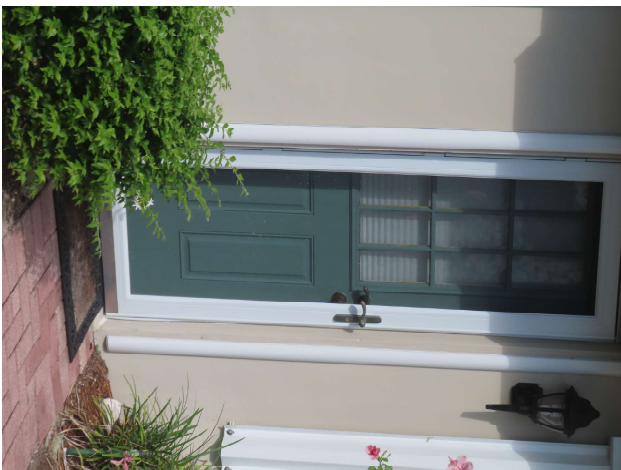
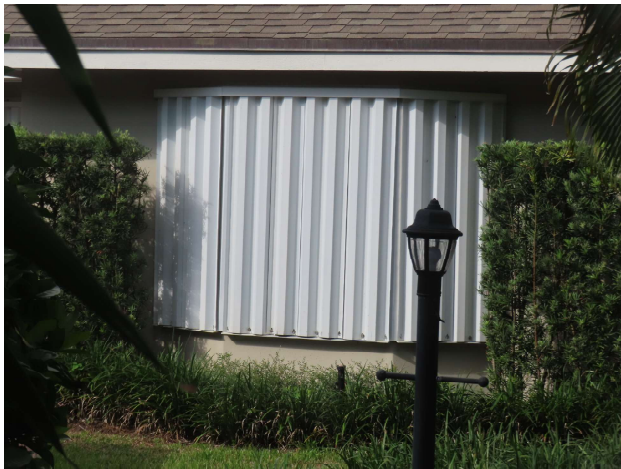
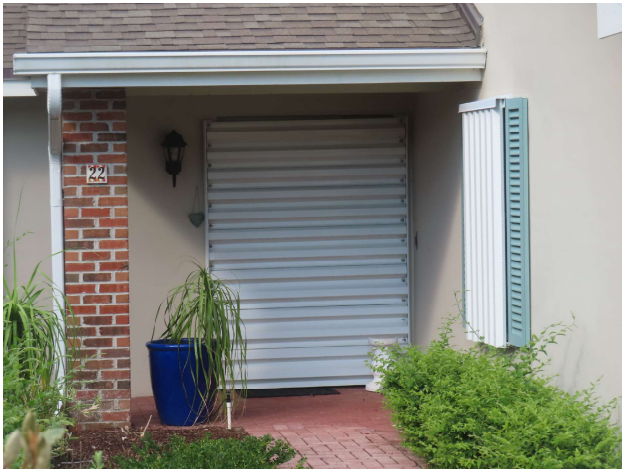
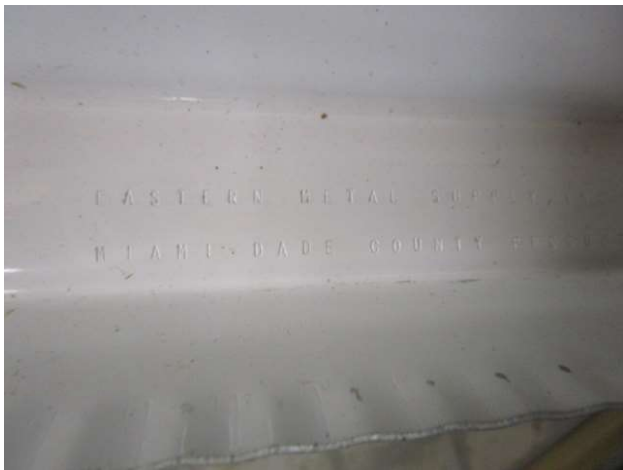
- ☒ **A. Exterior Openings Cyclic Pressure and 9-lb Large Missile (4.5 lb for skylights only)** All Glazed openings are protected at a minimum, with impact resistant coverings or products listed as wind borne debris protection devices in the product approval system of the State of Florida or Miami-Dade County and meet the requirements of one of the following for "Cyclic Pressure and Large Missile Impact" (Level A in the table above).

Large missile panels

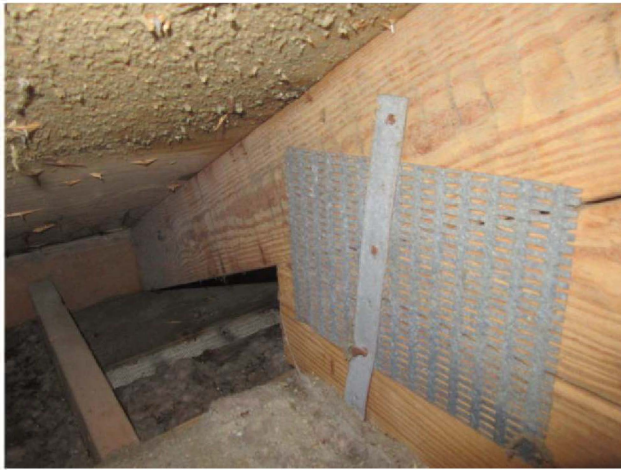
- ☒ Secured to truss/rafter with a minimum of three (3) nails, **and**
- ☒ Attached to the wall top plate of the wall framing, or embedded in the bond beam, with less than a ½" gap from the blocking or truss/rafter **and** blocked no more than 1.5" of the truss/rafter, **and** free of visible severe corrosion.
- ☒ B. Clips
  - ☒ Metal connectors that do not wrap over the top of the truss/rafter, **or**
  - ☐ Metal connectors with a minimum of 1 strap that wraps over the top of the truss/rafter and does not meet the nail position requirements of C or D, but is secured with a minimum of 3 nails.
- ☐ C. Single Wraps

Roof to Wall Attachment - Clips

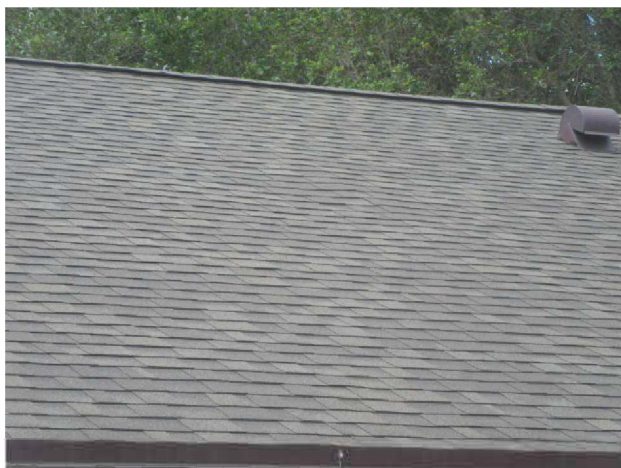
| 2.1 Roof Covering Type: | Permit Application Date | FBC or MDC Product Approval # | Year of Original Installation or Replacement | No Information Provided for Compliance |
|---|---|---|---|---|
| <input checked="" type="checkbox"/> 1. Asphalt/Fiberglass Shingle | 5/17/16 | #17759 | 2016 | <input type="checkbox"/> |

Re-Roof 8/01/16, Permit #17759
