Milestone Inspection Phase I Report

Bryn Mawr Ocean Towers

5055, 5059, and 5061 N Highway A1A

The intention of this report is to develop a substantially completed Milestone Inspection Phase One report per the requirements of Senate Bill 4-D and Florida Statutes 553.899.

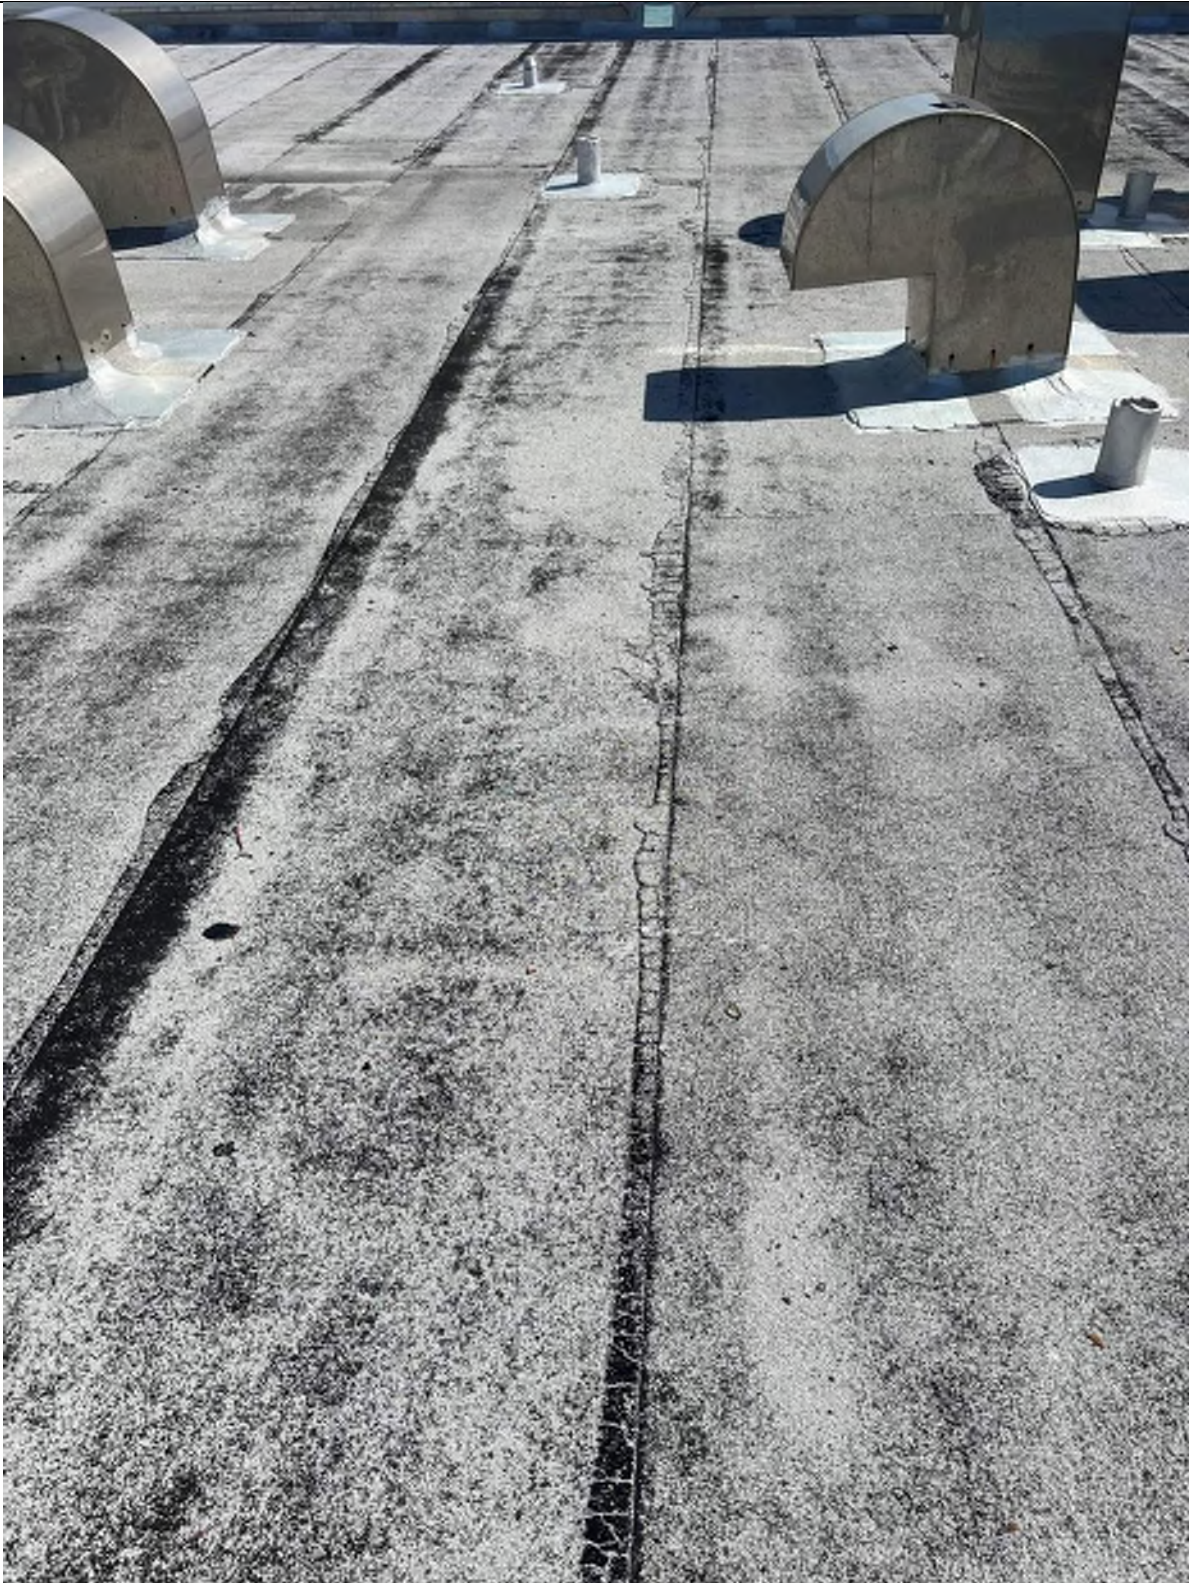
Picture 1.a.6.1

1.a.4. Useful life – Primary building Roof	20 years
1.a.5. Remaining useful life – Primary building roof	2 years
1.a.6. Overall Condition – Primary building roof	<p>The roof is in overall fair condition considering the age of the roof. See pictures 1.a.6.1 and 1.a.6.2. The roof showed signs of normal wear and tear with the granular cap sheet that is showing granule loss. The roof seams of the bitumen roof sheets were in fair condition and there were no signs of separation or gaps at the seams. There were signs of some roof blisters and cracks in the membrane. See pictures 1.a.6.3 and 1.a.6.4 The roof termination bar at parapet wall was also in fair condition; however, the caulking is starting to deteriorate and recommend to be recaulked. See pictures 1.a.6.5 and 1.a.6.6. There are granules of the top bitumen sheet accumulating in the corners of the roof. Recommend cleaning up the granules from the roof. See pictures 1.a.6.7 and 1.a.6.8. There is regular maintenance performed on the roof; however, it is recommended to replace the roof. There is also the option of a TAS-126 moisture survey, which detects moisture trapped within a roof system assembly, by a third-party engineer. If the existing roof passes the requirements of the moisture survey by having less than 25% wet area, a new roof can be installed over the existing roof, while still providing a 20-year No Dollar Limit warranty on both materials and workmanship.</p>

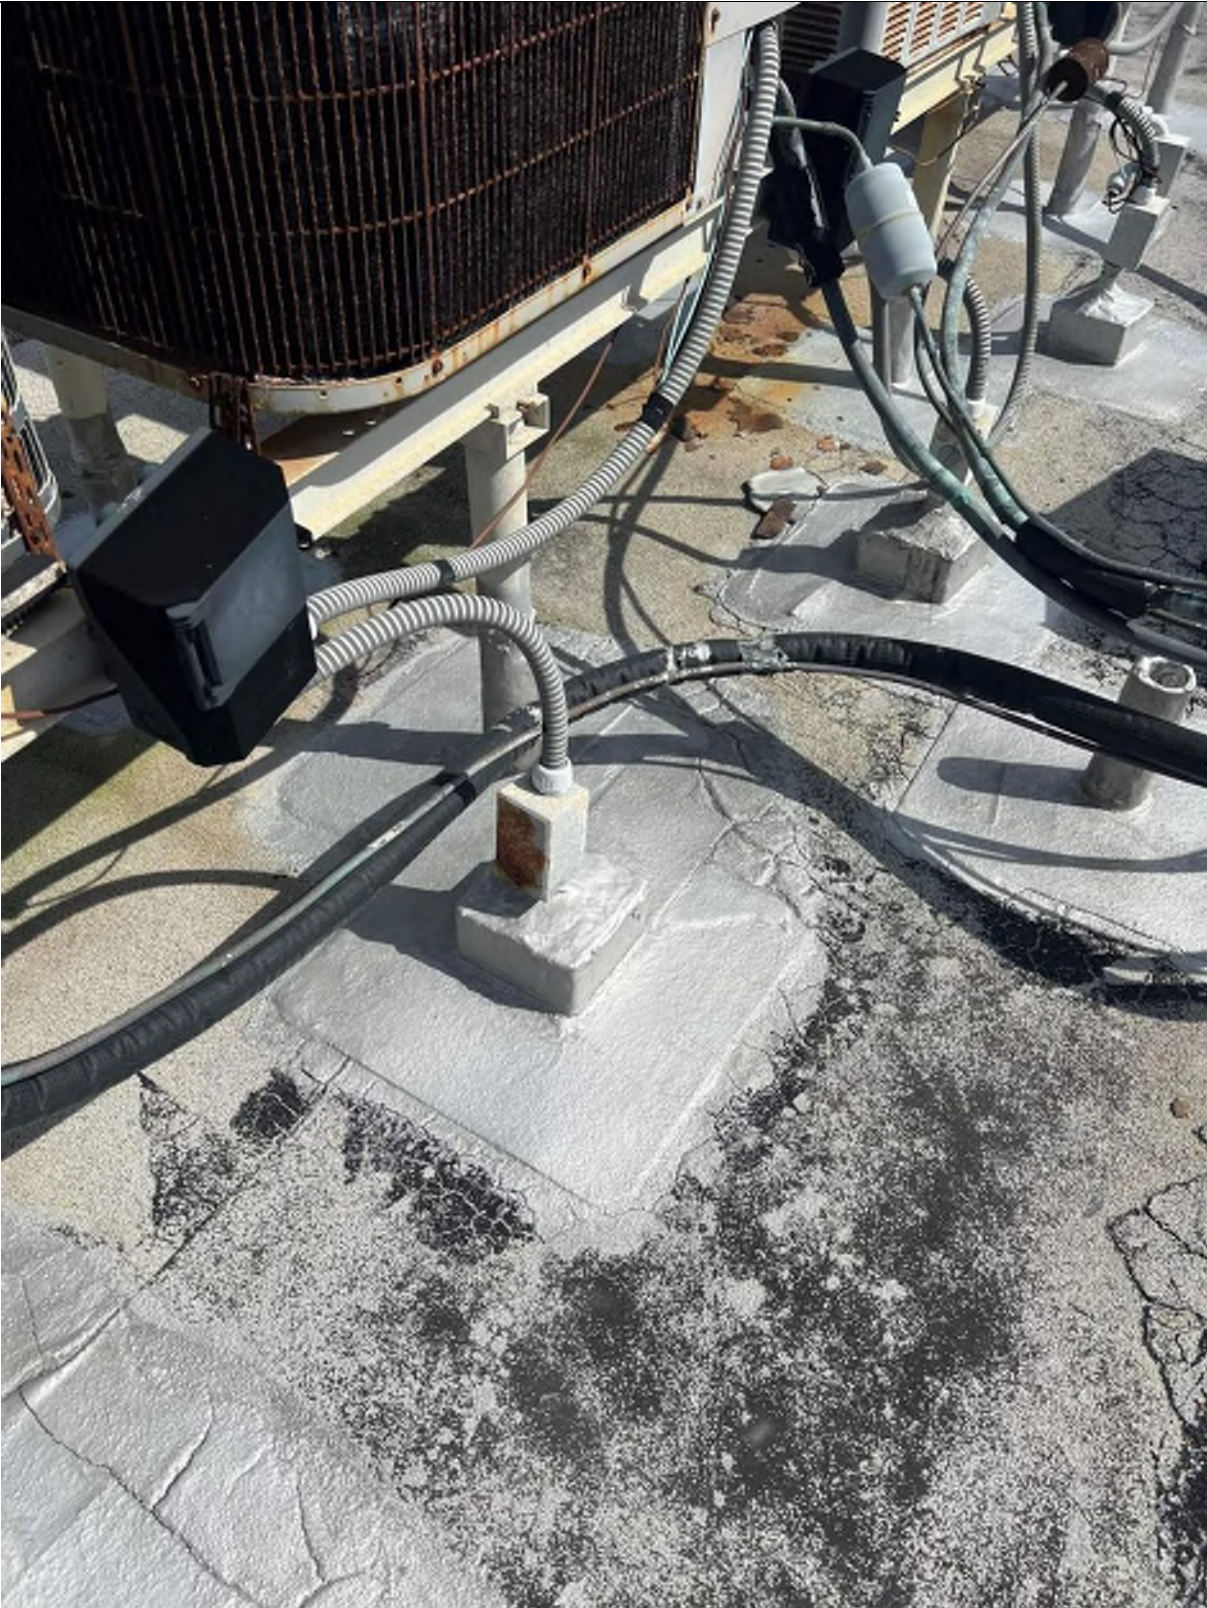
Picture 1.a.7.1

1.a.7. Roof vents and flashings – Primary building roof	Roof flashings in fair overall condition – See pictures 1.a.7.1 and 1.a.7.2.
1.a.8. Parapet wall – Primary building roof	Parapet wall is in good overall condition. See picture 1.a.8.1

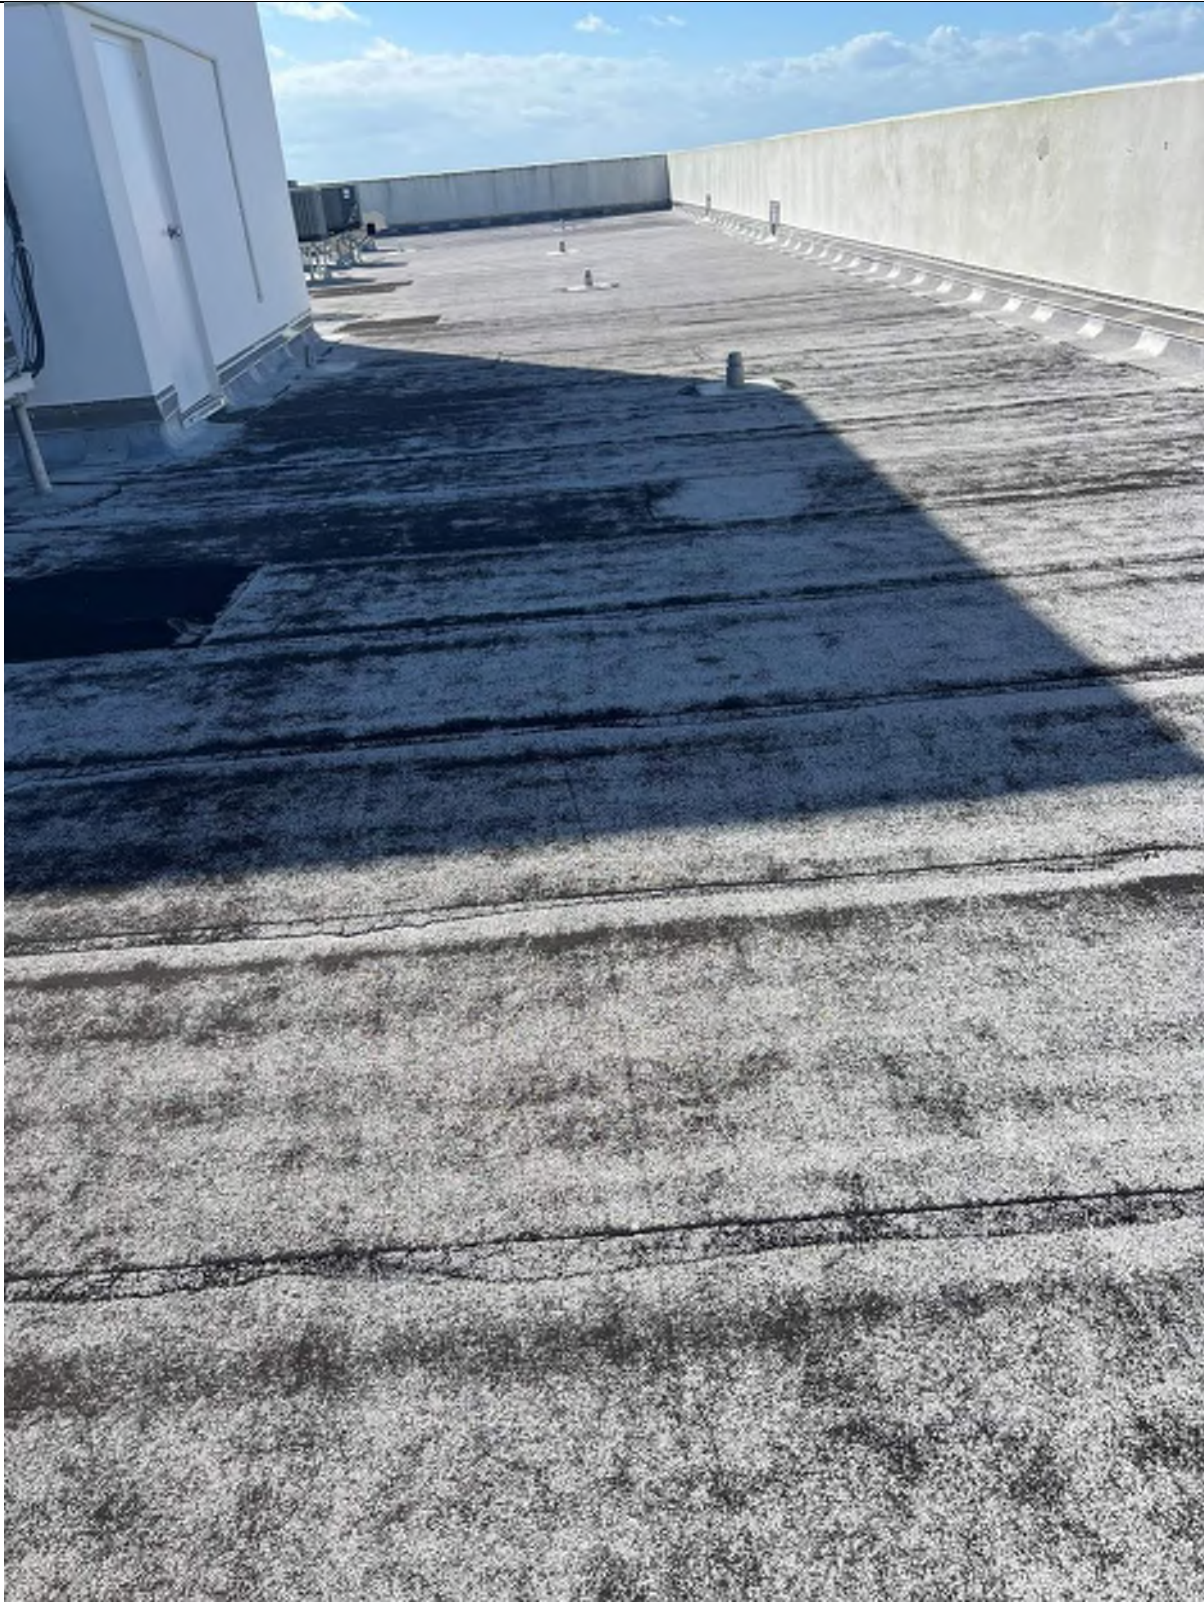
Picture 1.b.6.1

1.b.4. Useful life – Primary building Roof	20 years
1.b.5. Remaining useful life – Primary building roof	2 years
1.b.6. Overall Condition – Primary building roof	<p>The roof is in overall fair condition considering the age of the roof. See pictures 1.b.6.1 and 1.b.6.2. The roof showed signs of normal wear and tear with the granular cap sheet that is showing granule loss. The roof seams of the bitumen roof sheets were in fair condition and there were no signs of separation or gaps at the seams. There were signs of some cracks in the membrane that need to be addressed. See pictures 1.b.6.3 and 1.b.6.4 The roof termination bar at parapet wall is also in fair condition; however, the caulking is starting to deteriorate and recommend to be recaulked. See pictures 1.b.6.5 and 1.b.6.6. There are granules of the top bitumen sheet accumulating in the corners of the roof. Recommend cleaning up the granules from the roof. The 12”x7” overflow roof scuppers are in good overall condition. See picture 1.b.6.7. There is regular maintenance performed on the roof; however, it is recommended to replace the roof. There is also the option of a TAS-126 moisture survey, which detects moisture trapped within a roof system assembly, by a third-party engineer. If the existing roof passes the requirements of the moisture survey by having less than 25% wet area, a new roof can be installed over the existing roof, while still providing a 20-year No Dollar Limit warranty on both materials and workmanship.</p>

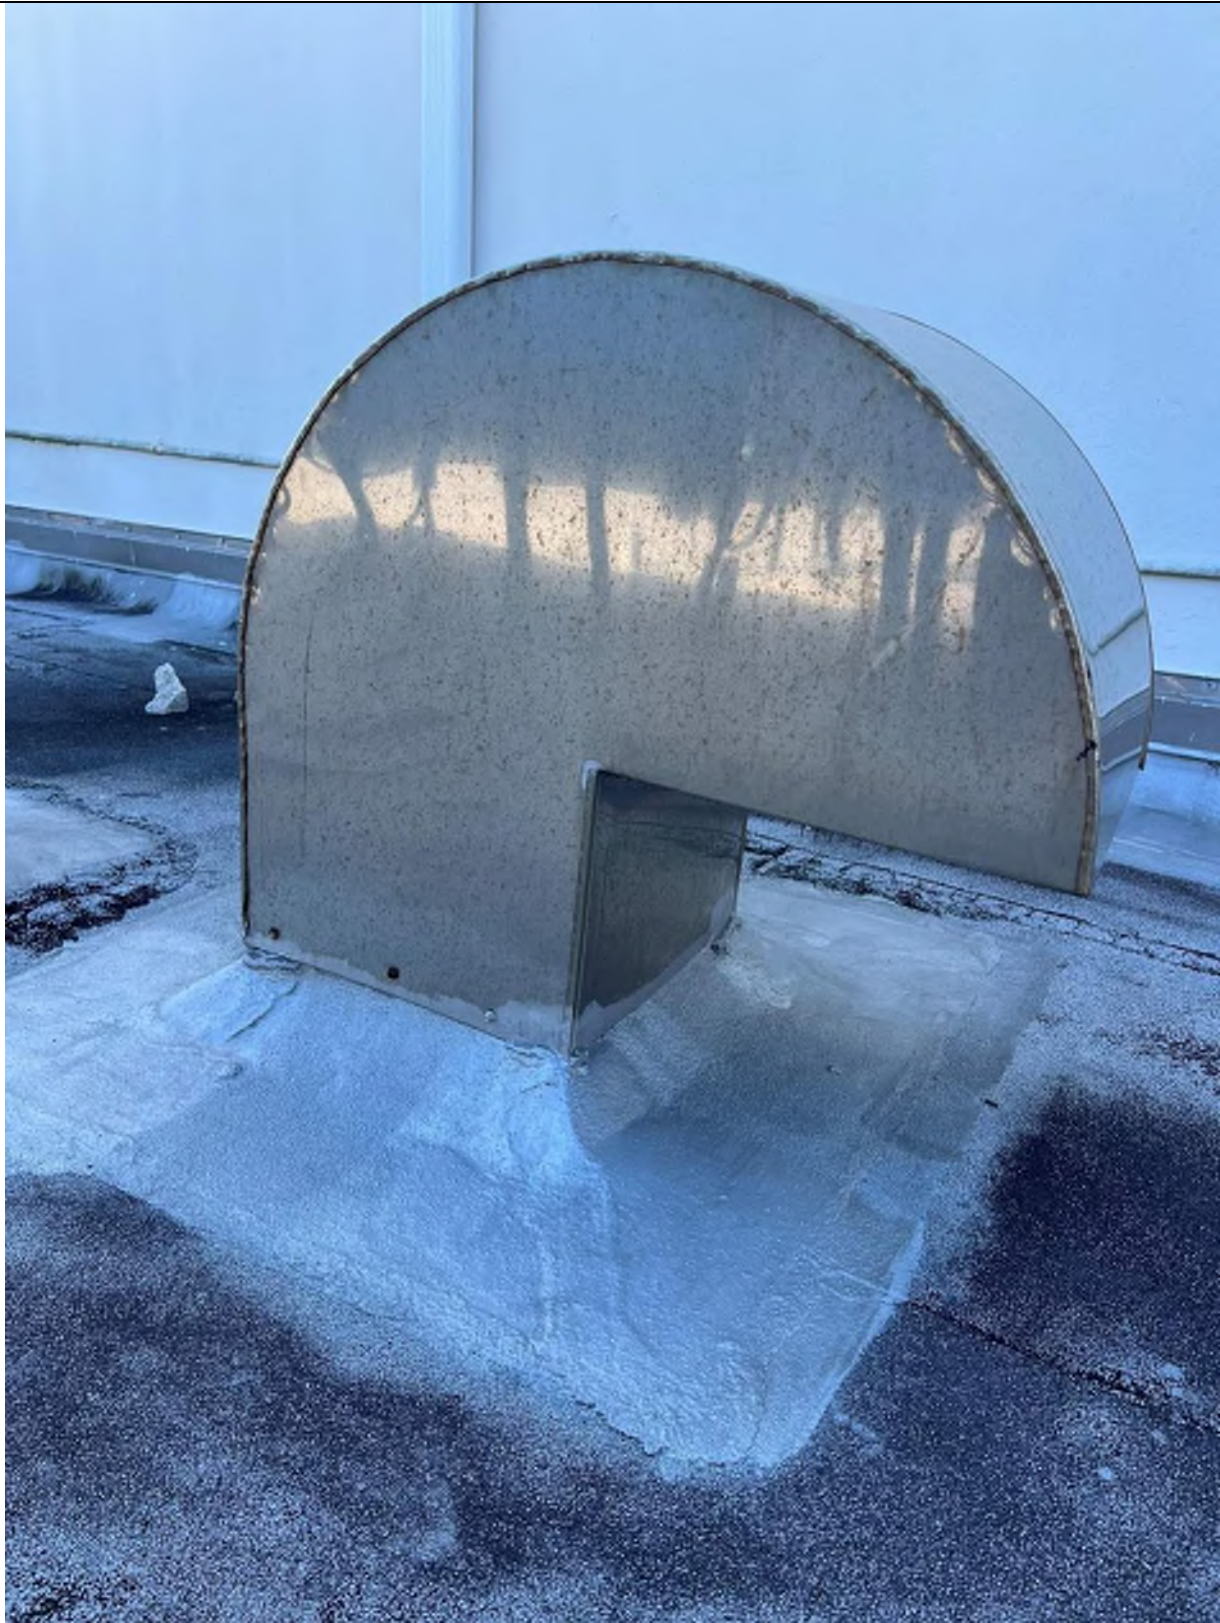
Picture 1.b.7.1

1.b.7. Roof vents and flashings – Primary building roof	Roof flashings in fair overall condition – See pictures 1.a.7.1 and 1.a.7.2.
1.b.8. Parapet wall – Primary building roof	Parapet wall is in good overall condition. See picture 1.b.8.1.

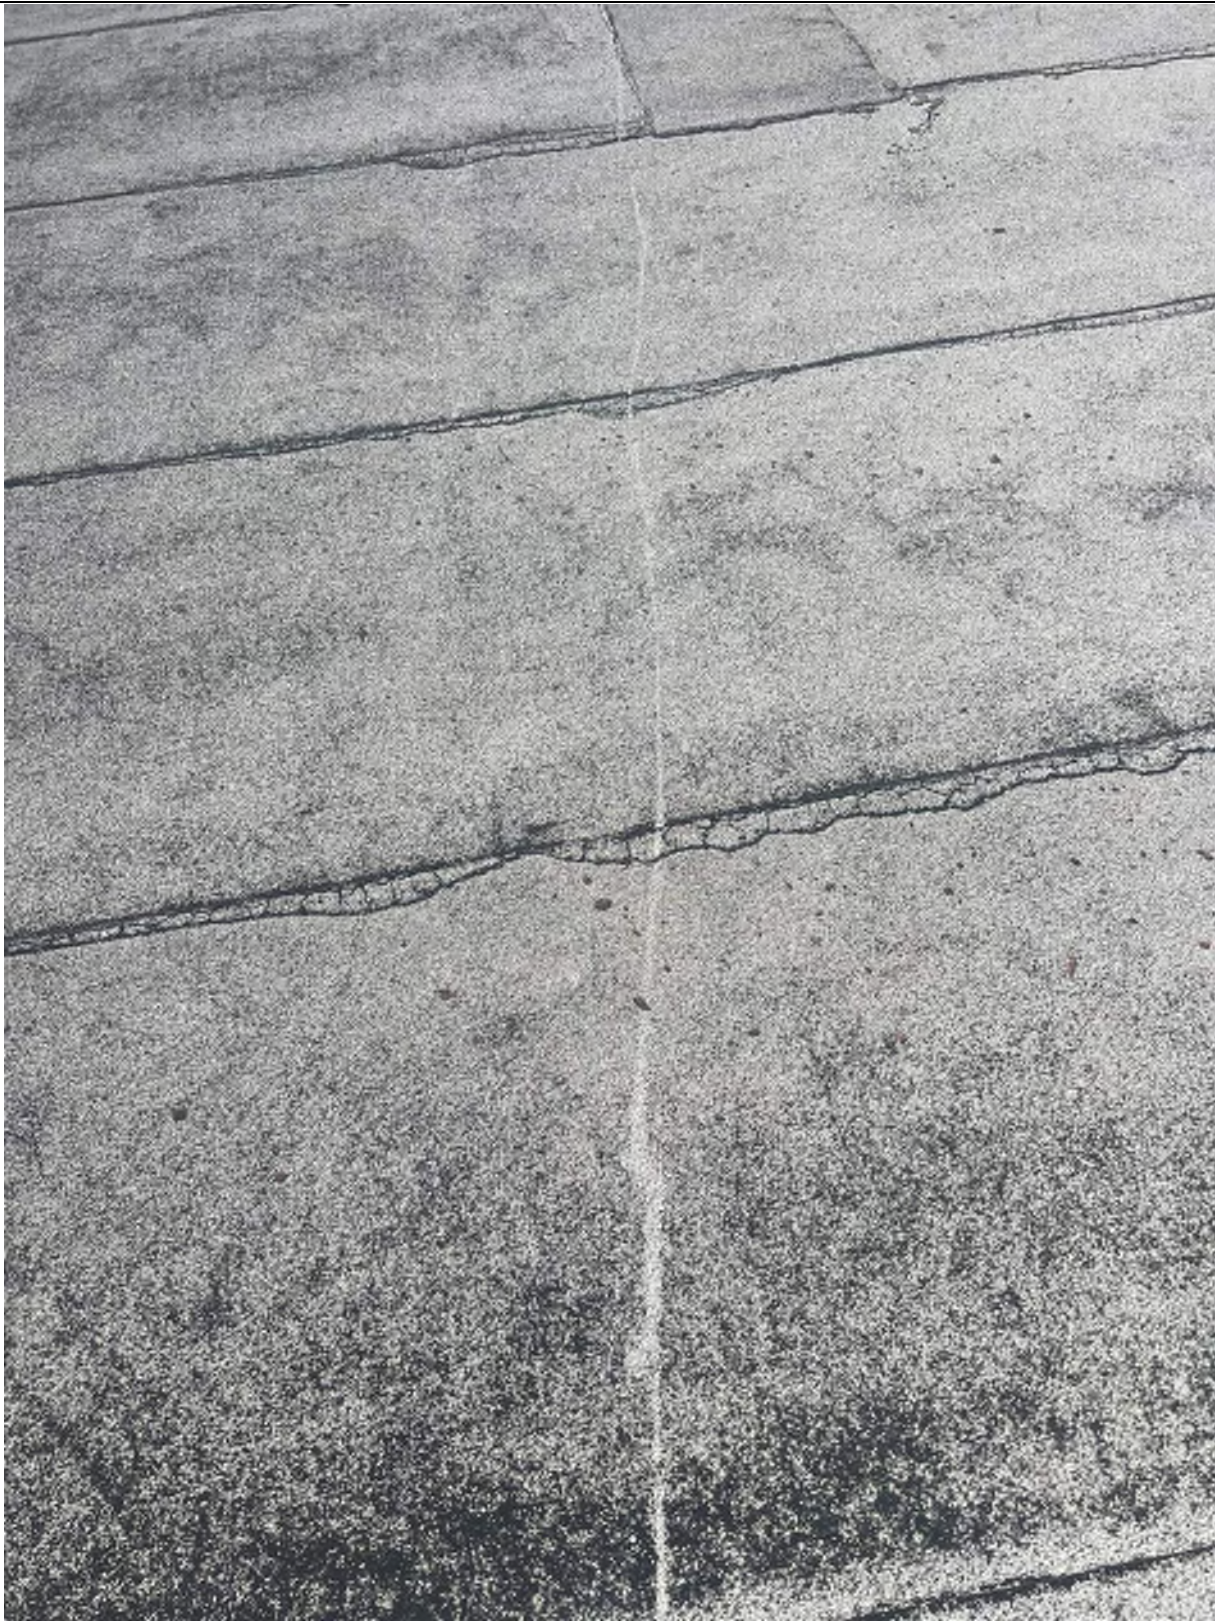
Picture 1.c.6.1

1.c.4. Useful life – Primary building Roof	20 years
1.c.5. Remaining useful life – Primary building roof	1 year
1.c.6. Overall Condition – Primary building roof	The roof is in overall fair condition considering the age of the roof. See pictures 1.c.6.1 and 1.c.6.2. The roof showed signs of normal wear and tear with the granular cap sheet that is showing granule loss. The roof seams of the bitumen roof sheets were in fair condition and there were no signs of separation or gaps at the seams. There were signs of some roof blisters and cracks in the membrane. See pictures 1.c.6.3. The roof termination bar at parapet wall was also in fair condition. See picture 1.c.6.4. There is regular maintenance performed on the roof; however, it is recommended to replace the roof. There is also the option of a TAS-126 moisture survey, which detects moisture trapped within a roof system assembly, by a third-party engineer. If the existing roof passes the requirements of the moisture survey by having less than 25% wet area, a new roof can be installed over the existing roof, while still providing a 20-year No Dollar Limit warranty on both materials and workmanship. The 12”x7” overflow roof scuppers are in good overall condition.

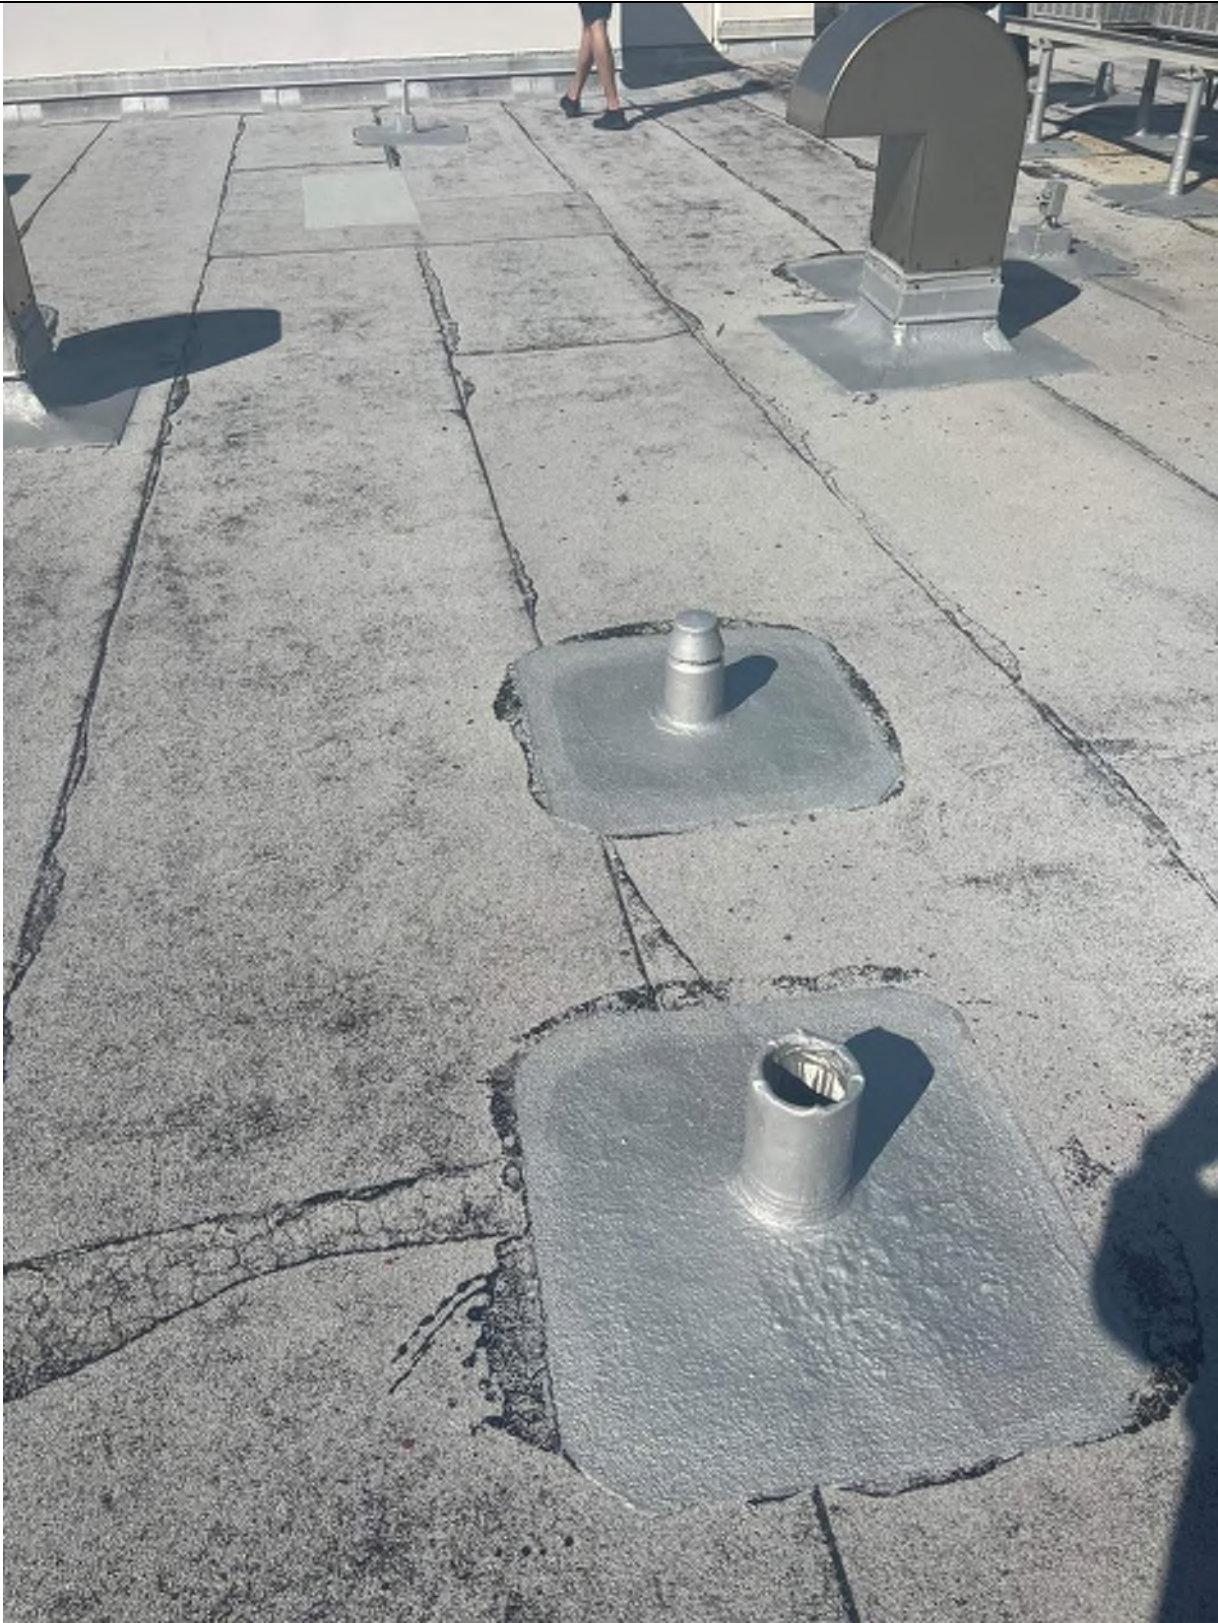
Picture 1.c.7.1

1.c.7. Roof vents and flashings – Primary building roof	Roof flashings in fair overall condition – See pictures 1.c.7.1 and 1.c.7.2.
1.c.8. Parapet wall – Primary building roof	8” concrete block wall, 64” tall, is showing signs of surface cracking. The cracks do not appear to be structural in nature; however, it is recommended to repair the surface cracks with Sto Guard Rapidseal applied with mesh. See pictures 1.c.8.1 and 1.c.8.2.

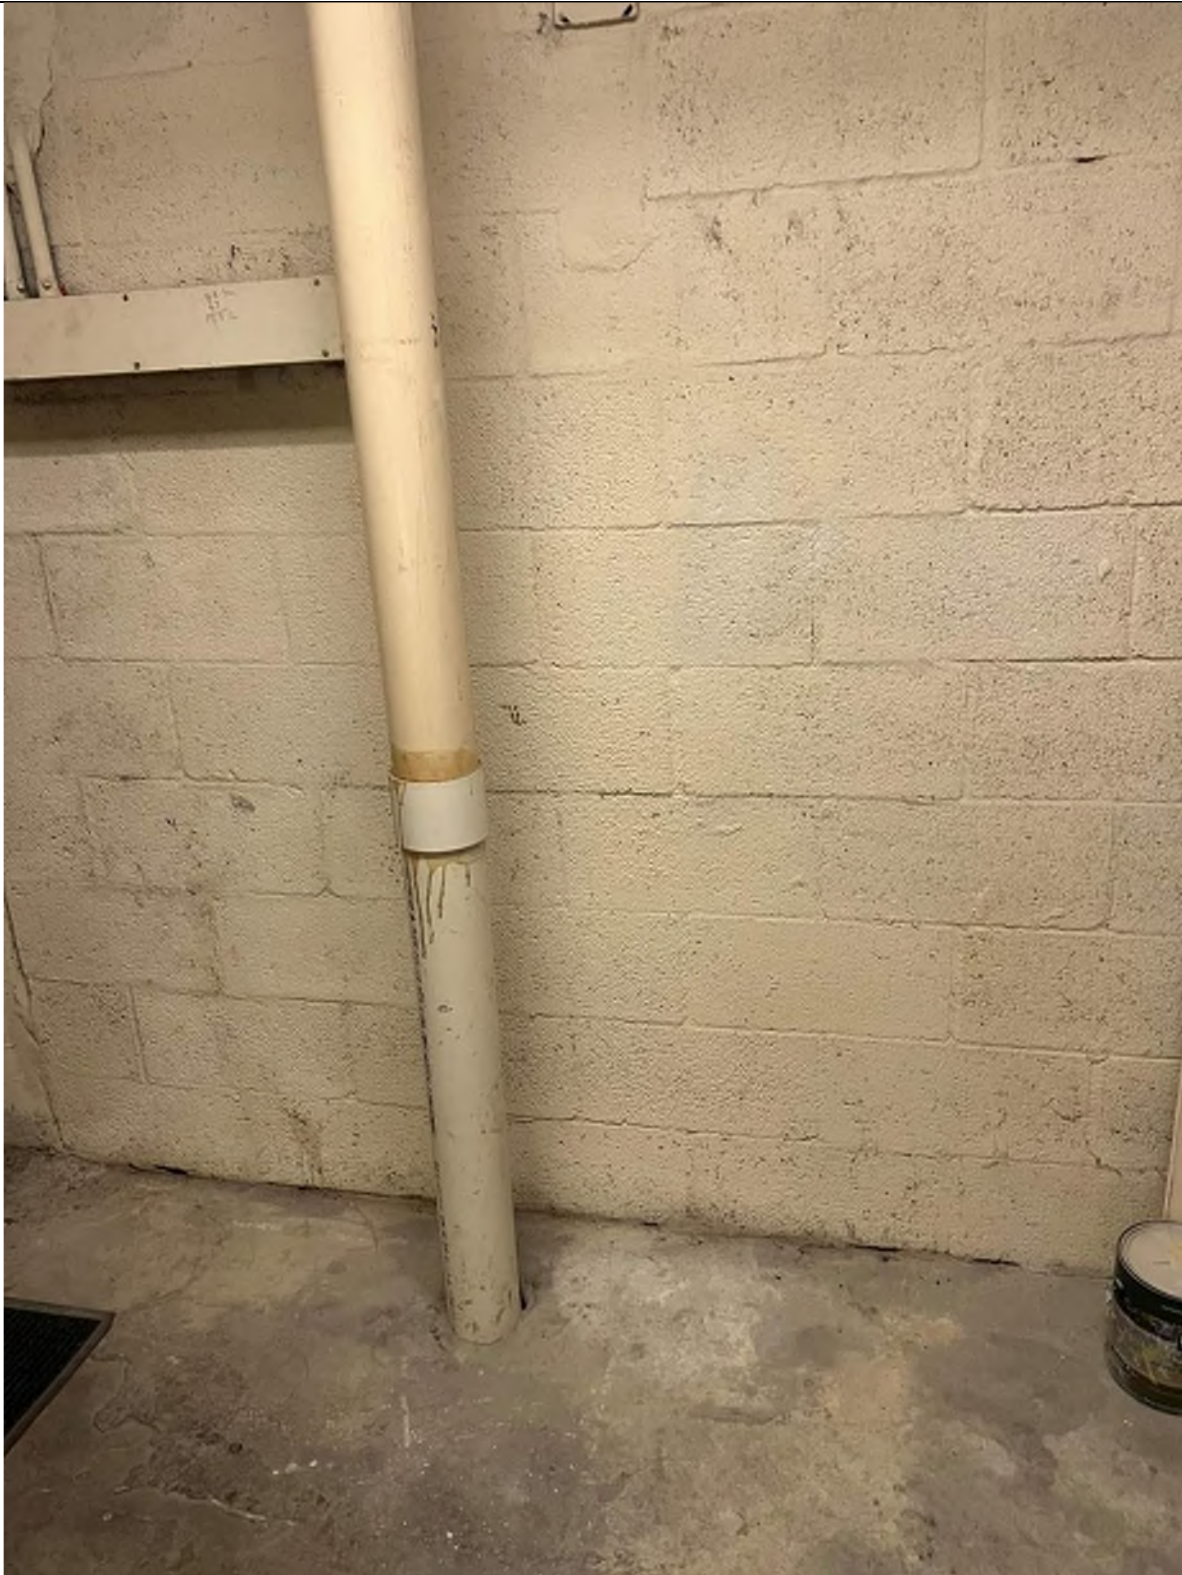
Picture 2.b.2.1

2.b.2 Overall condition	Overall good condition. The elevator shearwall and the exterior load bearing walls do not show signs of any settlement cracking or any other structural deterioration. See picture 2.b.2.1.

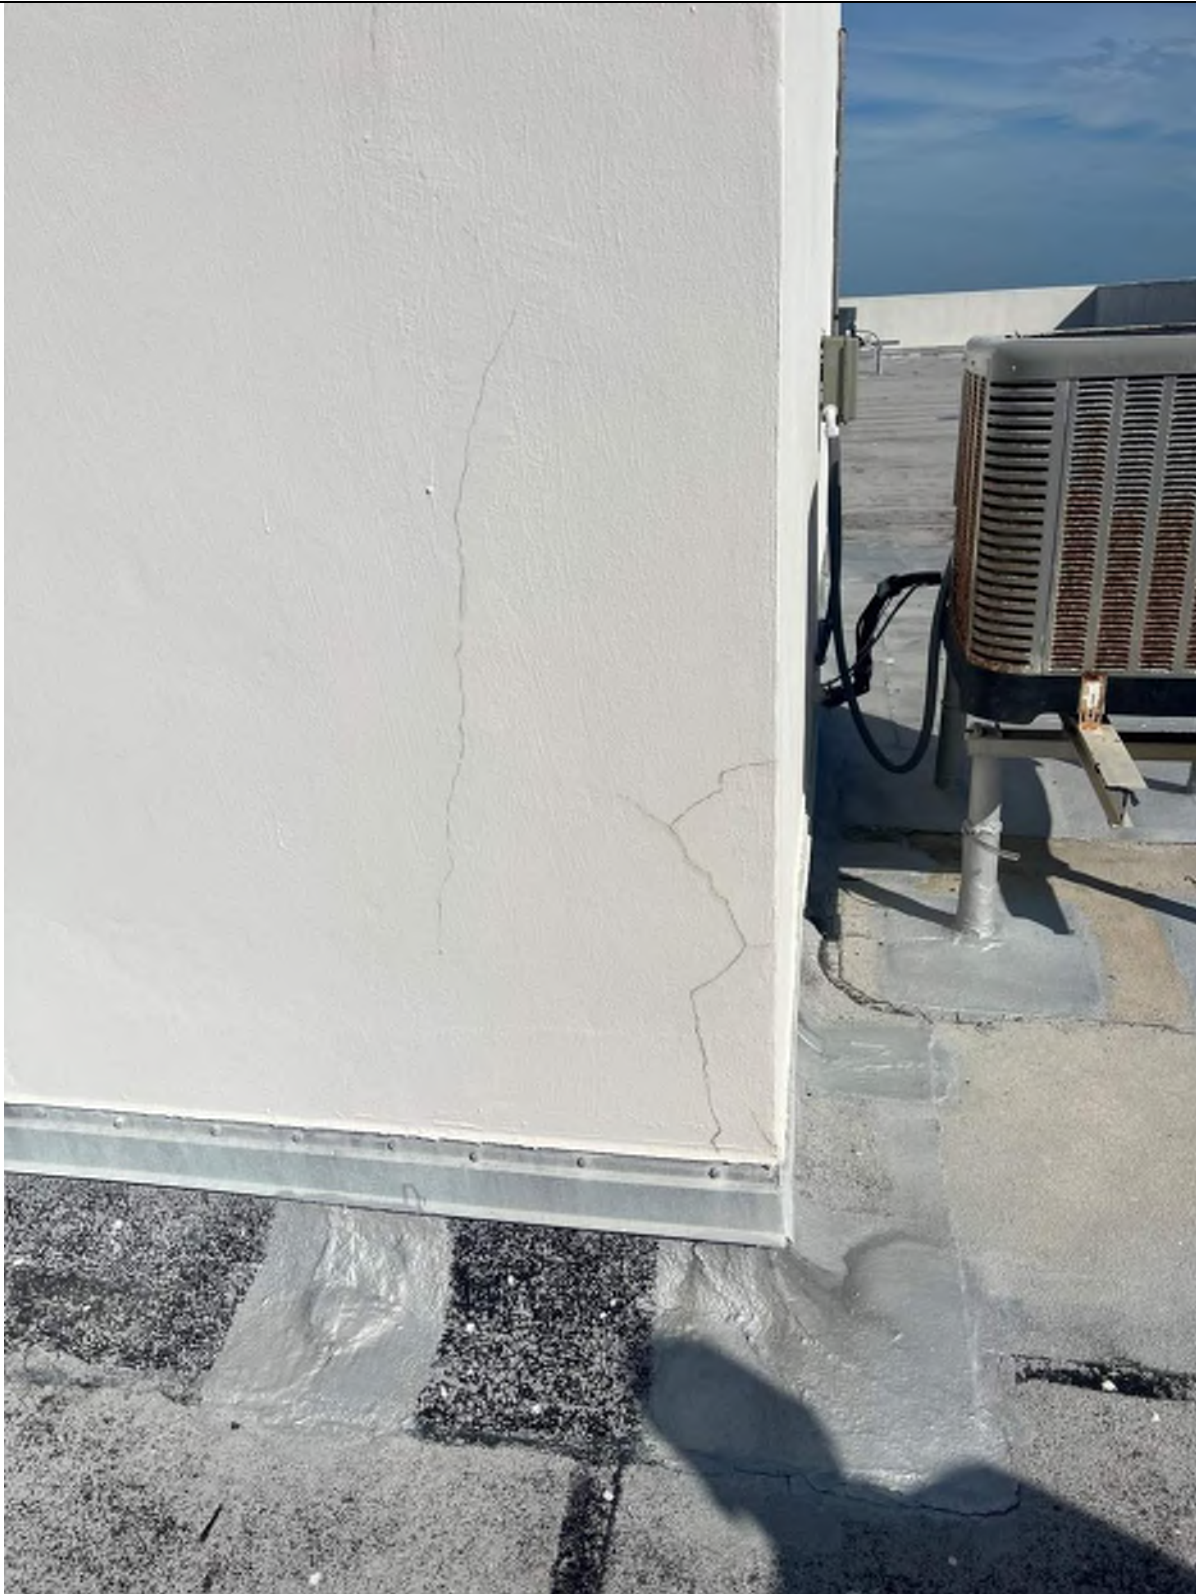
Picture 2.c.2.1

2.c.2 Overall condition	Overall good condition. The elevator shearwall and the exterior load bearing walls do not show signs of any settlement cracking; however, the C.M.U. block walls and the reinforced concrete beams/column at the central elevator tower above the roof level is showing signs of spalling. The floor slab at the interior of the doorway has some exposed reinforcement bar. This damage does not pose a risk to life safety; however, area shall be repaired according to A.C.I. and I.C.R.I. standards. See pictures 2.c.2.1, 2.c.2.2, and 2.c.2.3.

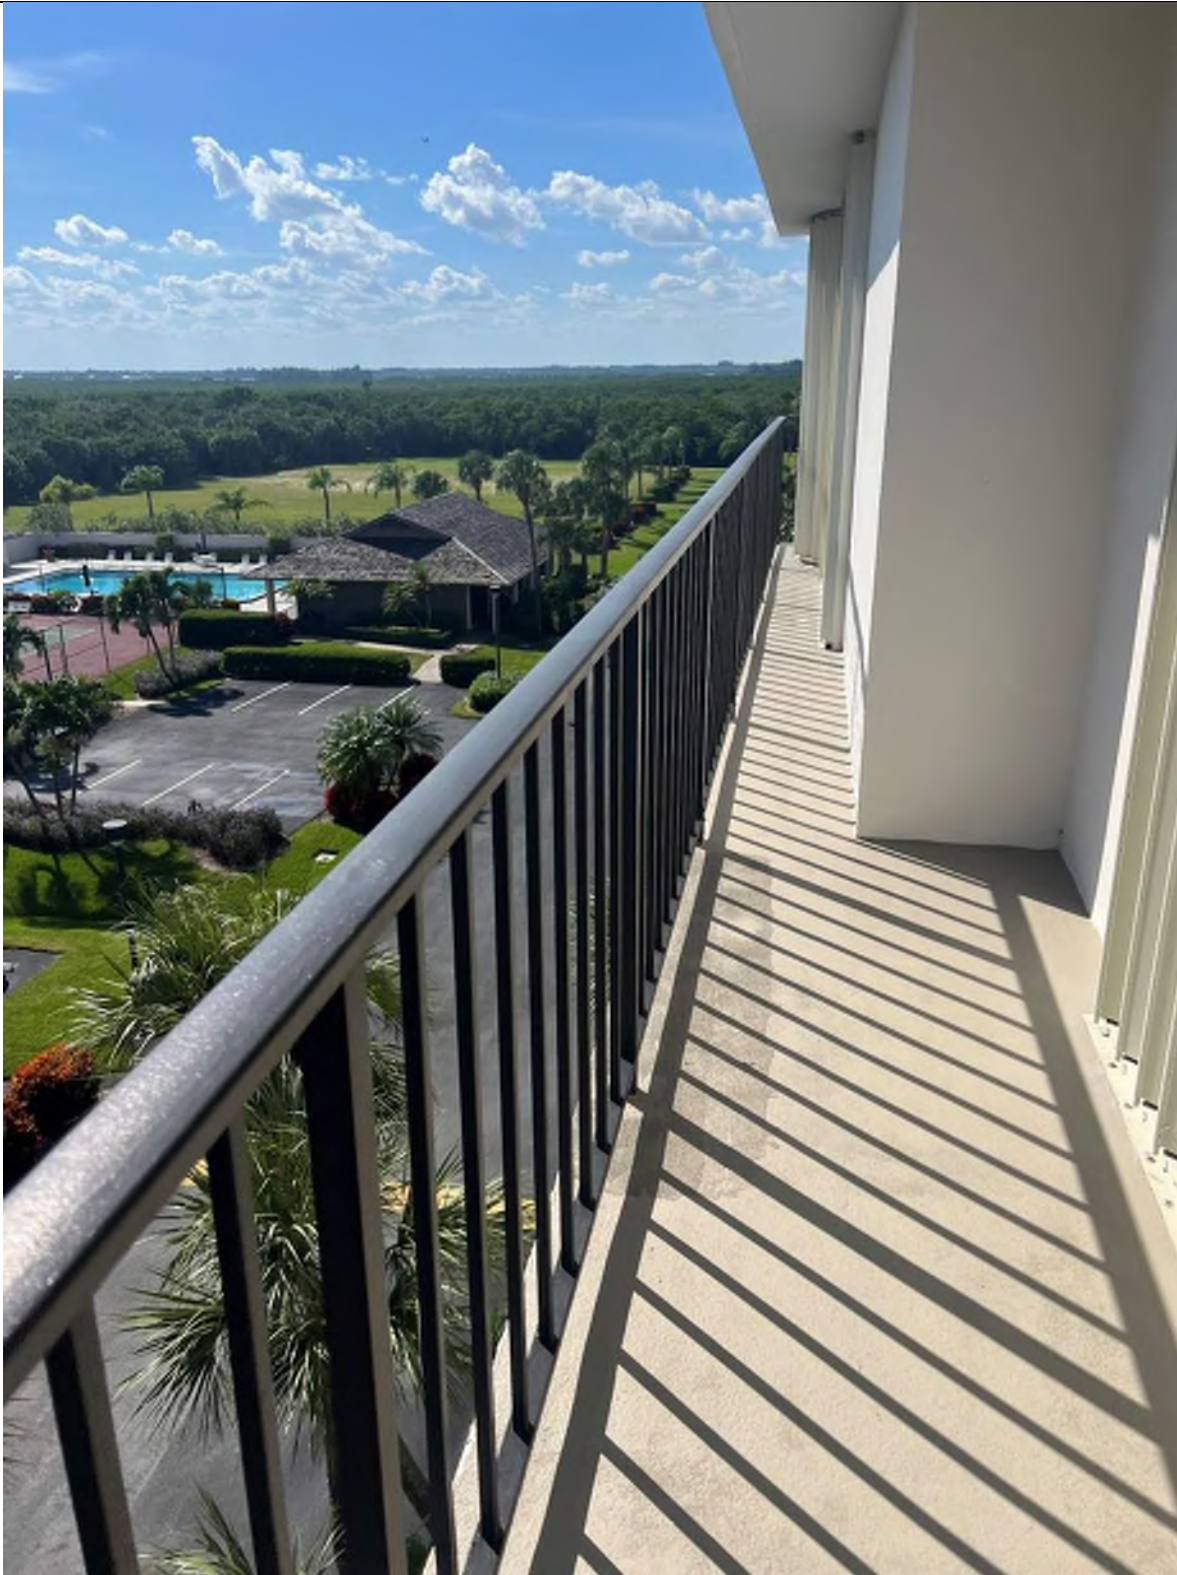
Picture 3.a.6.1

3.a.6. Structural concrete slab	Structural concrete slabs are 7” concrete “flat slabs” with #4 reinforcement bar every 12” each way. The concrete slabs are in good condition overall. See pictures 3.a.6.1, and 3.a.6.2

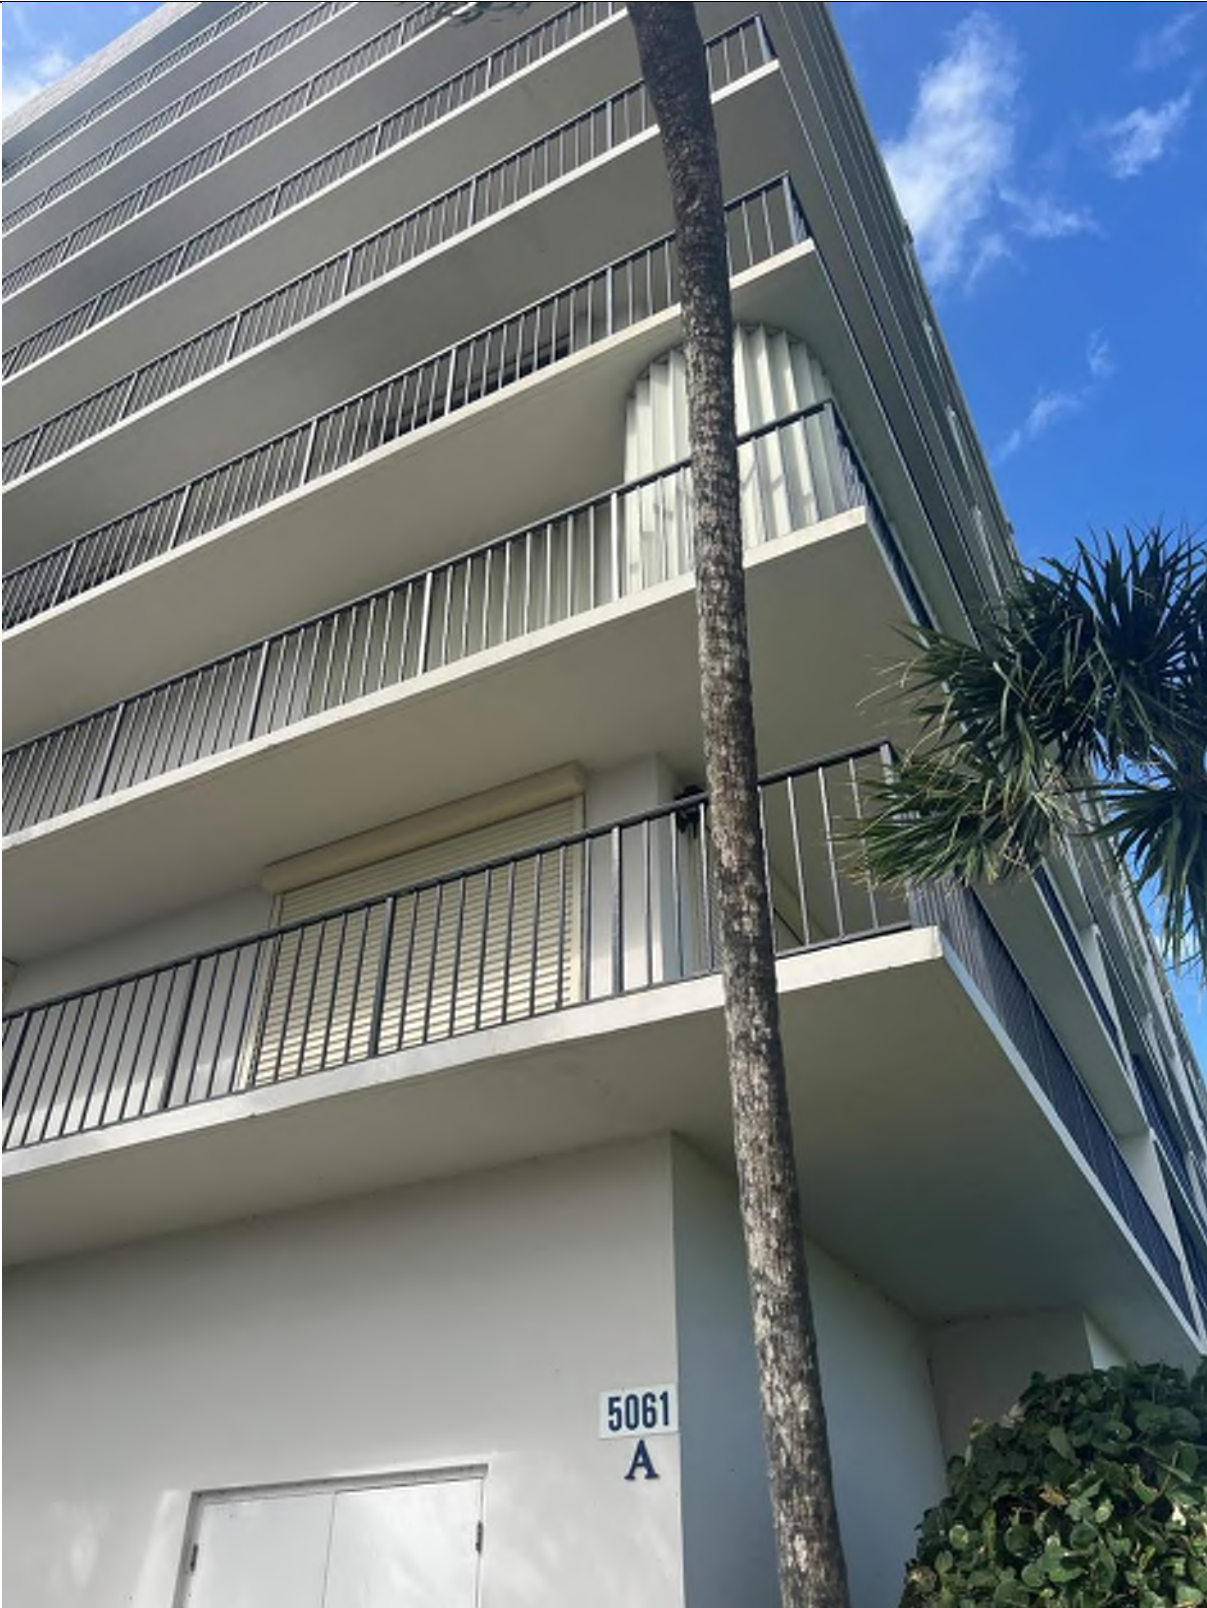
Picture 3.b.6.1

3.b.6. Structural concrete slab	Structural concrete slabs are 7" concrete "flat slabs" with #4 reinforcement bar every 12" each way. The concrete slabs are in good condition overall. See pictures 3.b.6.1, and 3.b.6.2. There are a couple balcony slabs showing the beginning stages of spalling; however, these areas do not pose a structural life safety concern. See picture 3.b.6.3.

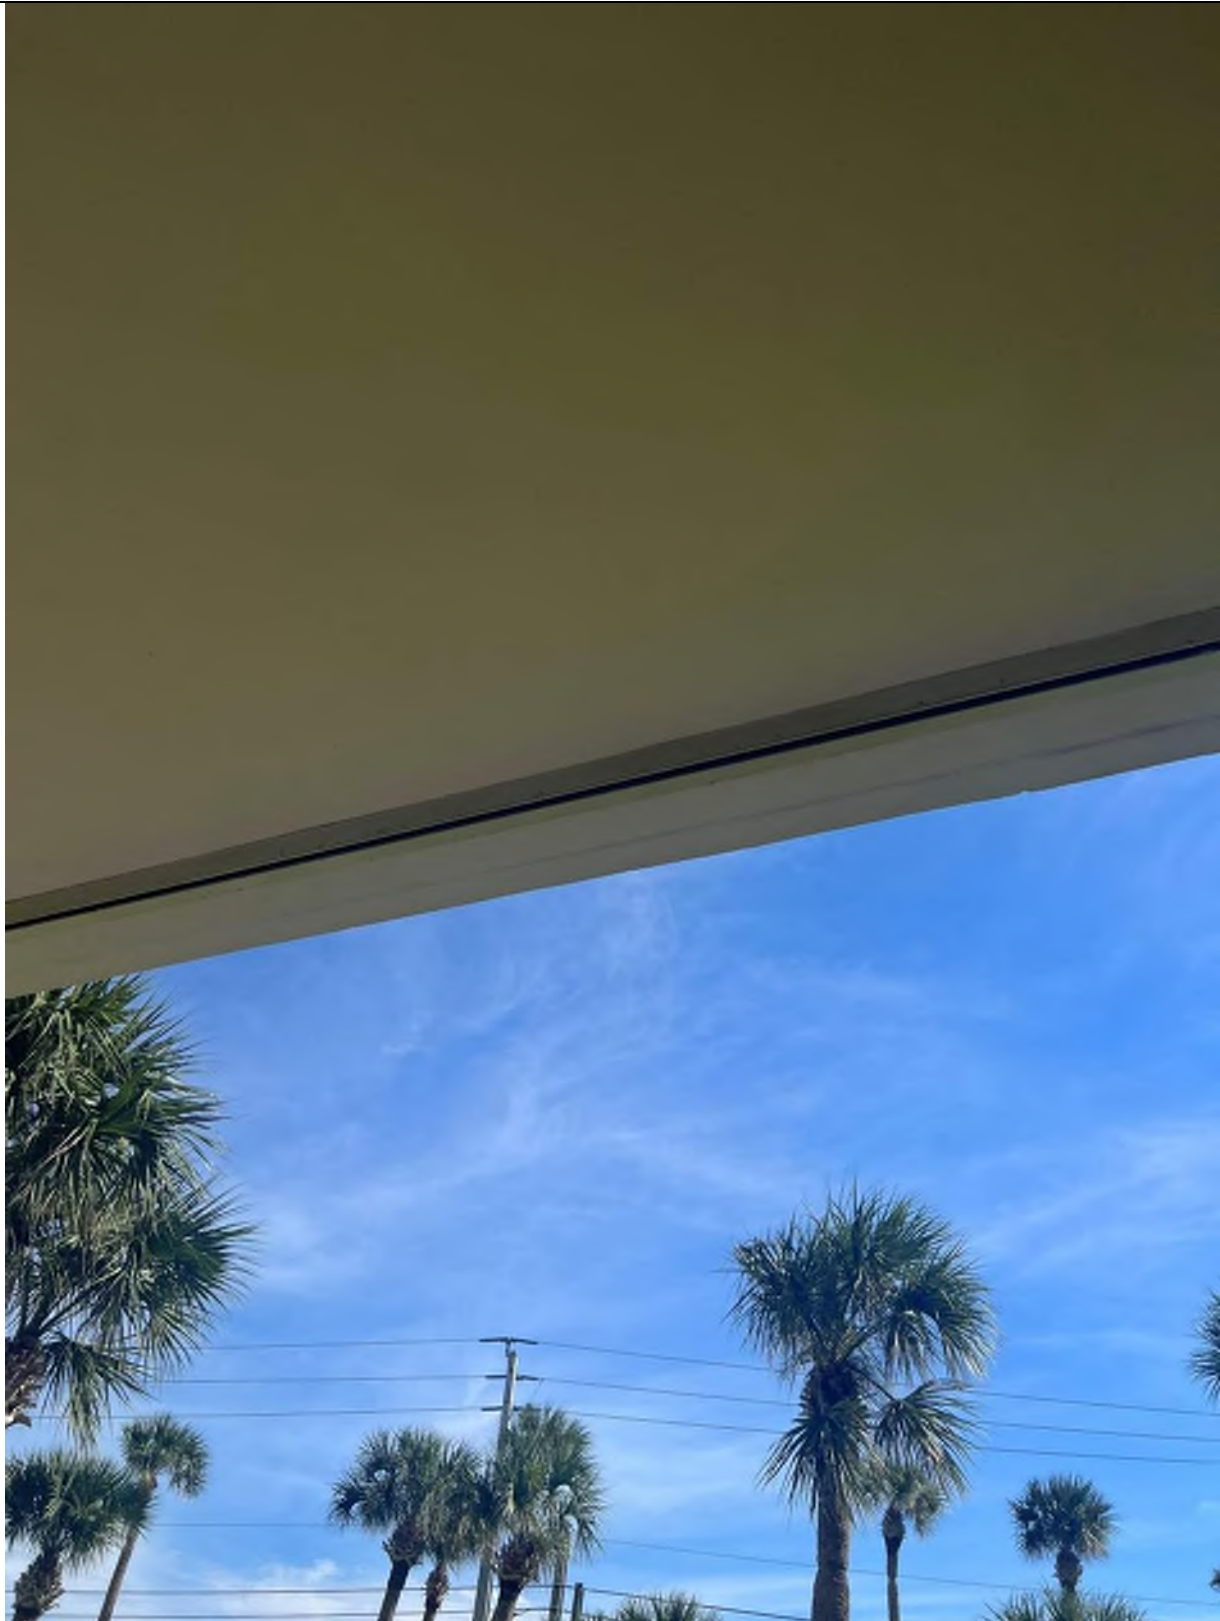
Picture 3.c.6.1

3.c.6. Structural concrete slab	Structural concrete slabs are 7" concrete "flat slabs" with #4 reinforcement bar every 12" each way. The concrete slabs are in good condition overall. See pictures 3.c.6.1, 3.c.6.2, and 3.c.6.3.
