Milestone Inspection Phase I Report

Bryn Mawr Ocean Towers

5055, 5059, and 5061 N Highway A1A

The intention of this report is to develop a substantially completed Milestone Inspection Phase One report per the requirements of Senate Bill 4-D and Florida Statutes 553.899.

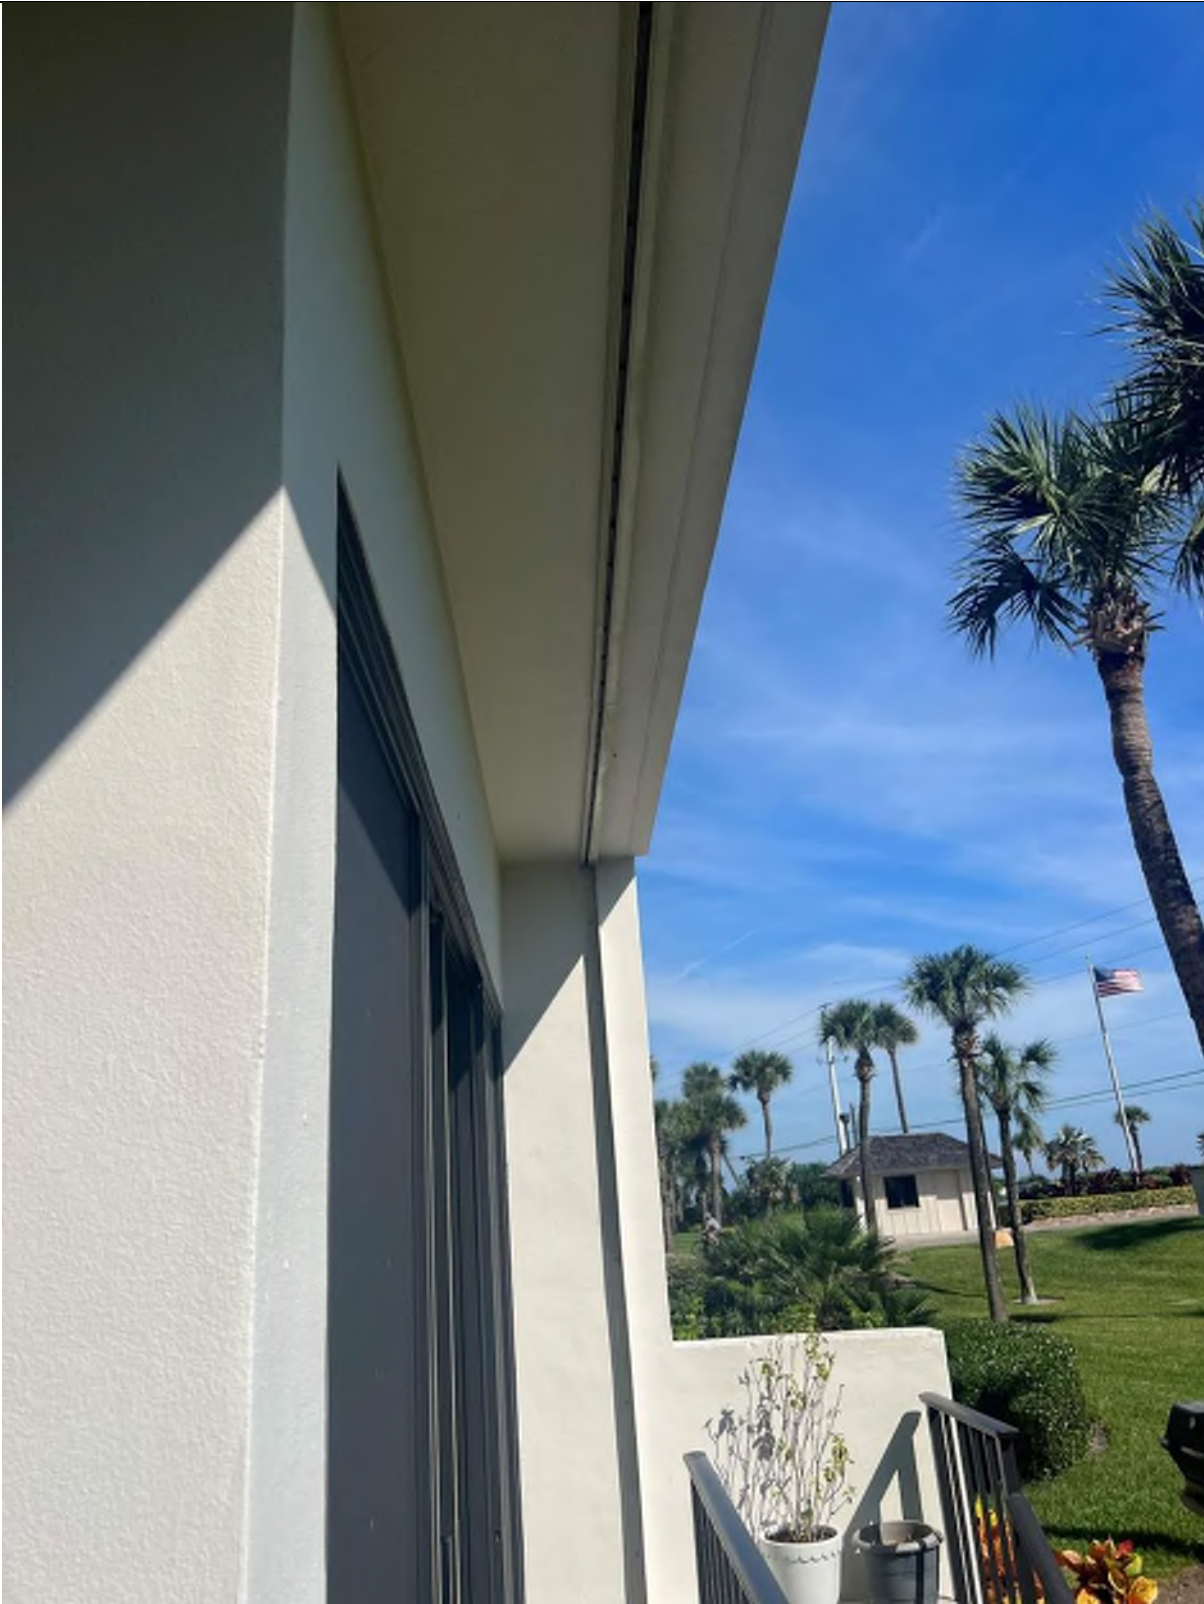
Picture 3.c.6.2

3.c.6. Structural concrete slab	Structural concrete slabs are 7" concrete "flat slabs" with #4 reinforcement bar every 12" each way. The concrete slabs are in good condition overall. See pictures 3.c.6.1, 3.c.6.2, and 3.c.6.3.

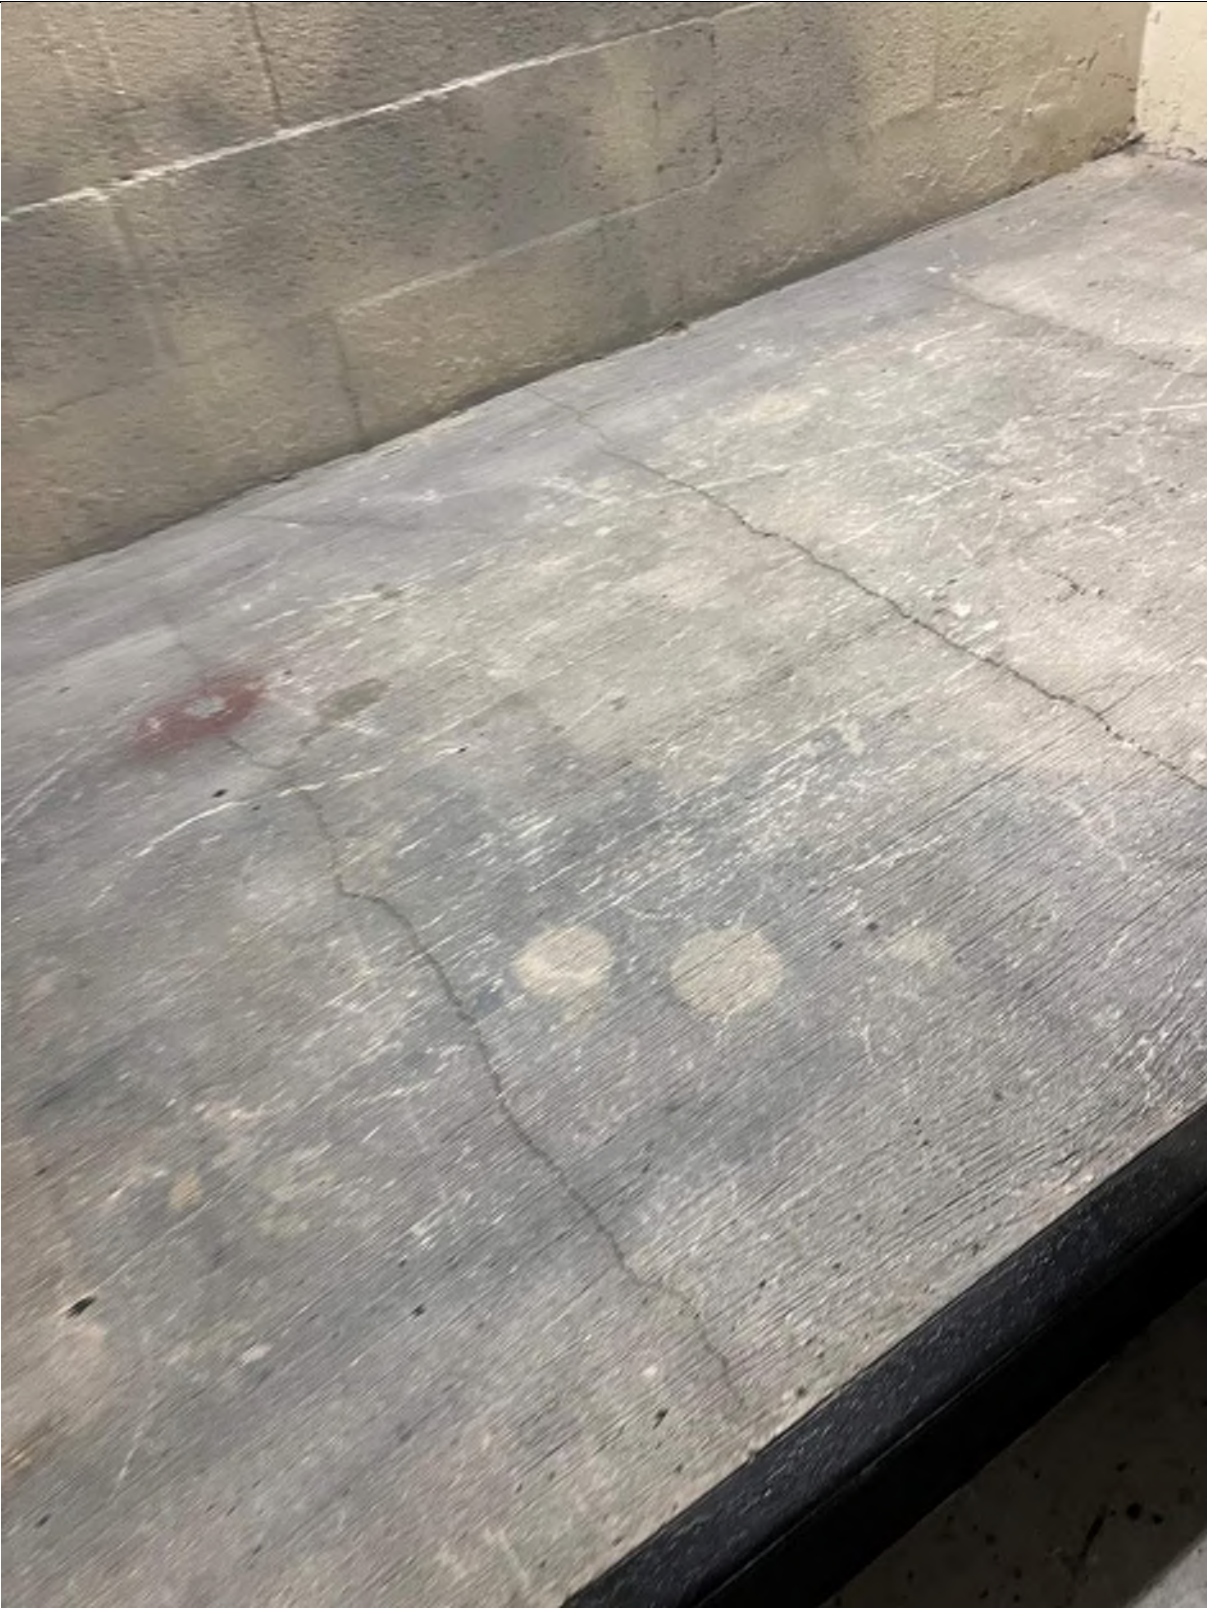
Picture 4.a.3.2

4.a.2. Plumbness	Good
4.a.3. Evidence of structural cracks	No; however, there is surface cracking throughout the interior pan deck metal composite stairs. These cracks shall be routed up to ¼” in depth and sealed with urethane caulk per section 3.3 of A.C.I. 224.1R-07. See pictures 4.a.3.1 and 4.a.3.2.

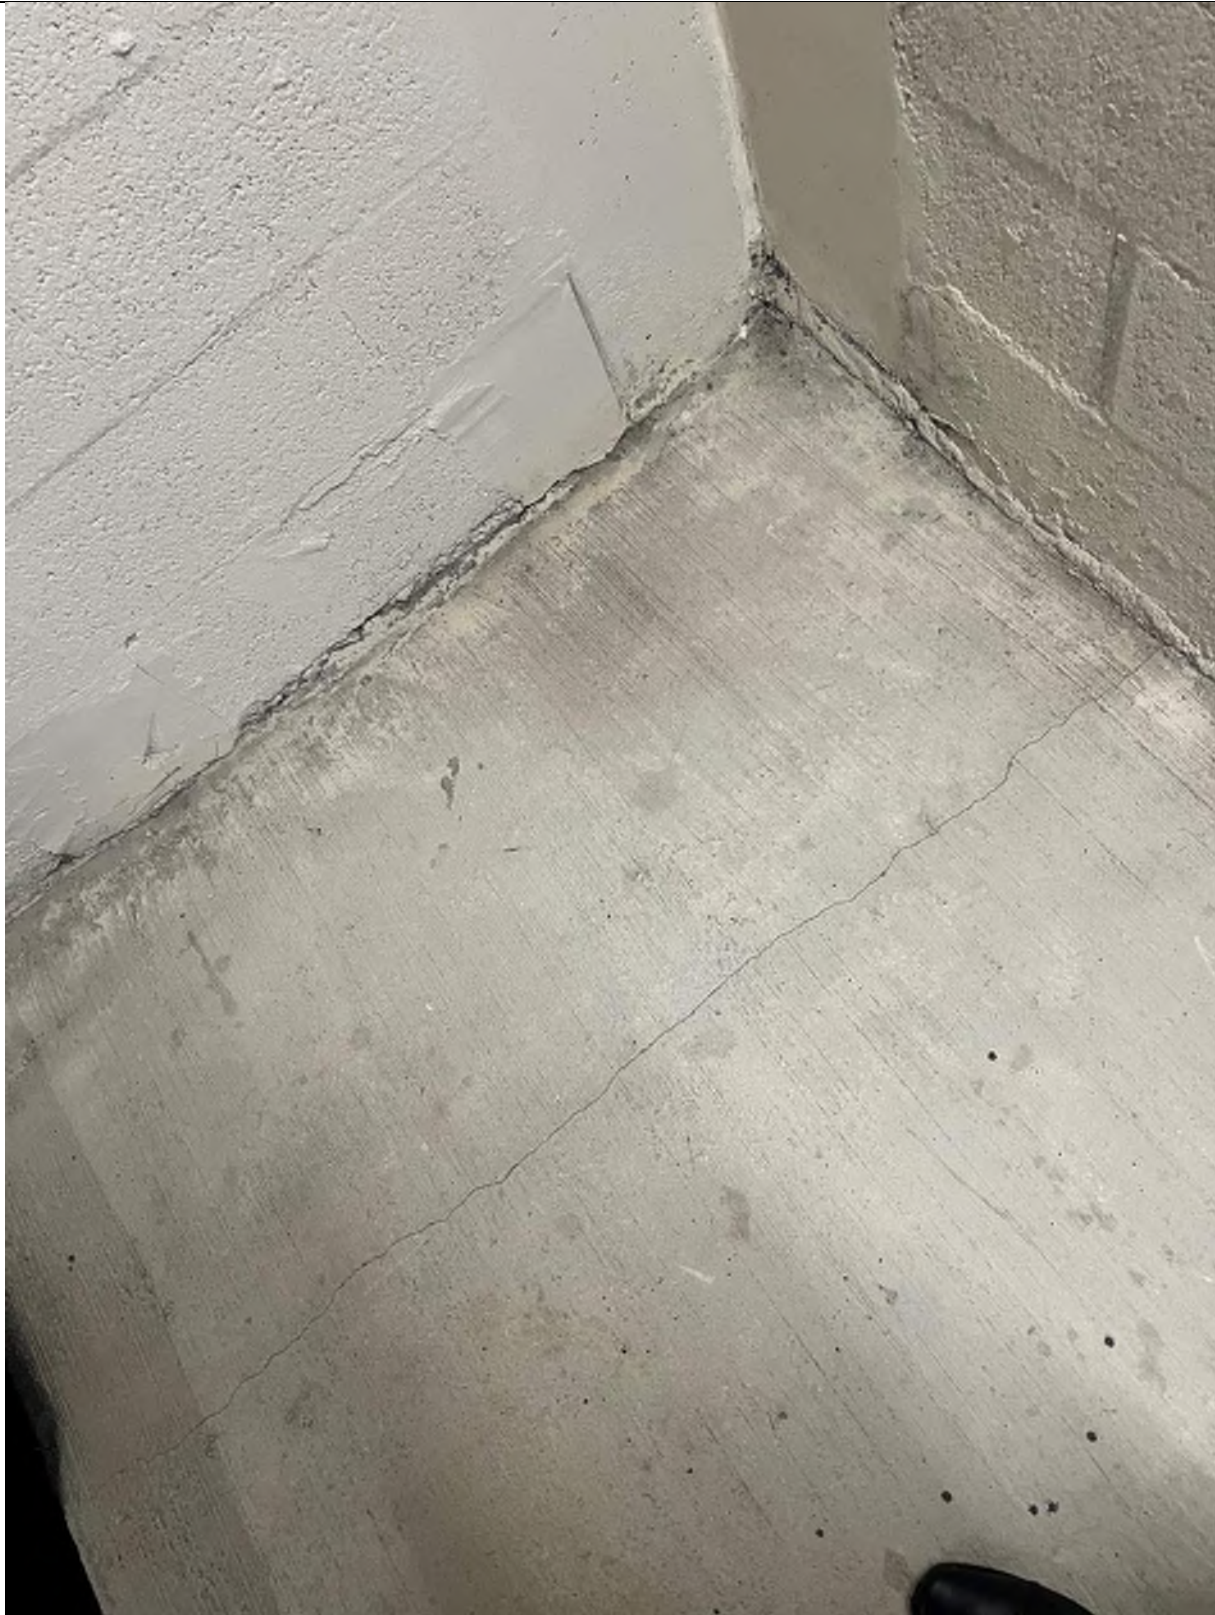
Picture 4.b.3.1

4.b.2. Plumbness	Good
4.b.3. Evidence of structural cracks	No; however, there is surface cracking throughout the interior pan deck metal composite stairs. These cracks shall be routed up to ¼” in depth and sealed with urethane caulk per section 3.3 of A.C.I. 224.1R-07. See pictures 4.b.3.1 and 4.b.3.2.

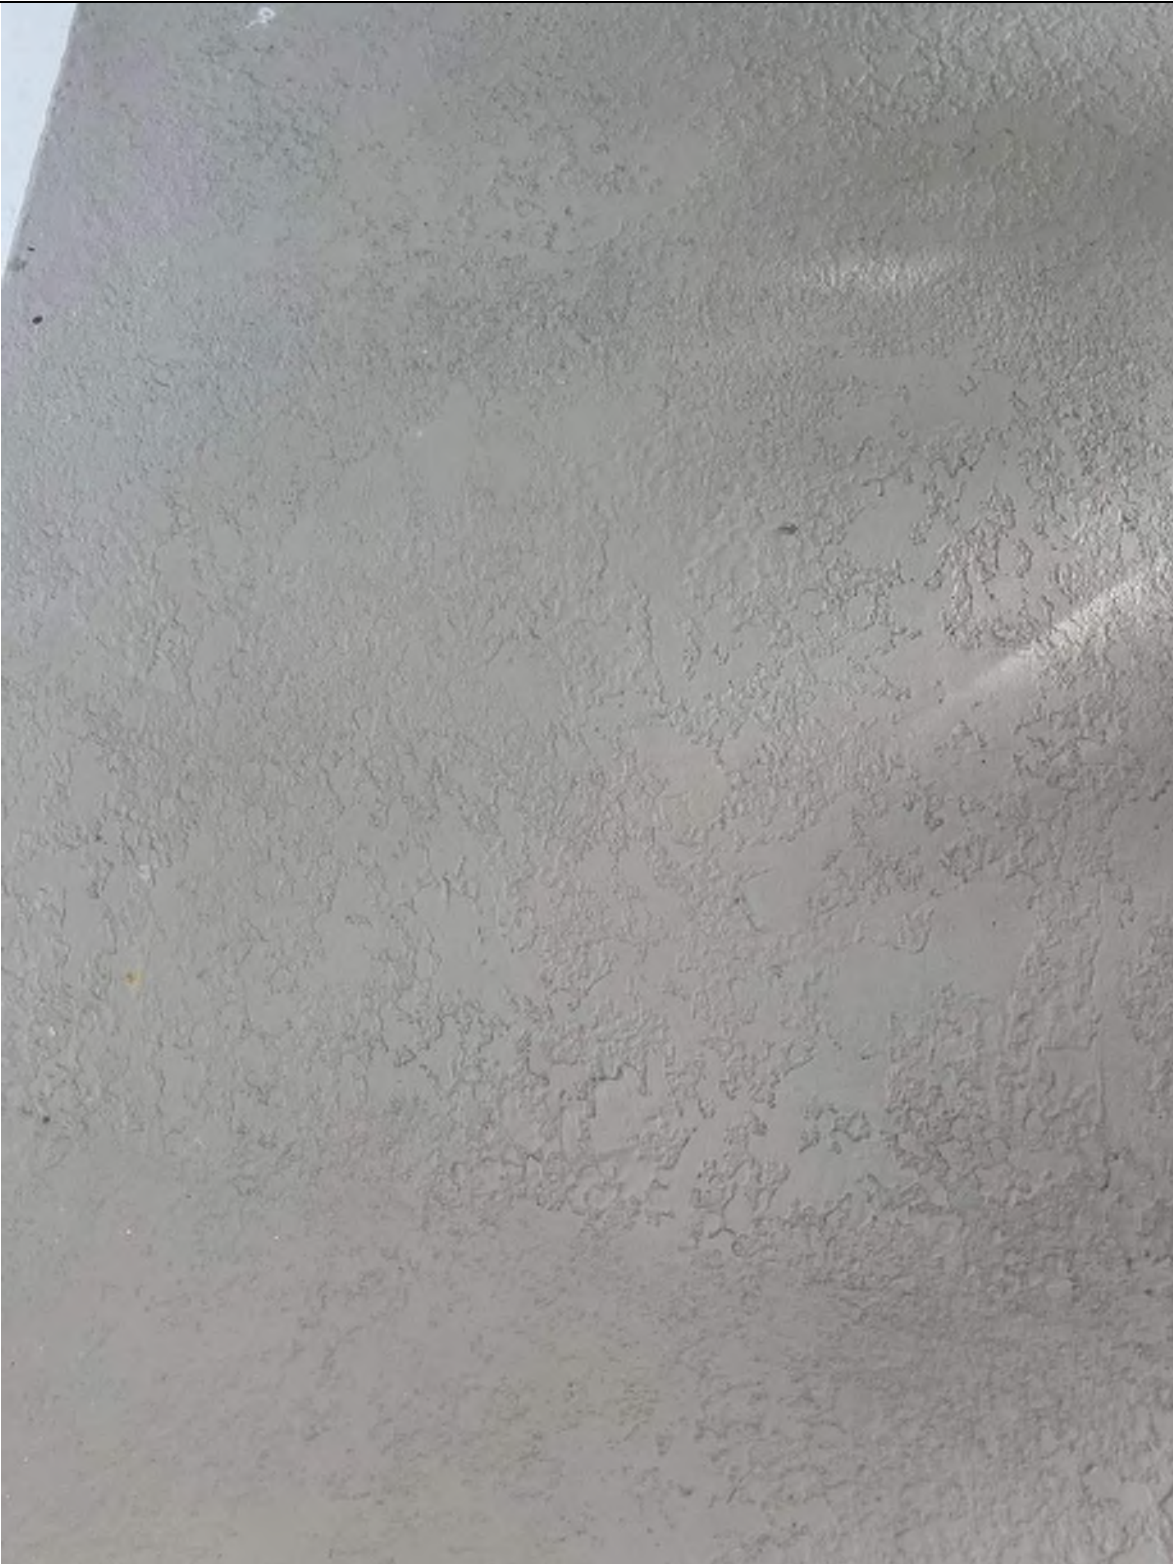
Picture 8.a.1.1

8.a.1. Waterproofing condition	The waterproofing coating of the catwalks is an acrylic type waterproofing coating. The coating is in good overall condition. See pictures 8.a.1.1 and 8.a.1.2. Note that the waterproofing finish is the same at the units and there is no tile permitted on the resident balconies to not allow for water entering under respective finish. Catwalks were last resurfaced in 2022.

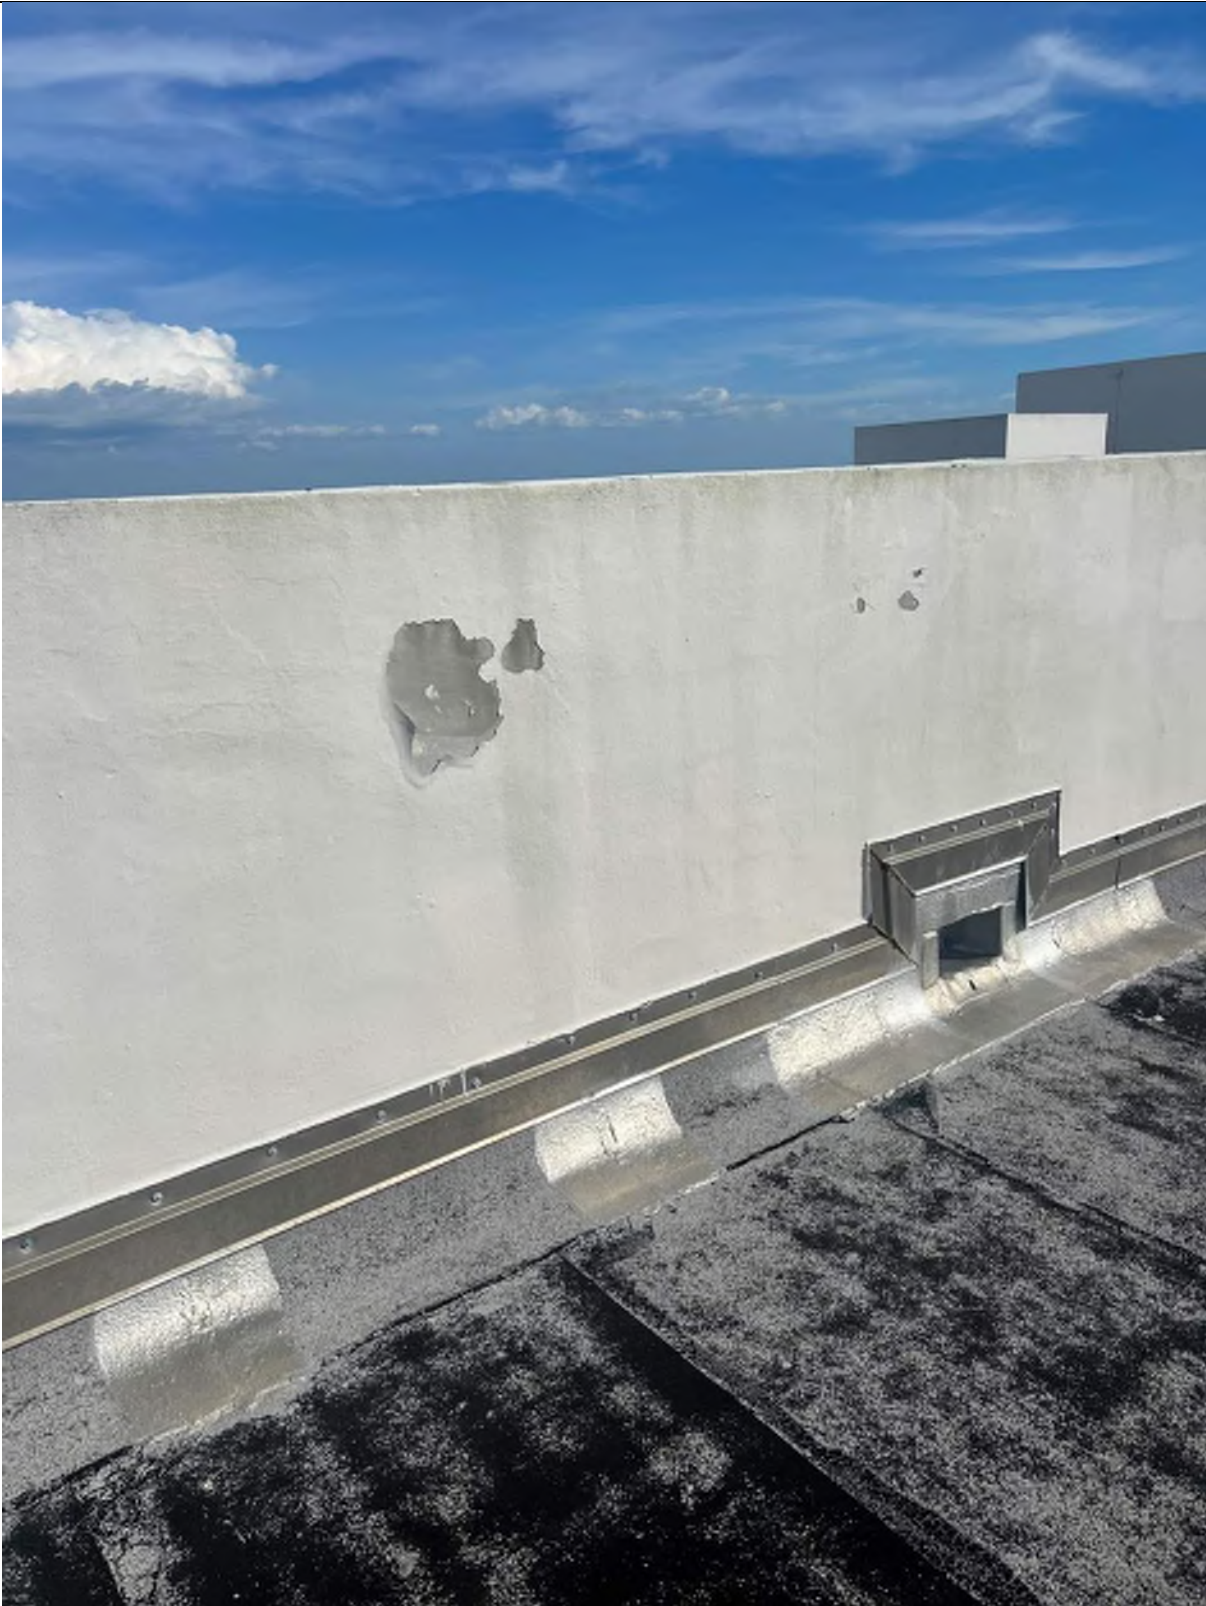
Picture 8.a.9.1

8.a.9. Paint condition – exterior building surfaces	Paint is in fair overall condition. There are a few areas with paint discoloration and paint/stucco surfaces that need to be patched. Painting of the building was last performed in 2018. See pictures 8.a.9.1 and 8.a.9.2.

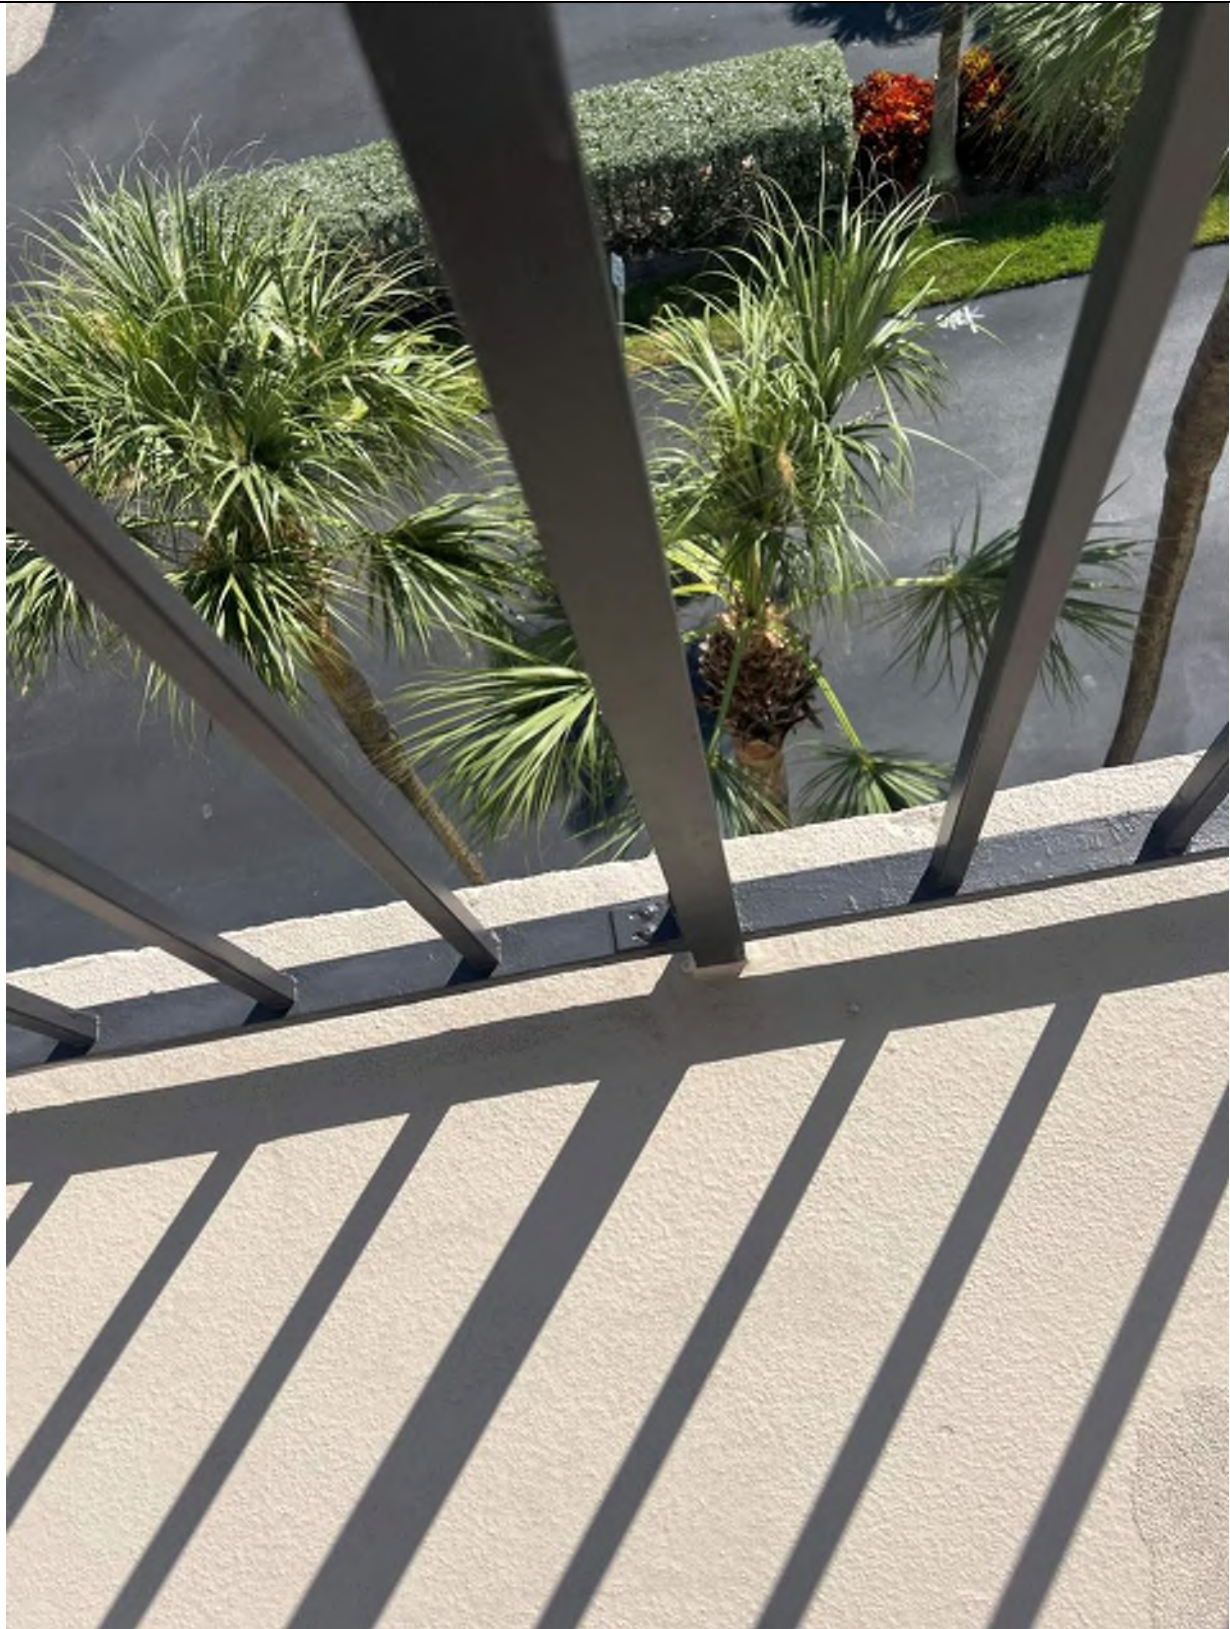
Picture 8.a.14.1

8.a.13. Exterior building surfaces repaint cost	59,512 S.F. x \$2.12 x \$227,052
8.a.14. Paint condition – Aluminum railings	Good overall condition. See pictures 8.a.14.1 and 8.a.14.2.

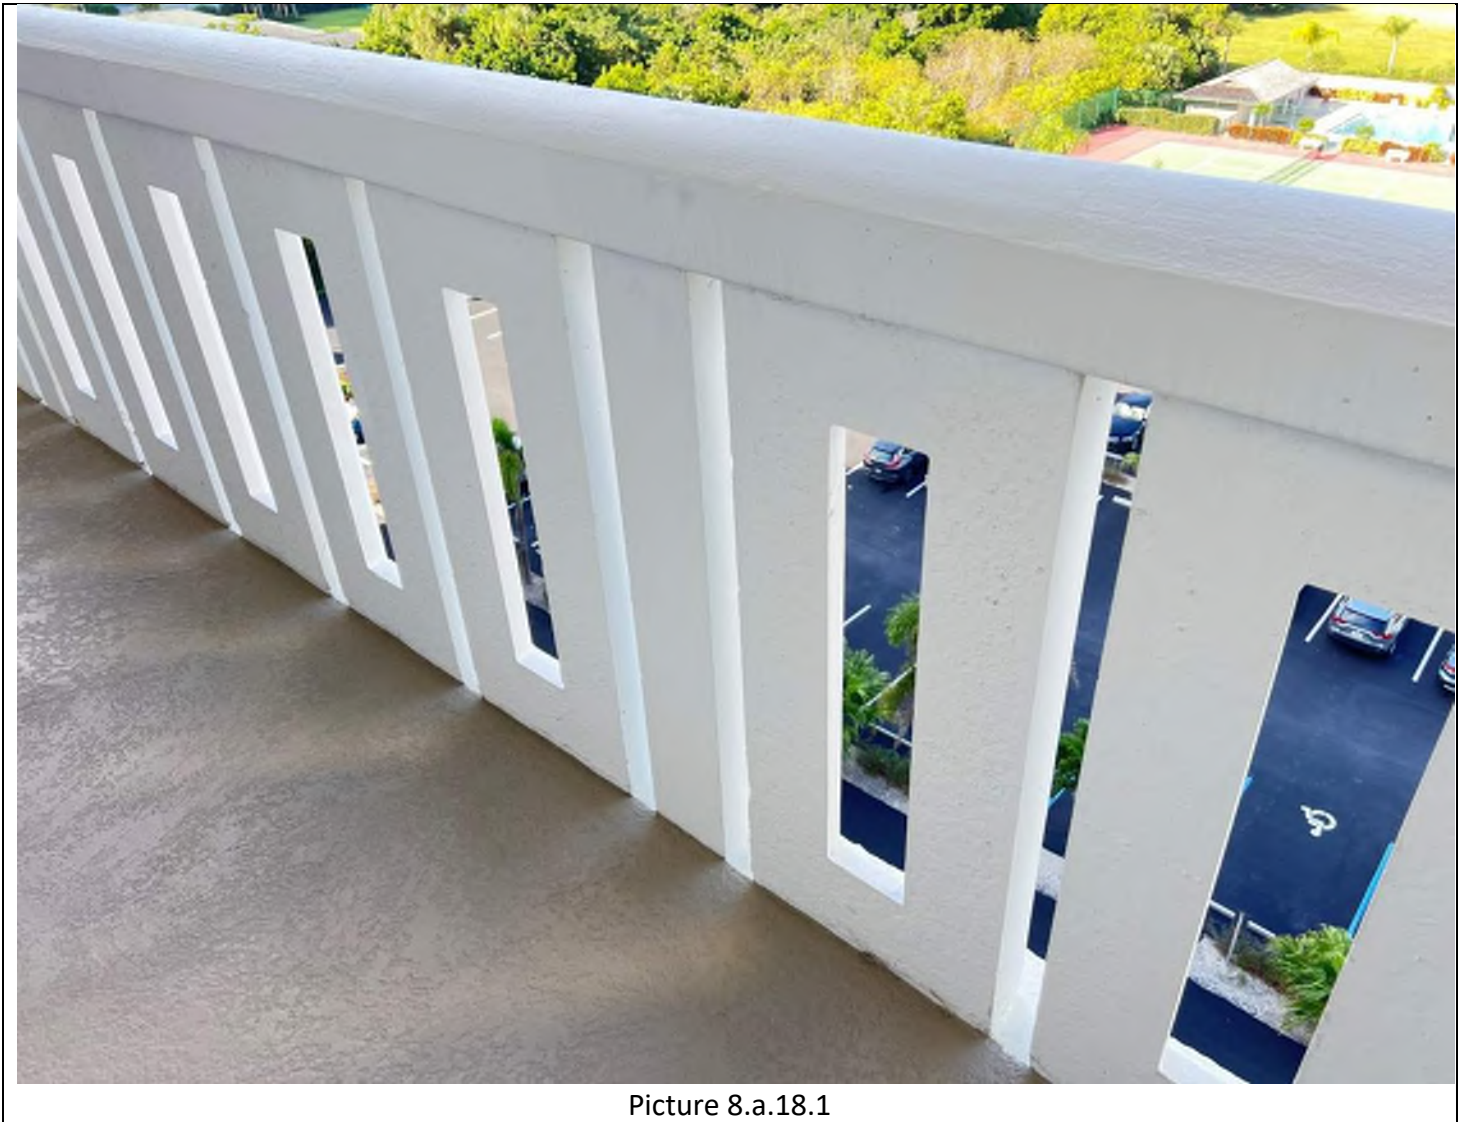
Picture 8.a.18.1

8.a.18. Paint condition – Precast concrete railings	Good overall condition. See pictures 8.a.18.1
8.a.19. Paint – Precast concrete railings – paint useful life	8 years

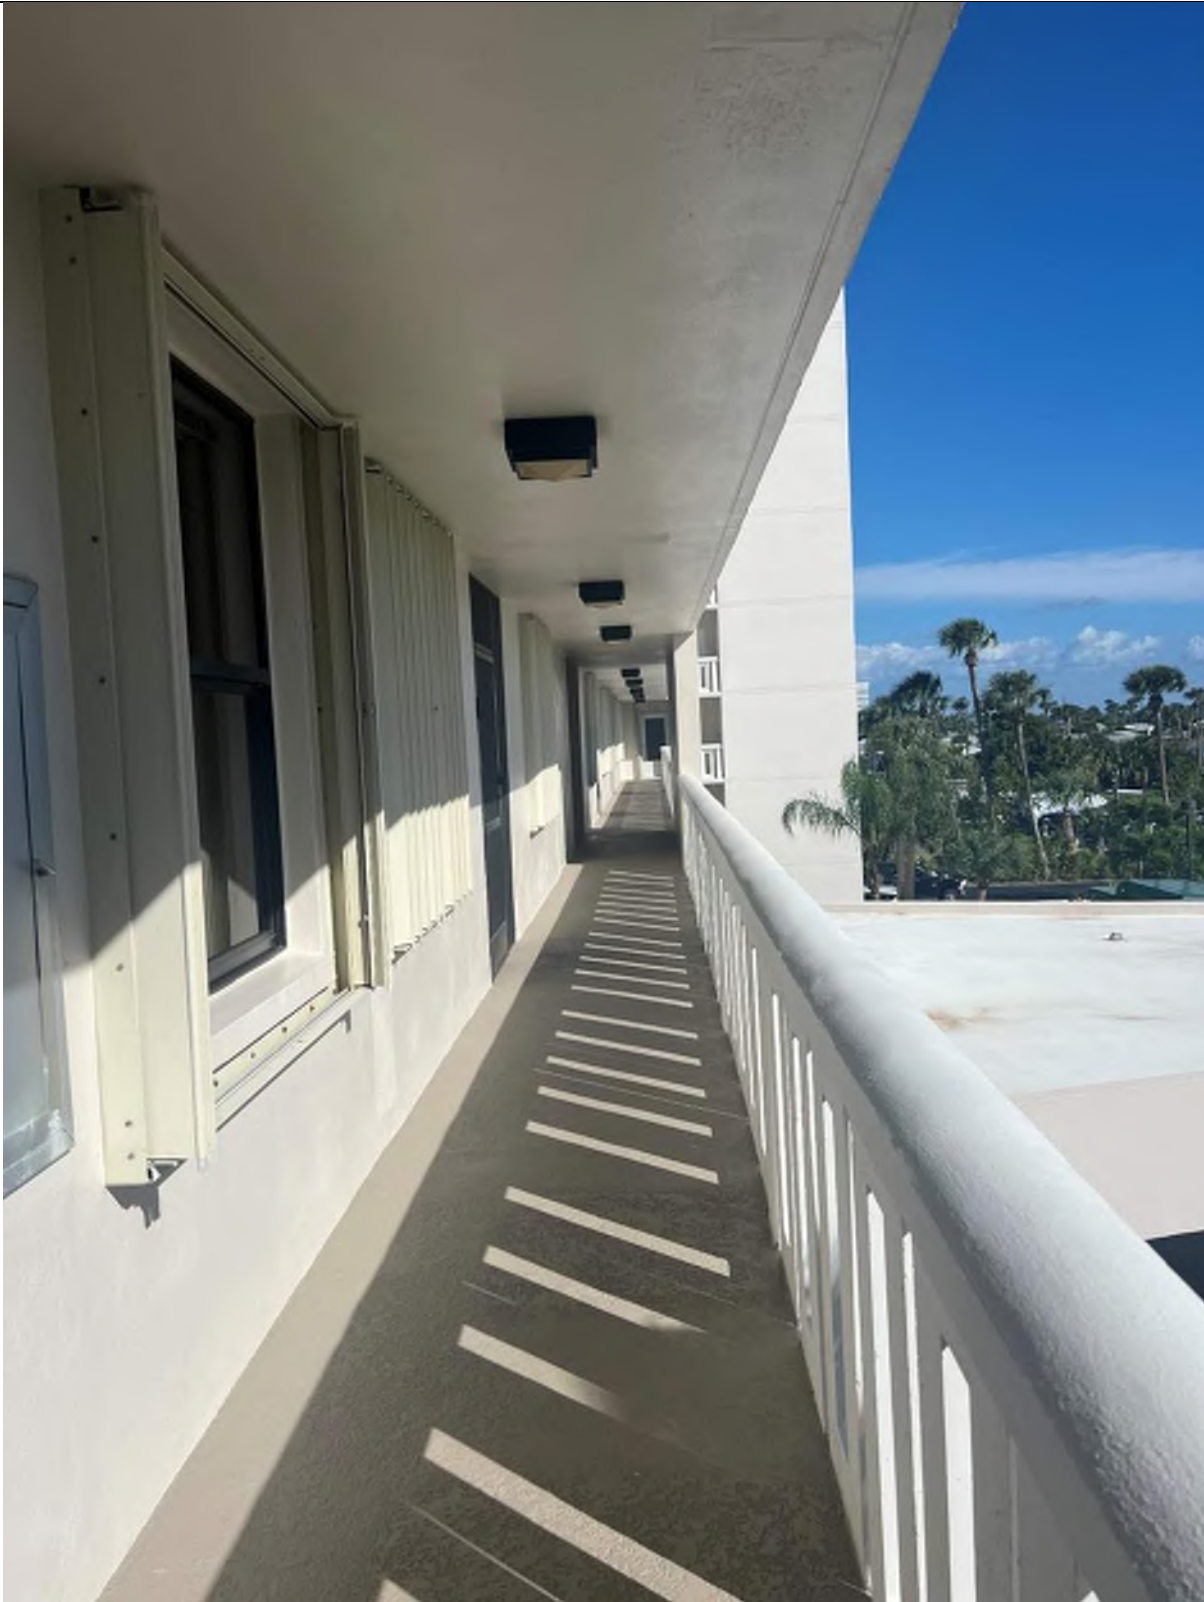
Picture 8.b.1.1

8.b. 5059 N A1A (Building B)	
8.b.1. Waterproofing condition	The waterproofing coating of the catwalks is an acrylic type waterproofing coating. The coating is in good overall condition. See picture 8.b.1.1. Note that the waterproofing finish is the same at the units and there is no tile permitted on the resident balconies to not allow for water entering under respective finish. Catwalks were last resurfaced in 2022.

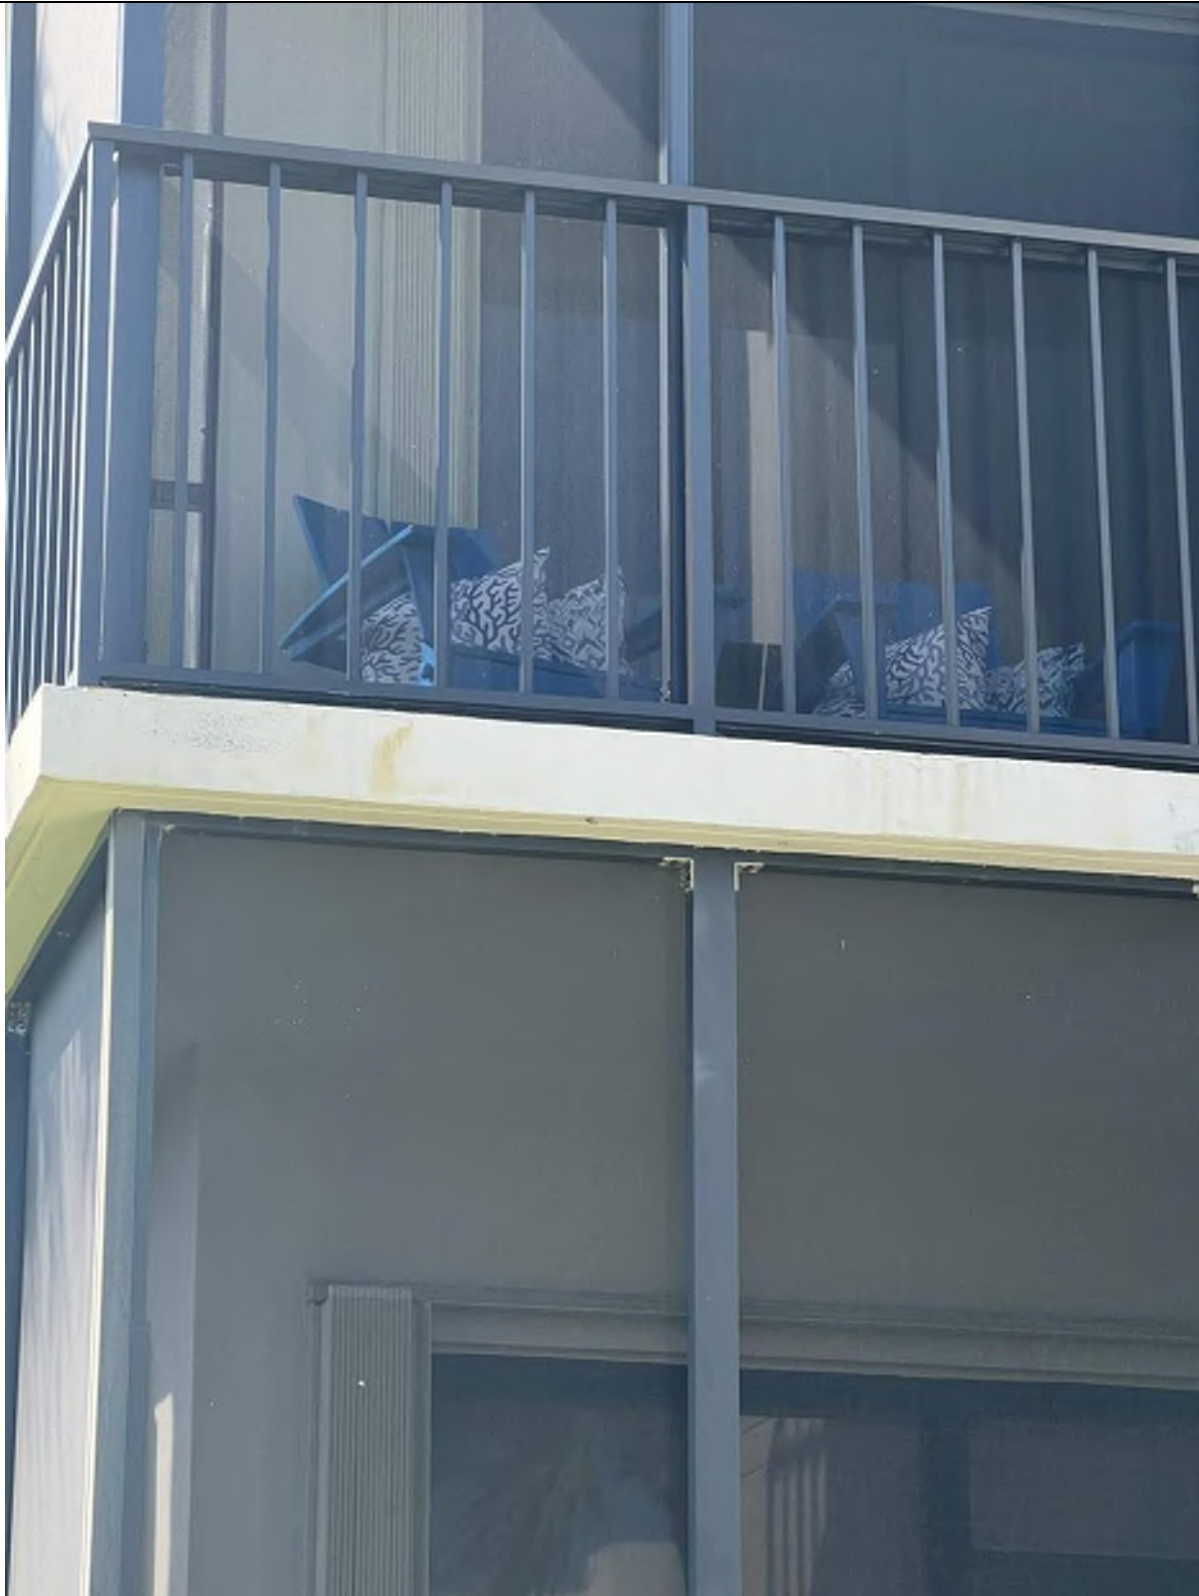
Picture 8.b.9.1

8.b.9. Paint condition – Exterior building surfaces	Paint is in fair overall condition. There are a few areas with paint discoloration and paint/stucco surfaces that need to be patched. Painting of the building was last performed in 2018. See pictures 8.b.9.1 and 8.b.9.2.

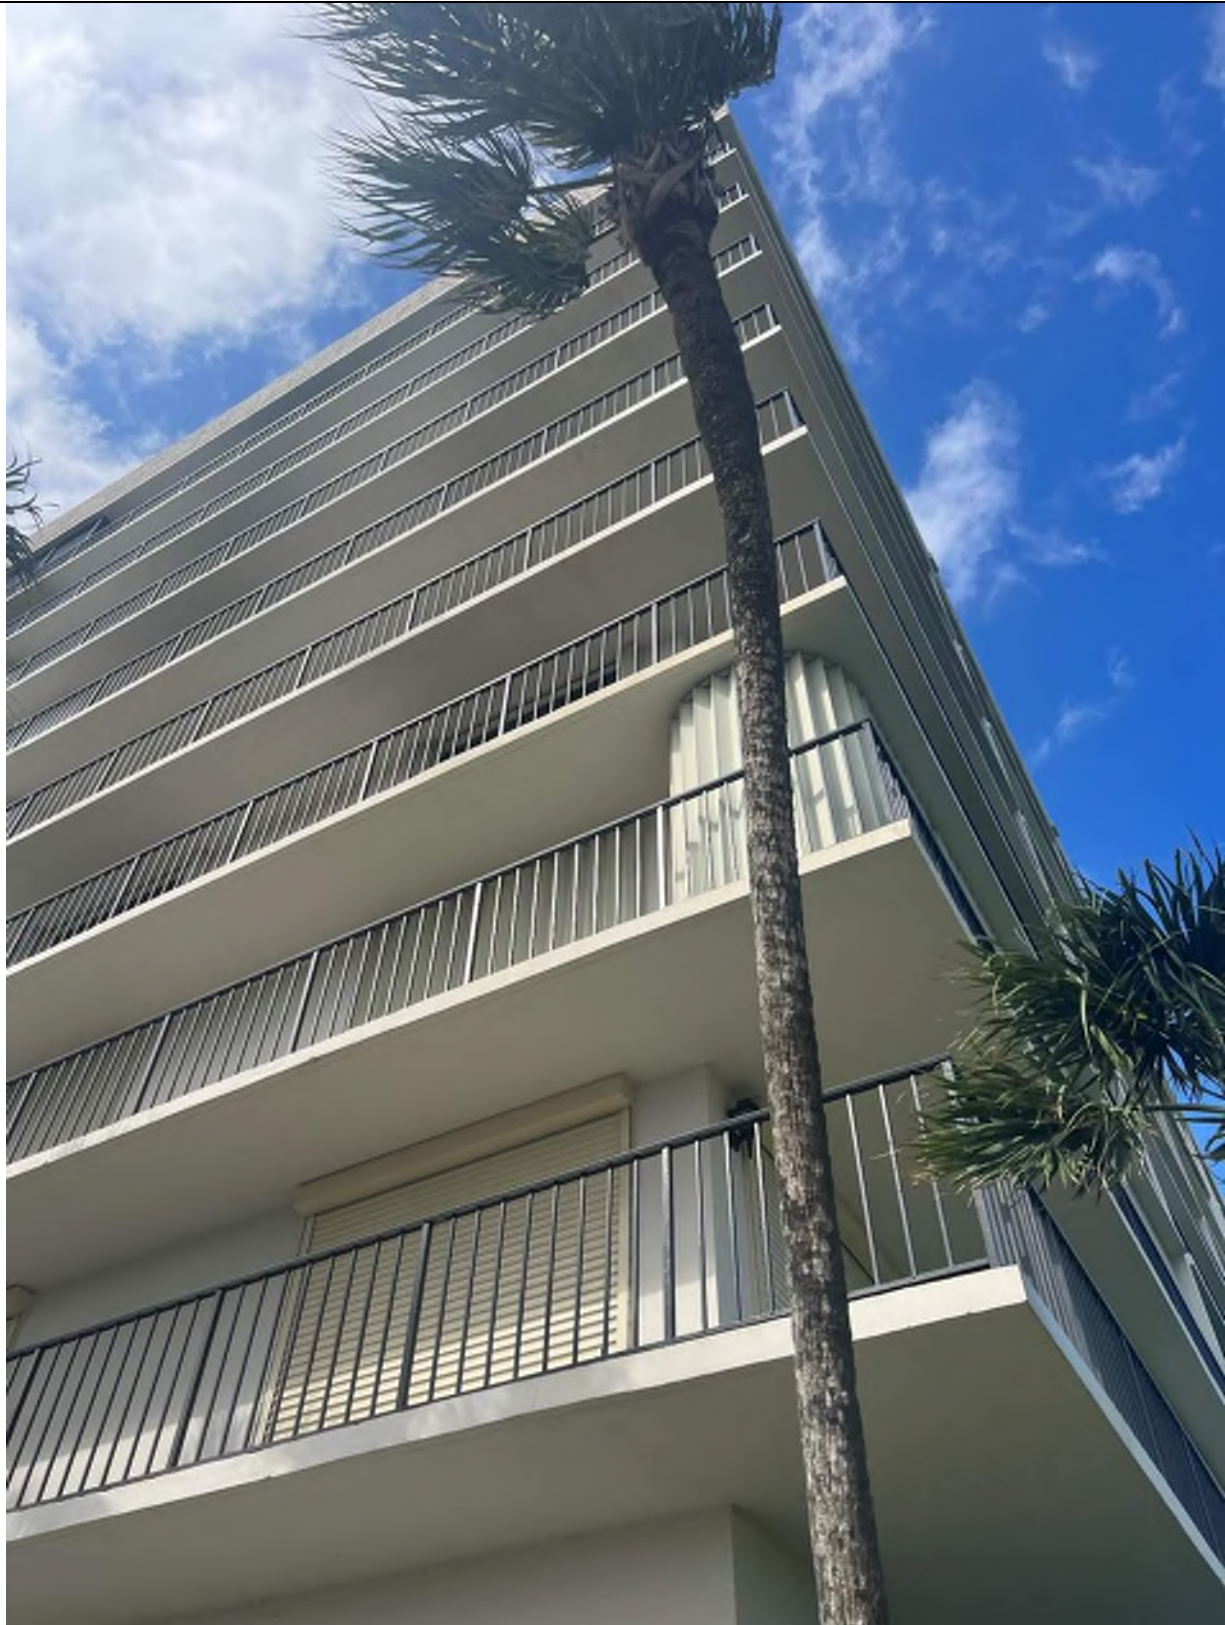
Picture 8.b.14.1

8.b.13. Exterior building surfaces repaint cost	59,512 S.F. x \$2.12 x \$227,052
8.b.14. Paint condition – Aluminum balcony railings	Good overall condition. See pictures 8.b.14.1 and 8.b.14.2.

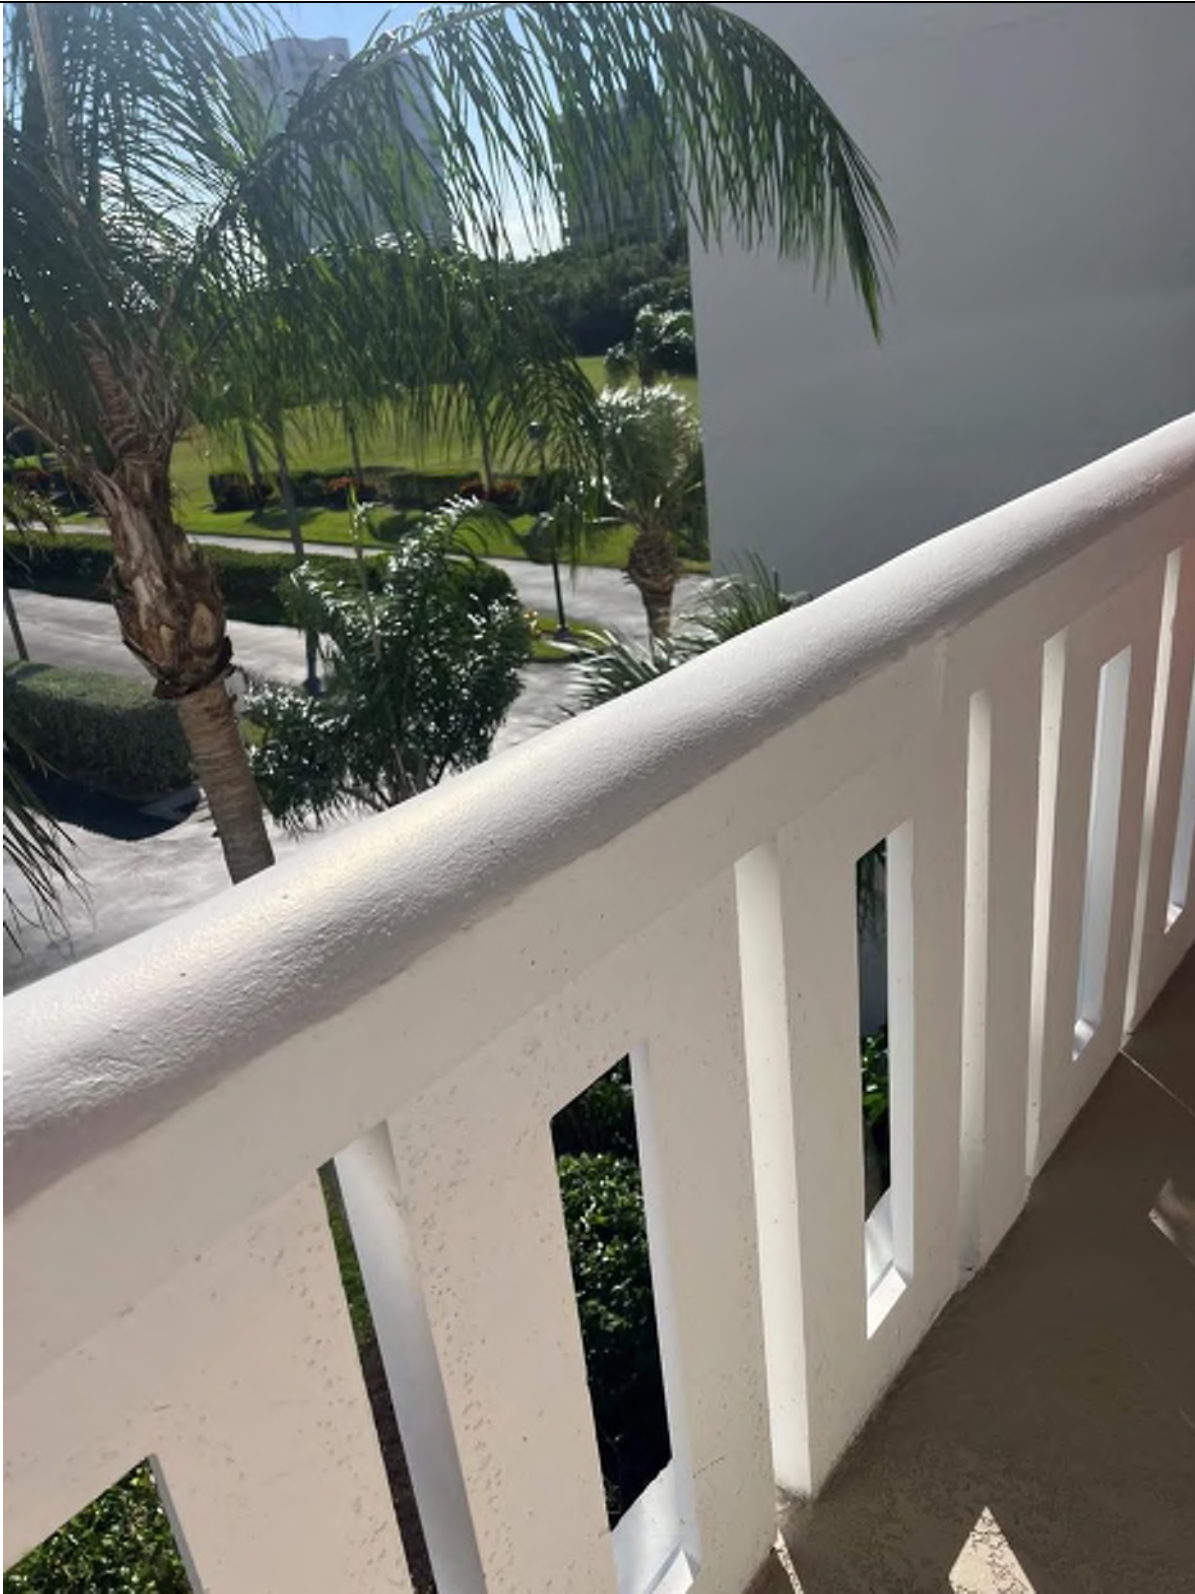
Picture 8.b.18.1

8.b.18. Paint condition – Precast concrete railings	Good overall condition. See pictures 8.b.18.1
8.b.19. Paint – Precast concrete railings – paint useful life	8 years
