Milestone Inspection Phase I Report

Bryn Mawr Ocean Towers

5055, 5059, and 5061 N Highway A1A

The intention of this report is to develop a substantially completed Milestone Inspection Phase One report per the requirements of Senate Bill 4-D and Florida Statutes 553.899.

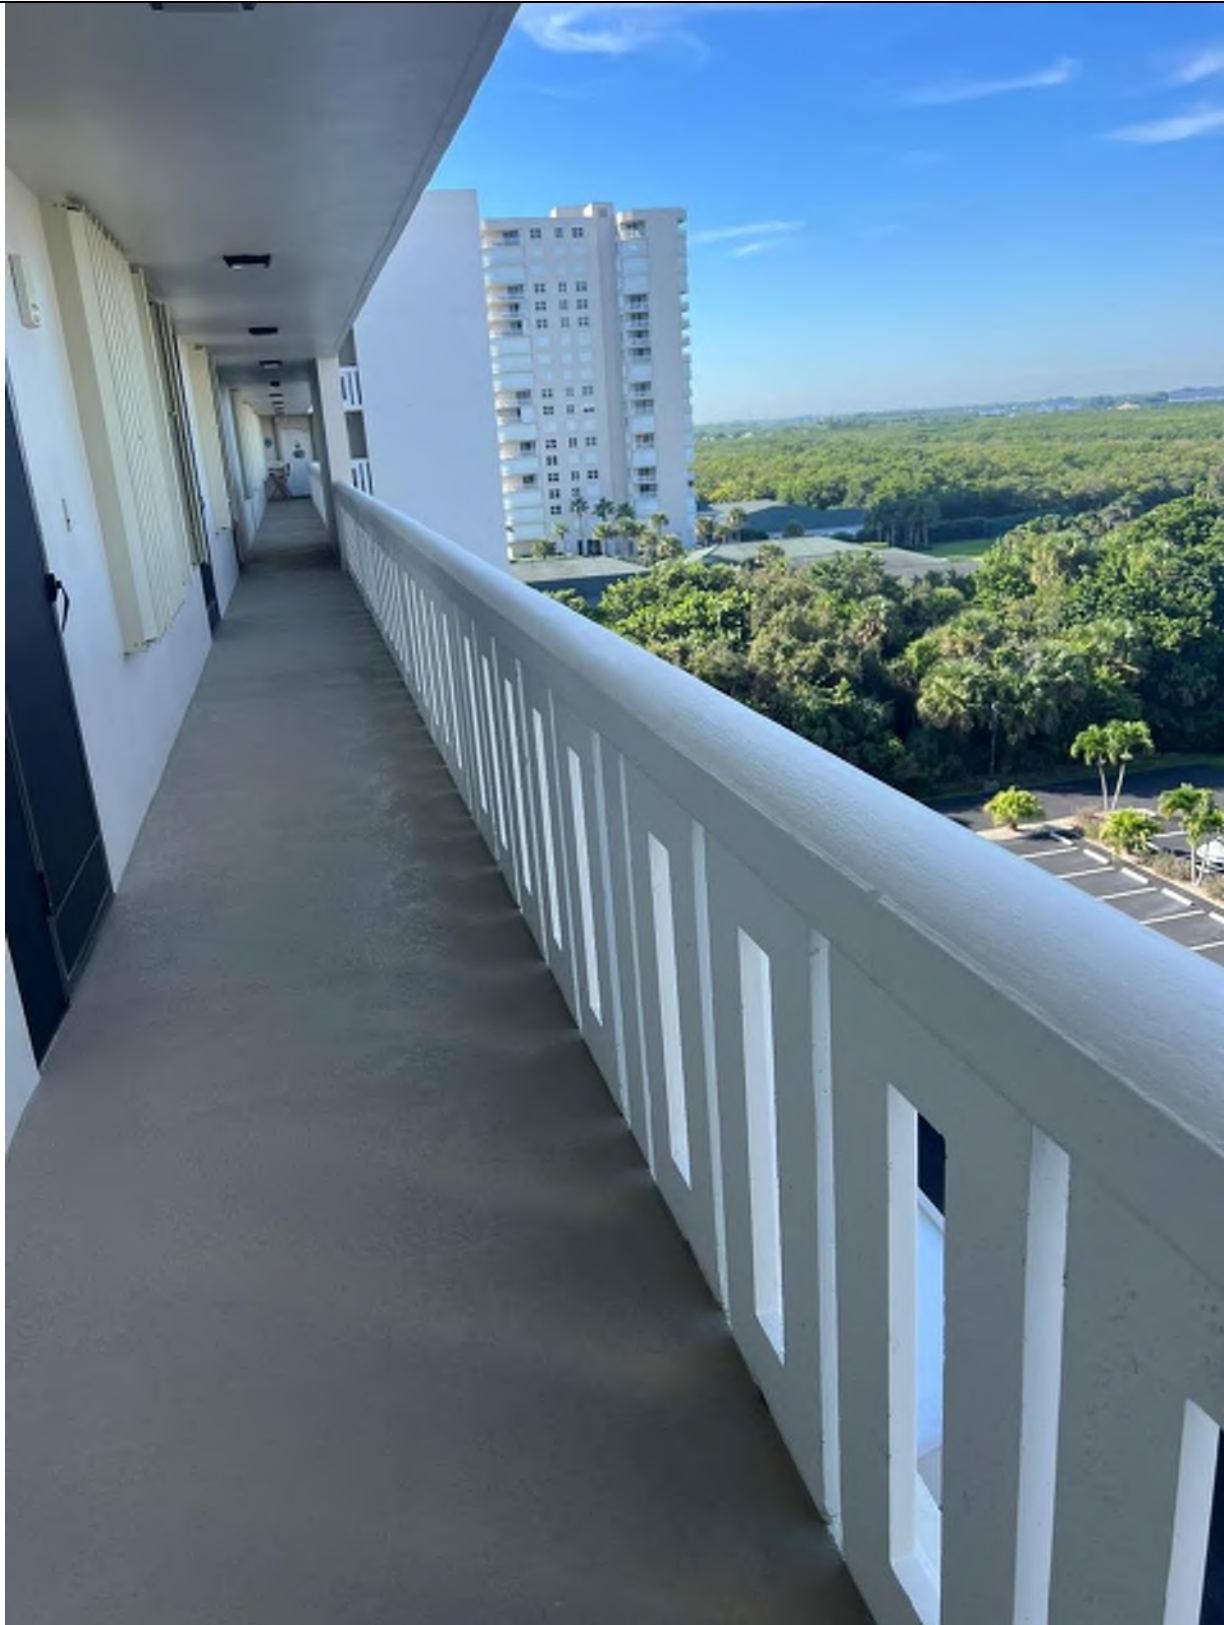
Picture 8.c.1.1

8.b. 5055 N A1A (Building C)	
8.c.1. Waterproofing condition	The waterproofing coating of the catwalks is an acrylic type waterproofing coating. The coating is in good overall condition. See picture 8.c.1.1. Note that the waterproofing finish is the same at the units and there is no tile permitted on the resident balconies to not allow for water entering under respective finish. Catwalks were last resurfaced in 2022.

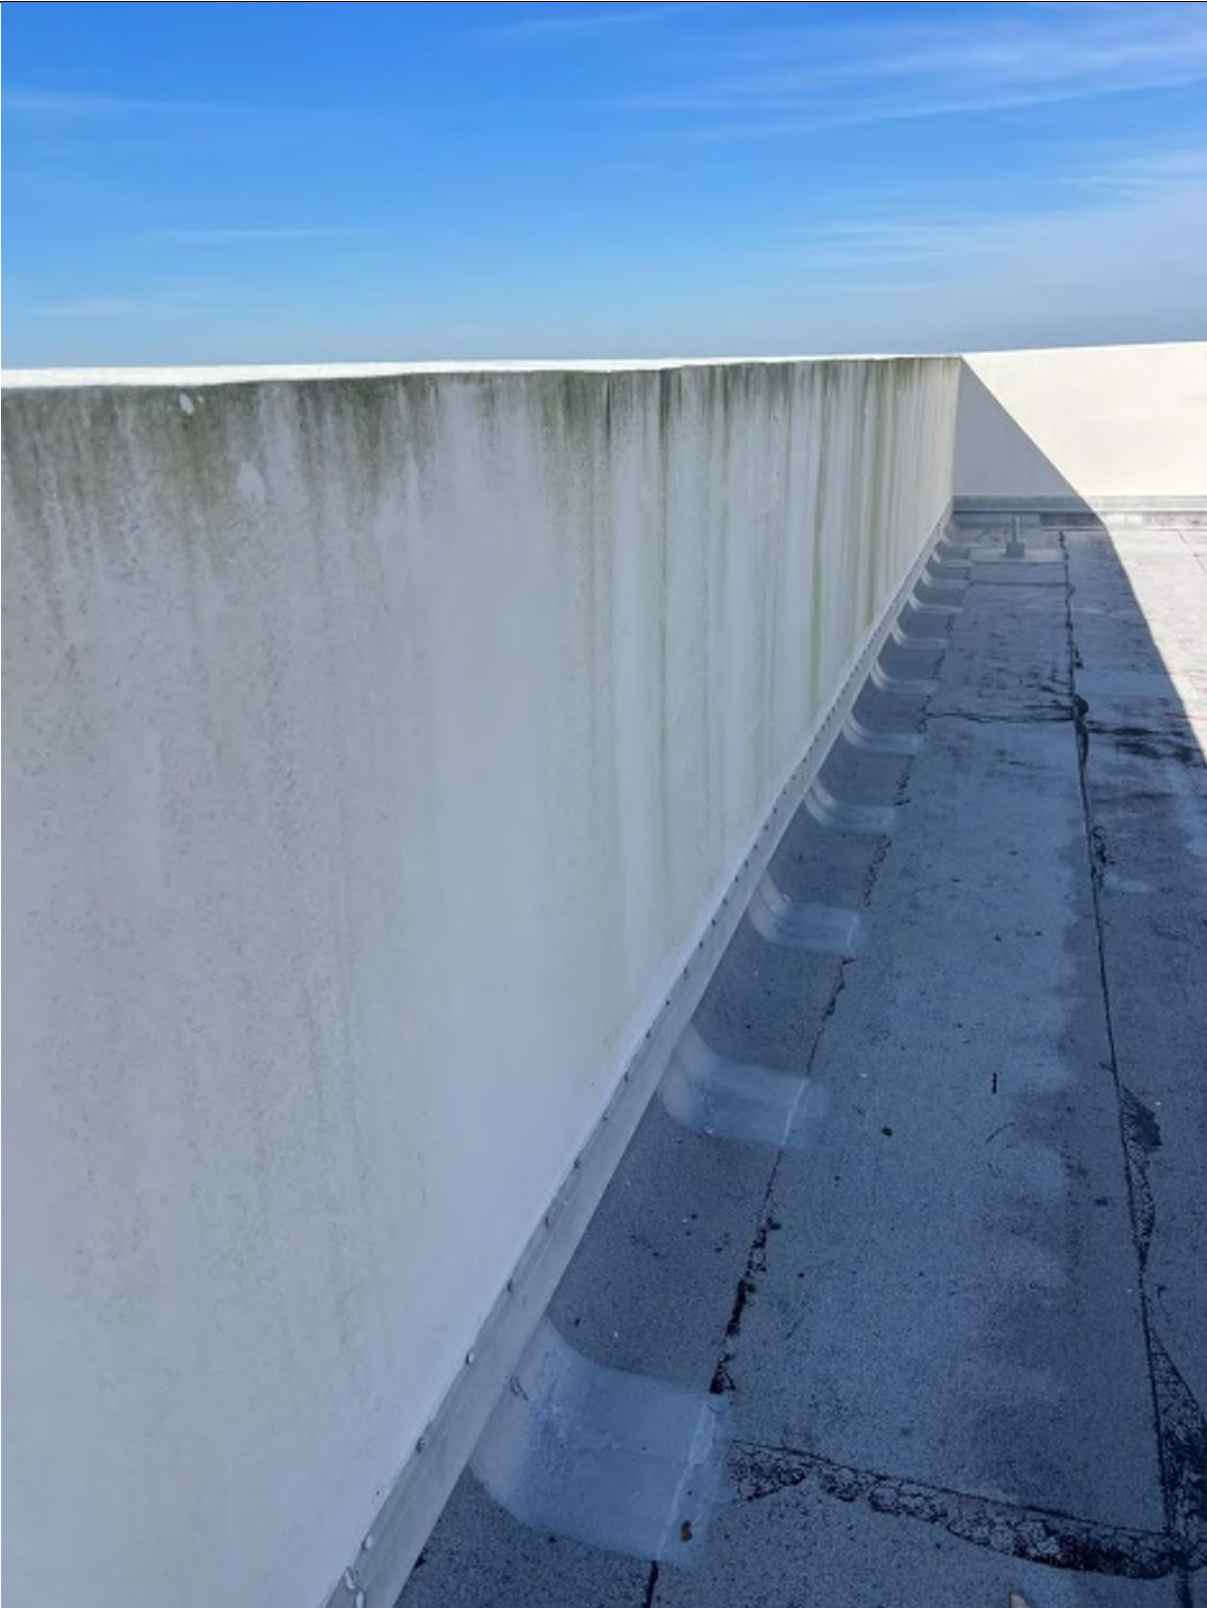
Picture 8.c.9.1

8.c.9. Paint condition – exterior building surfaces	Paint is in fair overall condition. There are a few areas with paint discoloration and paint/stucco surfaces that need to be patched. Painting of the

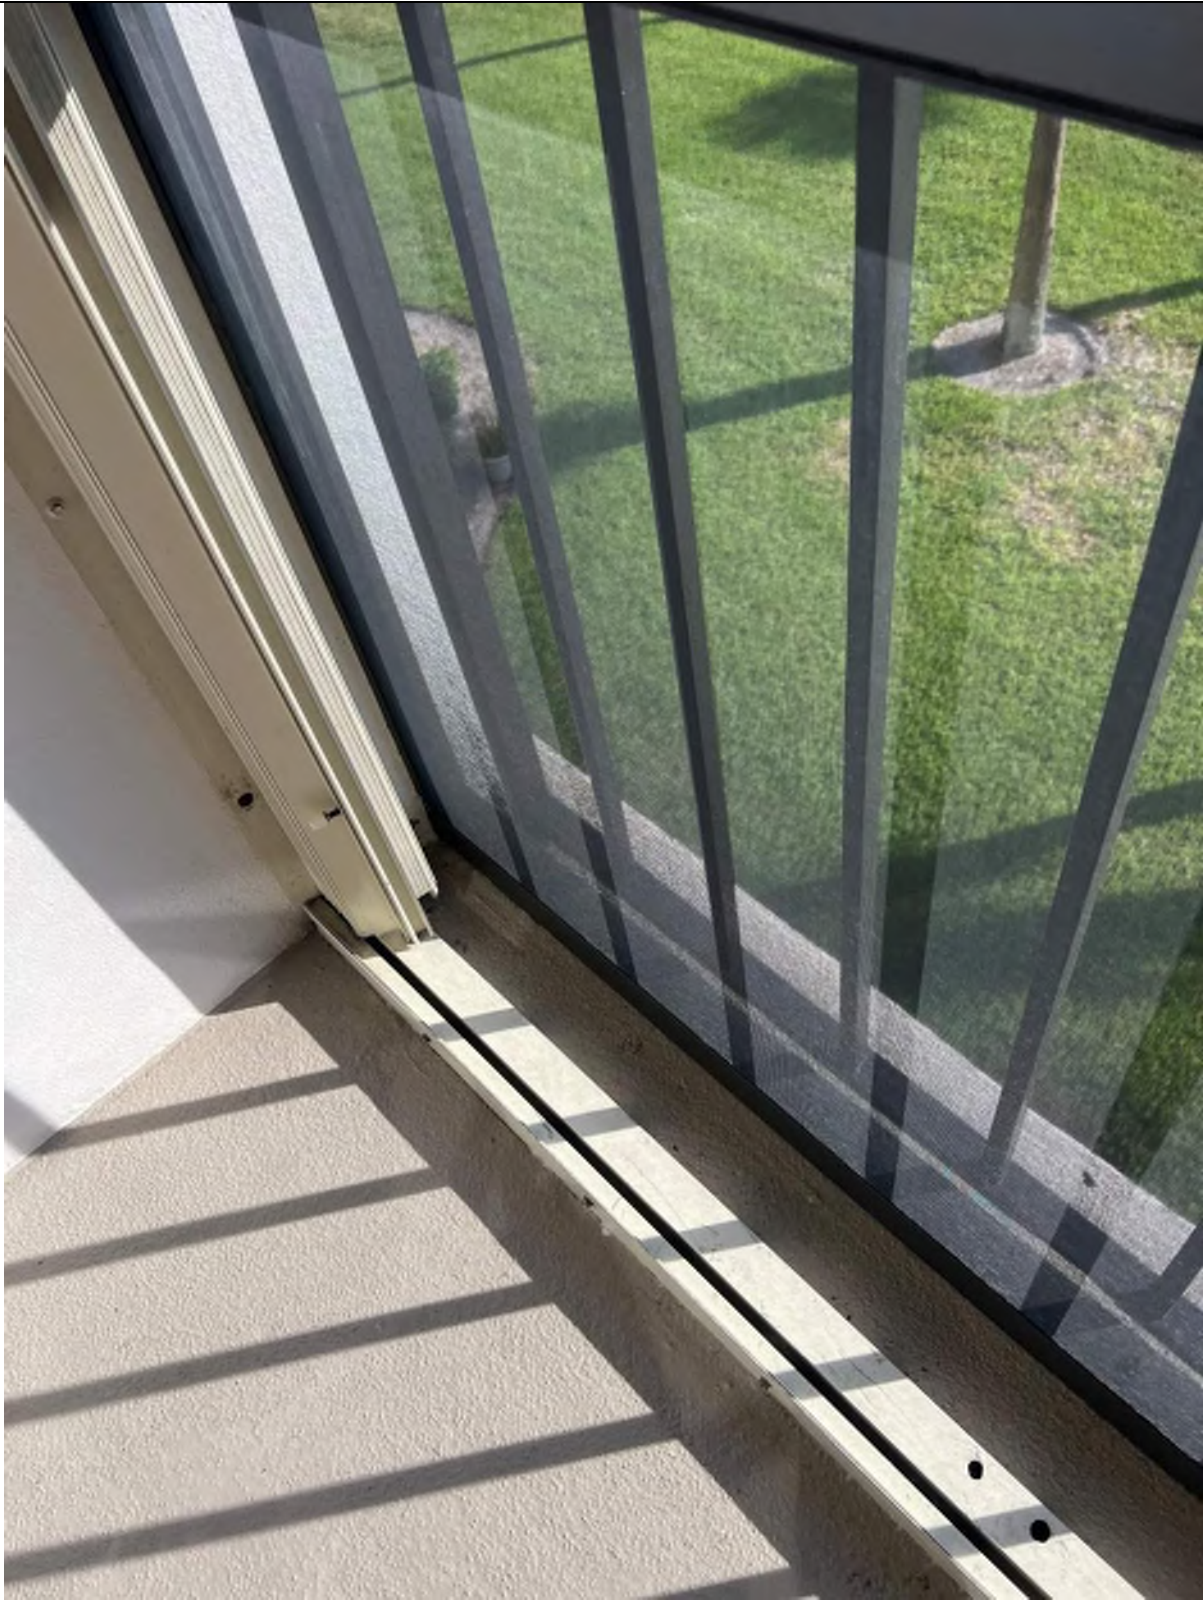
Picture 8.c.14.1

8.c.13. Exterior building surfaces repaint cost	59,512 S.F. x \$2.12 = \$227,052
8.c.14. Paint condition – Aluminum balcony railings	Good overall condition. See pictures 8.c.14.1 and 8.c.14.2.

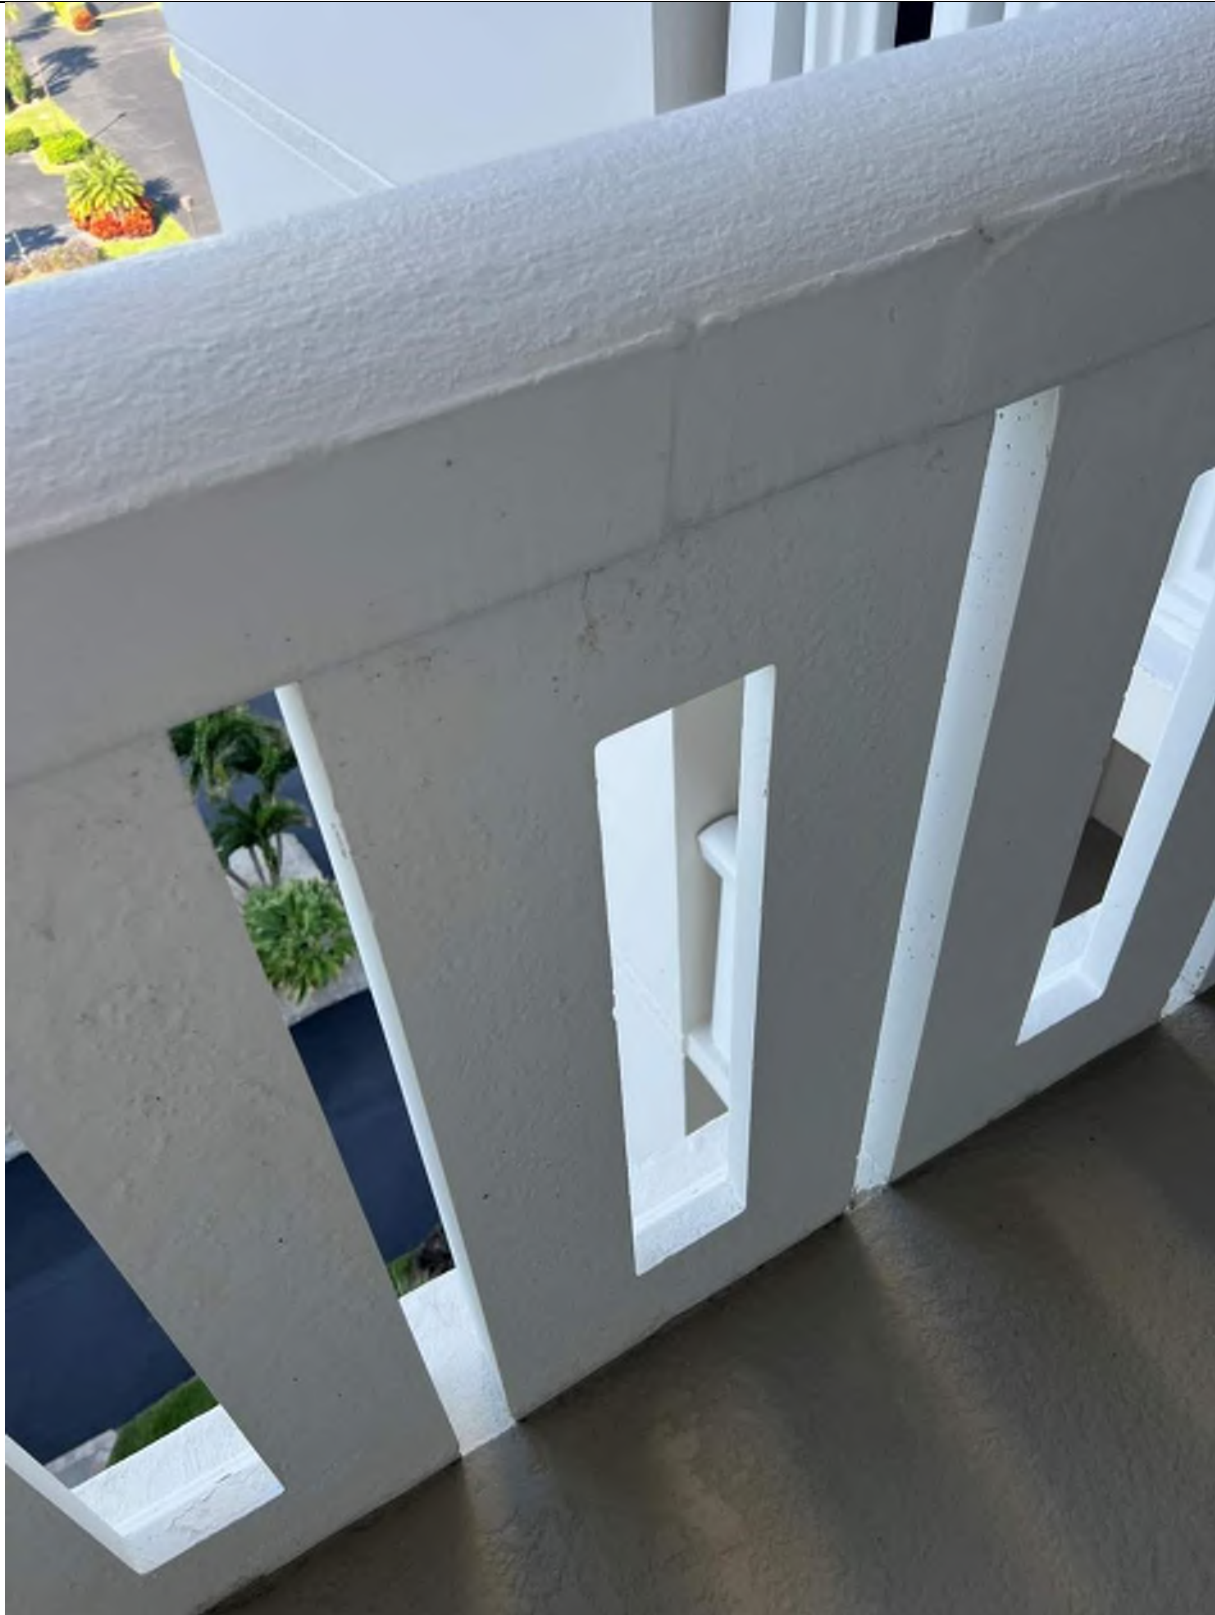
Picture 8.c.18.1

8.c.18. Paint condition – Precast concrete railings	Good overall condition. See pictures 8.c.18.1
8.c.19. Paint – Precast concrete railings – paint useful life	8 years

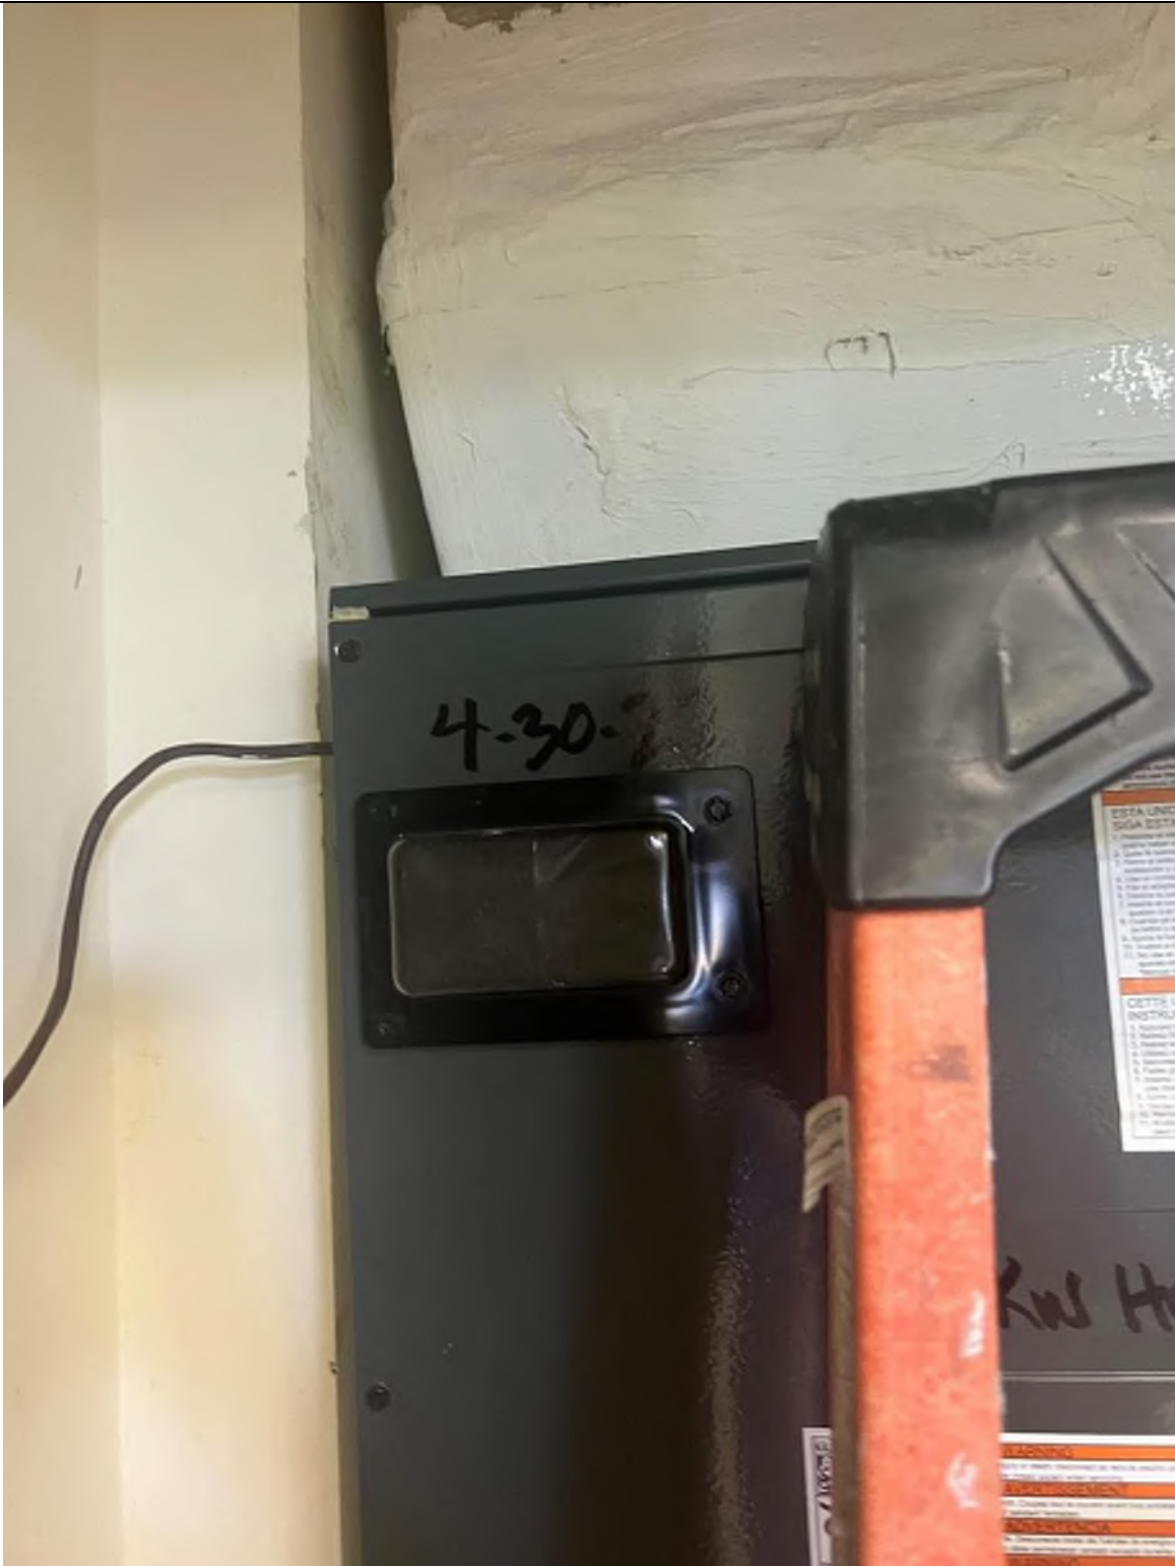
Picture 10.a.1.1

10.a. 5061 N A1A (Building A)	
10.a.1. Package heating and cooling type and condition – game room	The 3.5 ton A/C unit with 8 kW heater in the game room is in good overall condition. The unit was replaced in 2022. See picture 10.a.1.1

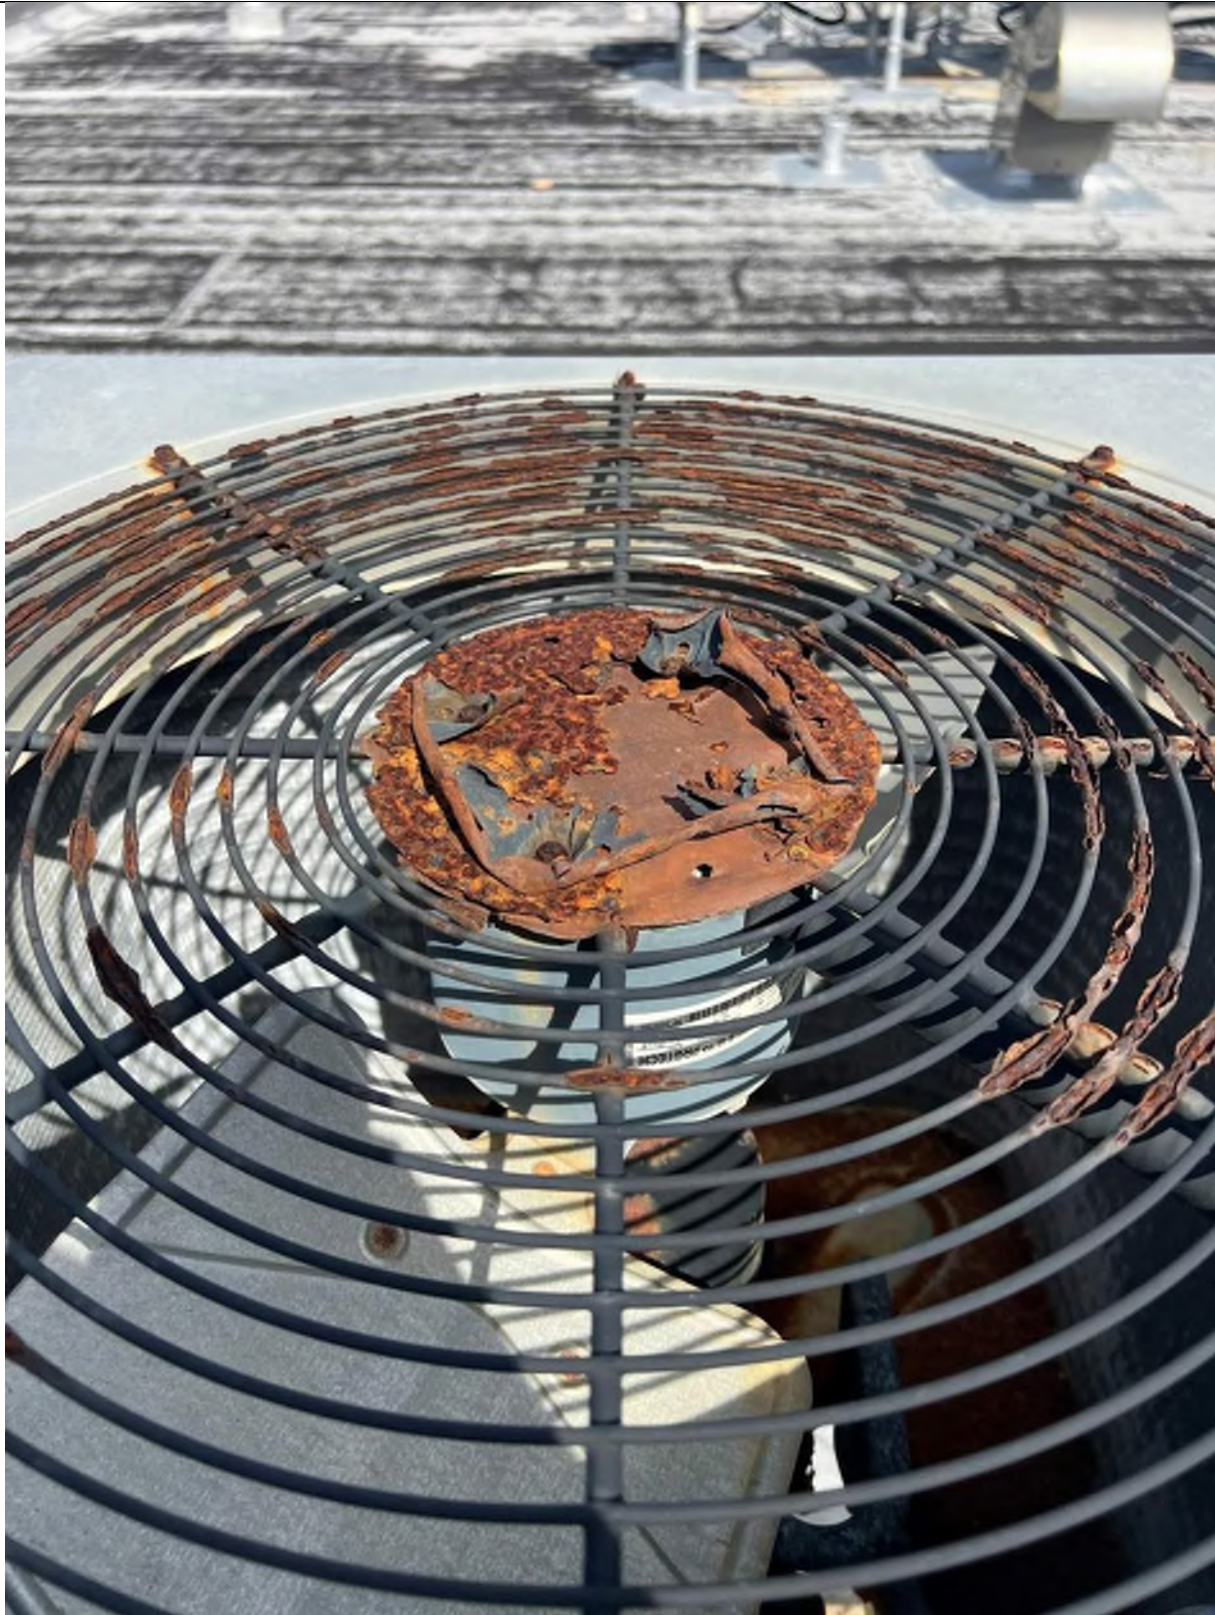
Picture 10.a.5.1

10.a.4. Package heating and cooling unit – game room - replacement cost	\$12,250
10.a.5. Package heating and cooling type and condition – game room	Although this is the responsibility of the unit owner, it is important to keep an eye on the condition of the AC units. For instance, if an A/C compressor is not properly fastened to the A/C stand, it can act as a dangerous projectile in a hurricane. Also, if the corrosion of the fan shroud gets excessive, it can cause damage to the roof/building if the fan would get dislodged. If there are holes/openings in the conduits, water can get into the building and affect all the residents. The units appear to be in fair overall condition with minor oxidation. The majority of refrigerant lines are adequately protected with Armorflex. See pictures 10.a.5.1 and 10.a.5.2.

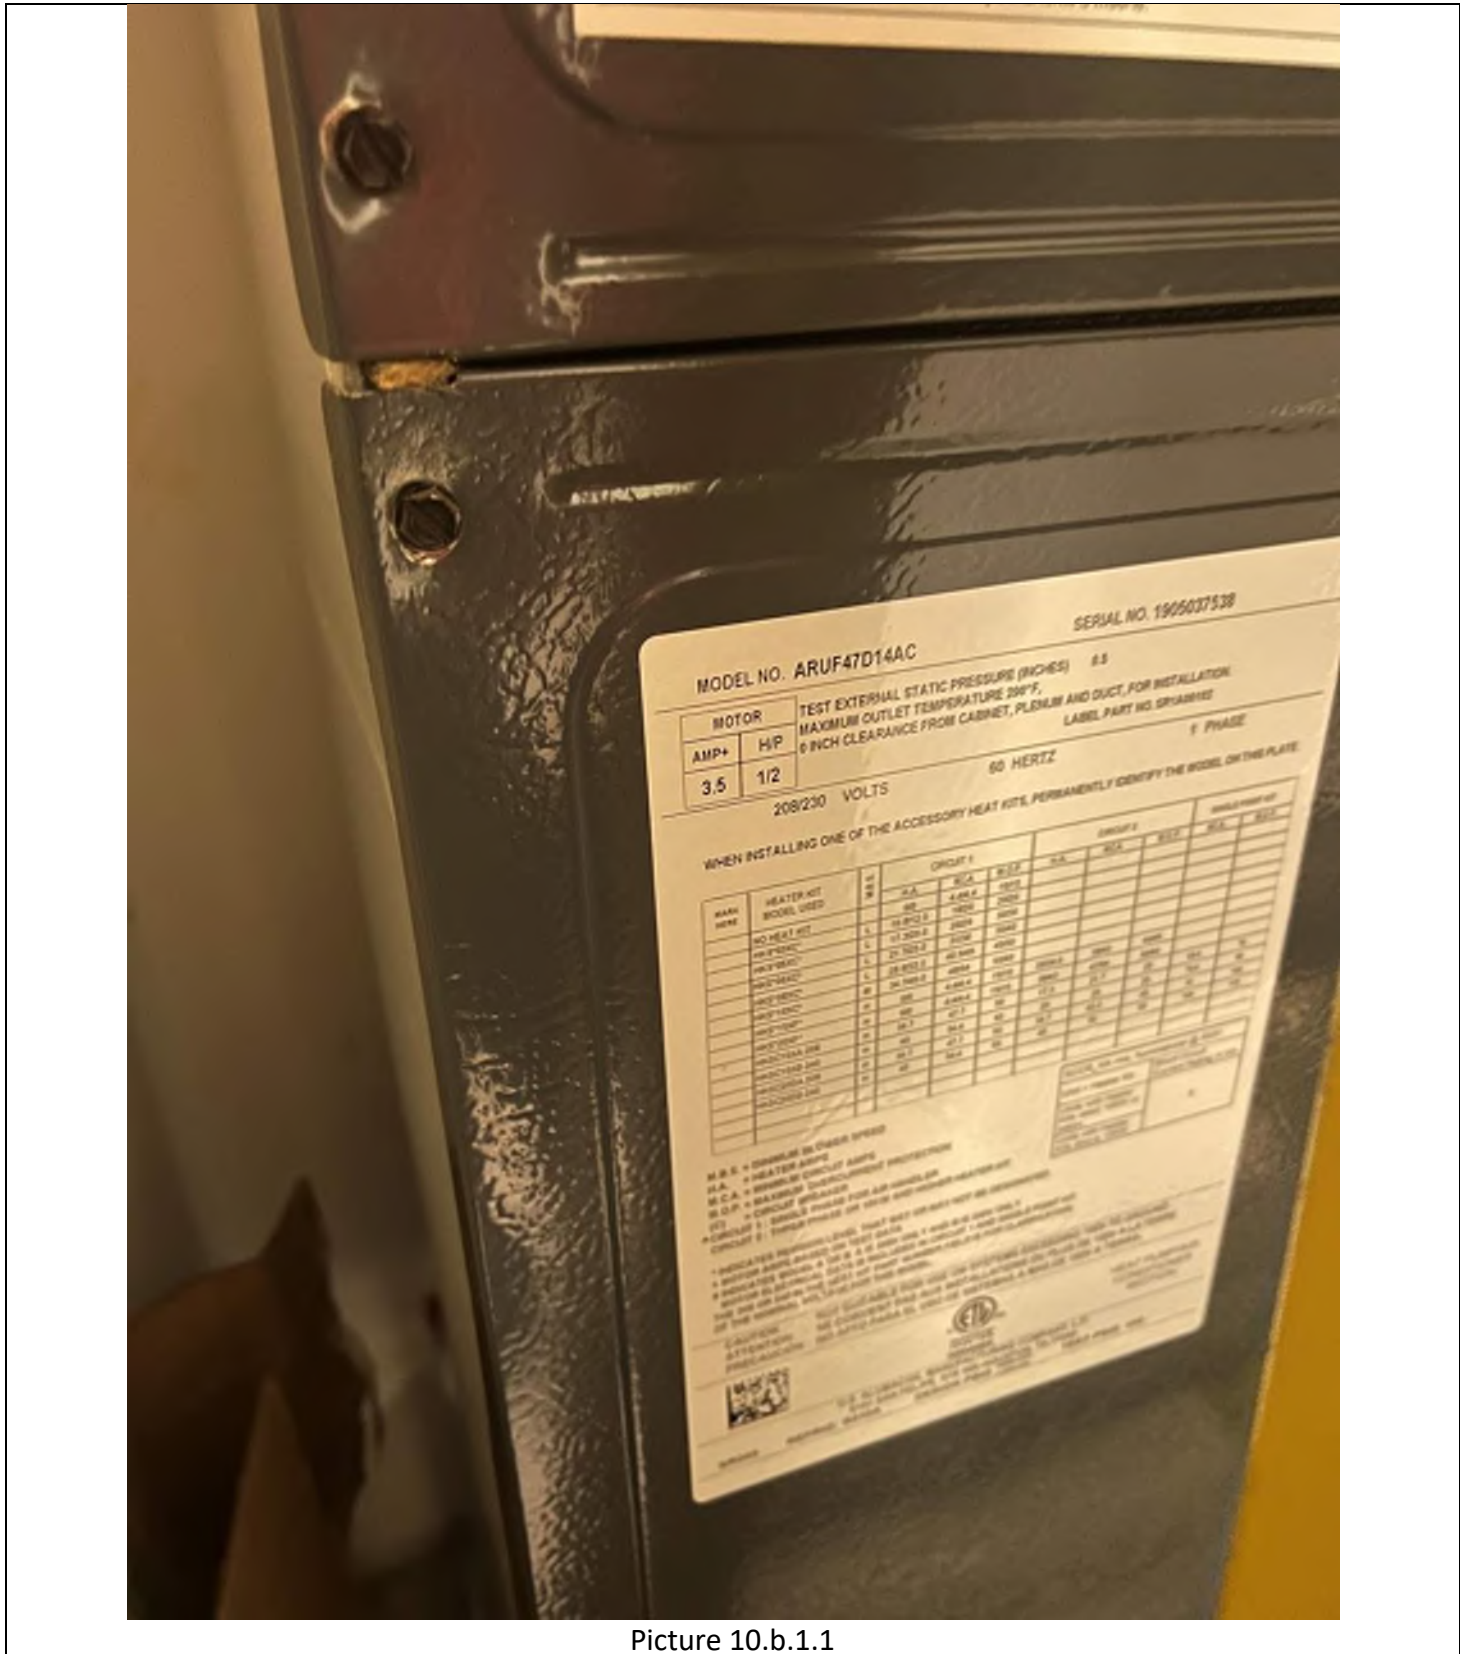
Picture 10.b.1.1

10.a.8. Package heating and cooling unit – units - replacement cost per unit	\$12,250
10.b. 5059 N A1A (Building B)	
10.b.1. Package heating and cooling type and condition – game room	The 3.5 ton A/C unit with 8 kW heater in the game room is in good overall condition. The unit was replaced in 2022. See picture 10.b.1.1

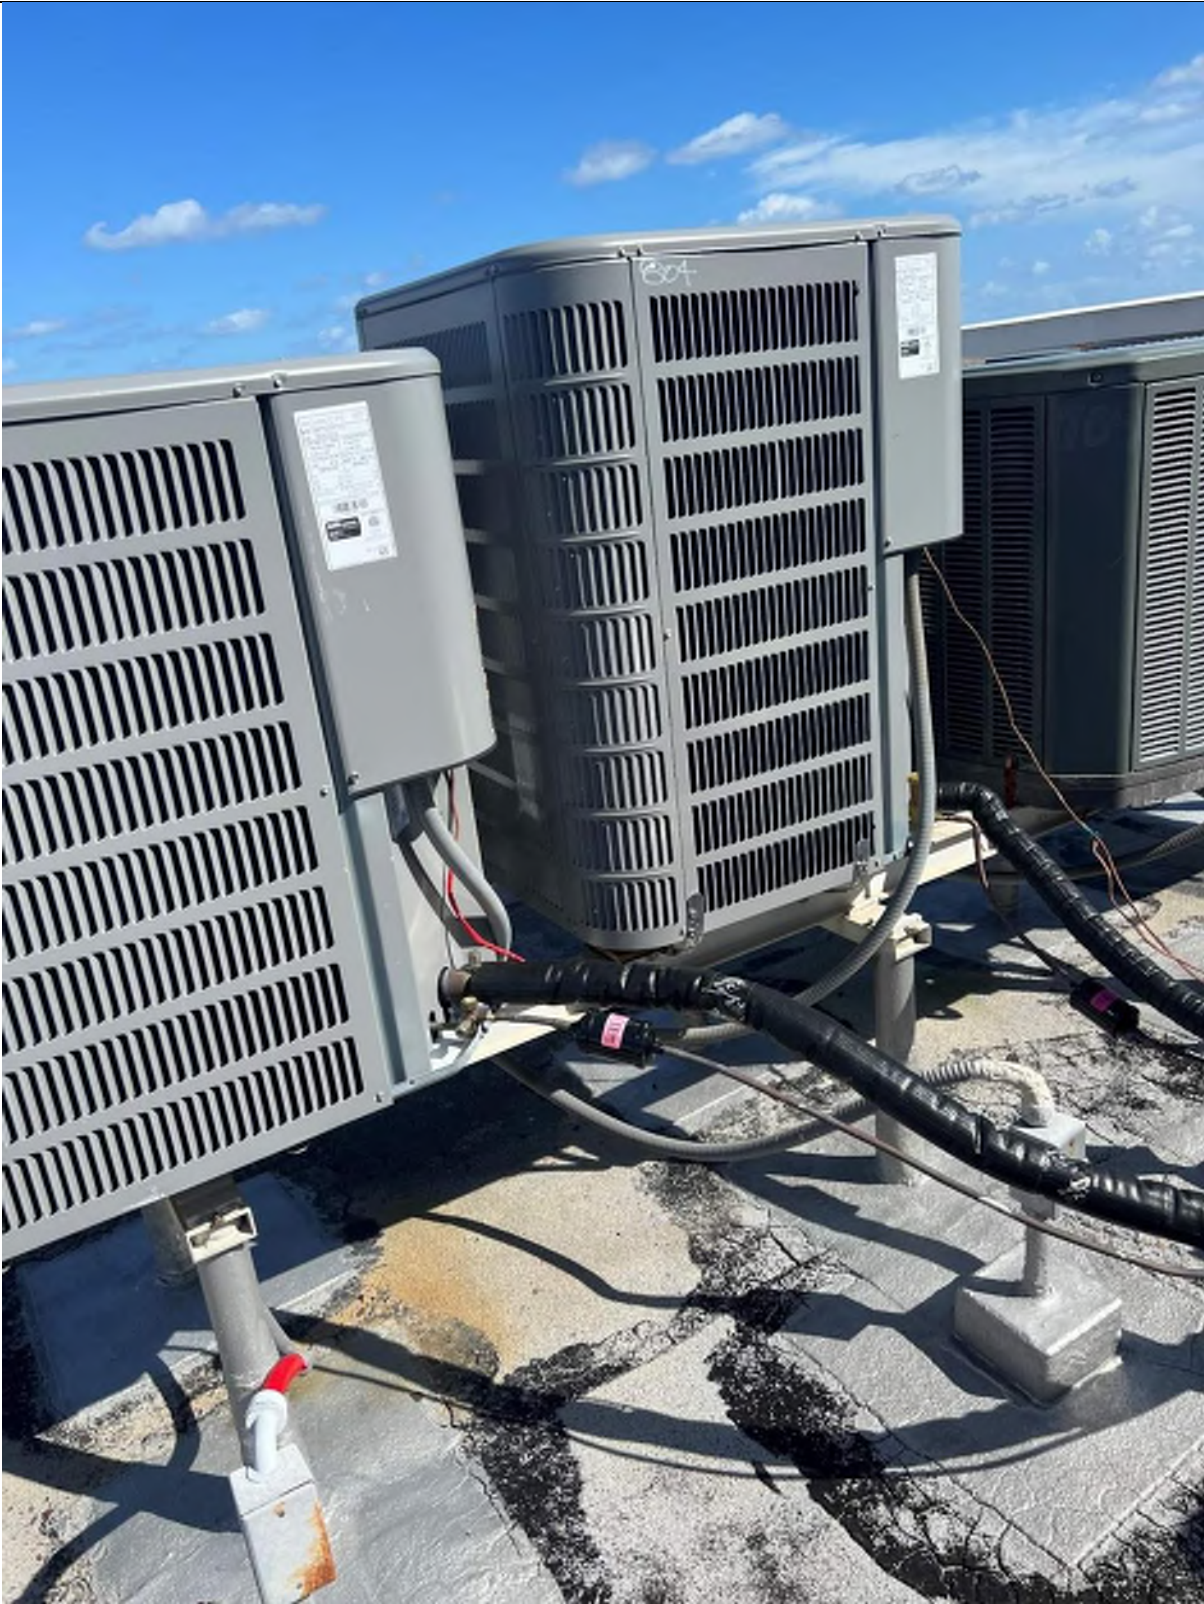
Picture 10.b.5.1

10.b.4. Package heating and cooling unit – game room - replacement cost	\$12,250
10.b.5. Package heating and cooling type and condition – game room	Although this is the responsibility of the unit owner, it is important to keep an eye on the condition of the AC units. For instance, if an A/C compressor is not properly fastened to the A/C stand, it can act as a dangerous projectile in a hurricane. Also, if the corrosion of the fan shroud gets excessive, it can cause damage to the roof/building if the fan would get dislodged. If there are holes/openings in the conduits, water can get into the building and affect all the residents. The units appear to be in fair overall condition with minor oxidation. The majority of refrigerant lines are adequately protected with Armorflex. See pictures 10.b.5.1 and 10.b.5.2.

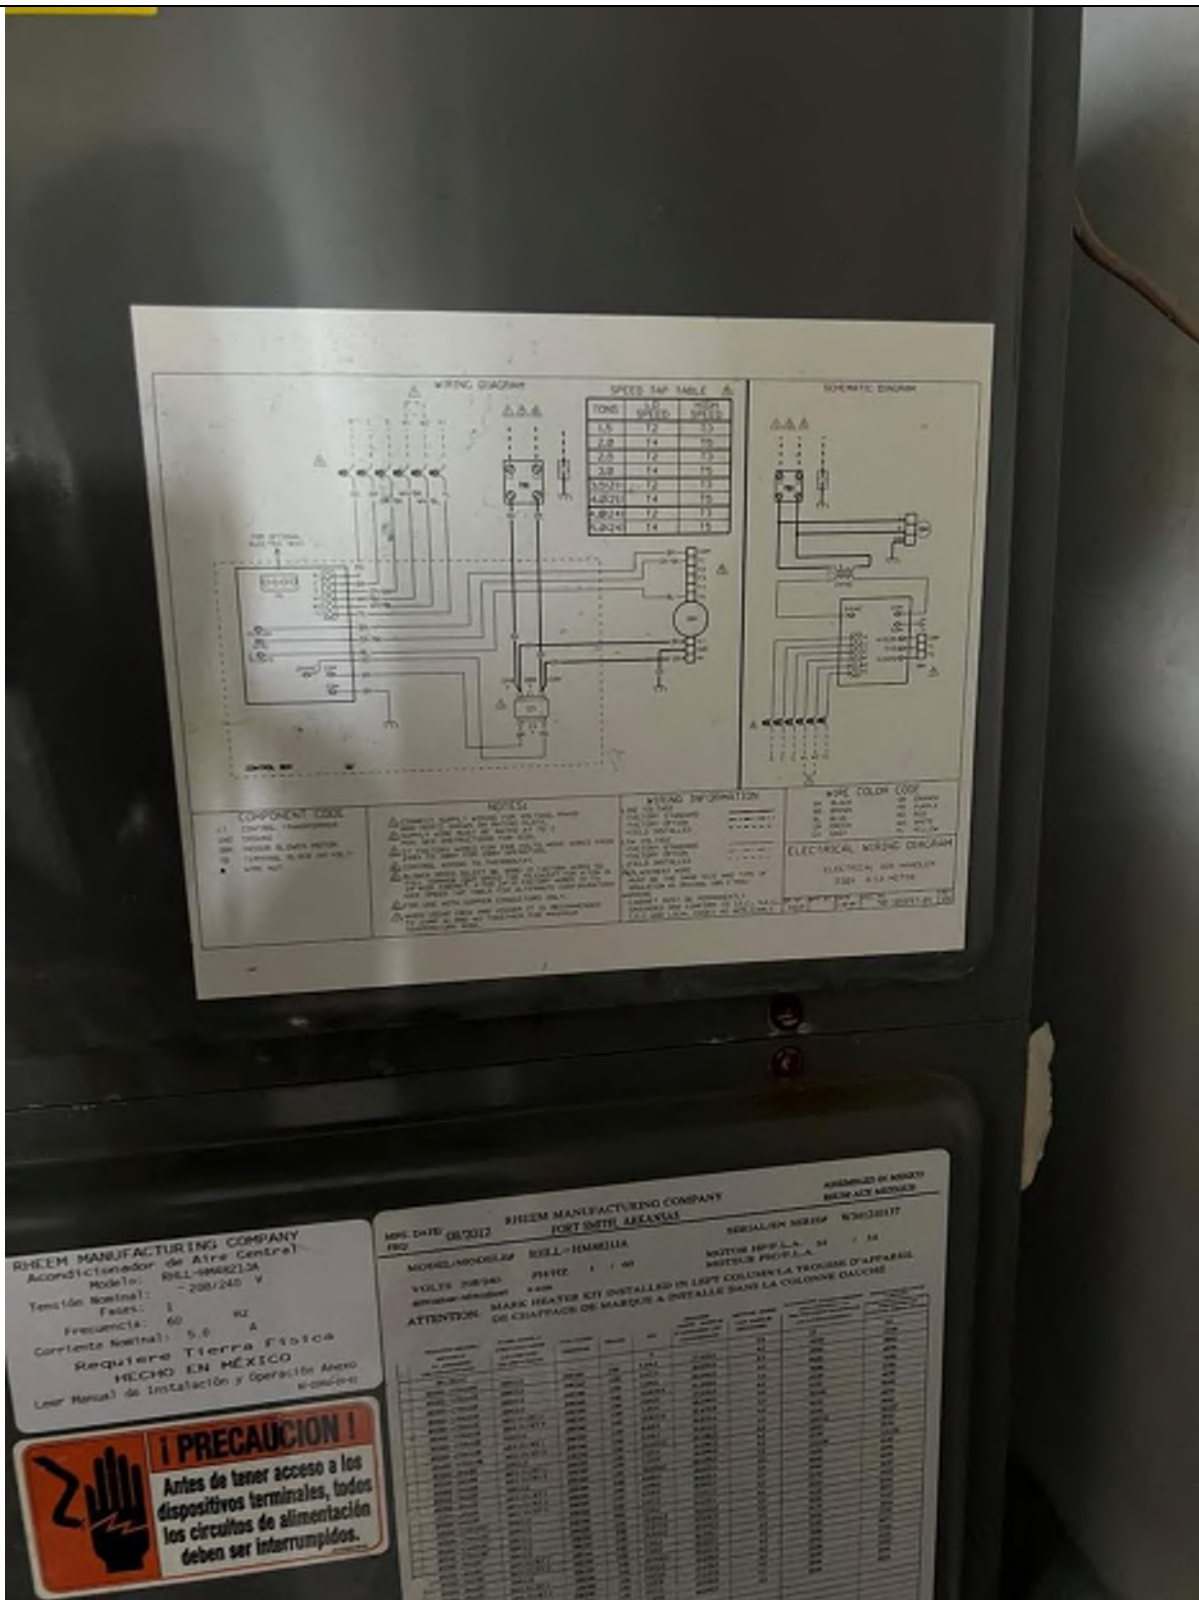
Picture 10.c.1.1

10.b.8. Package heating and cooling unit – units - replacement cost per unit	\$12,250
10.a. 5061 N A1A (Building C)	
10.c.1. Package heating and cooling type and condition – game room	The 3.5 ton A/C unit with 8 kW heater in the game room is in good overall condition. The unit was replaced in 2012. See picture 10.c.1.1

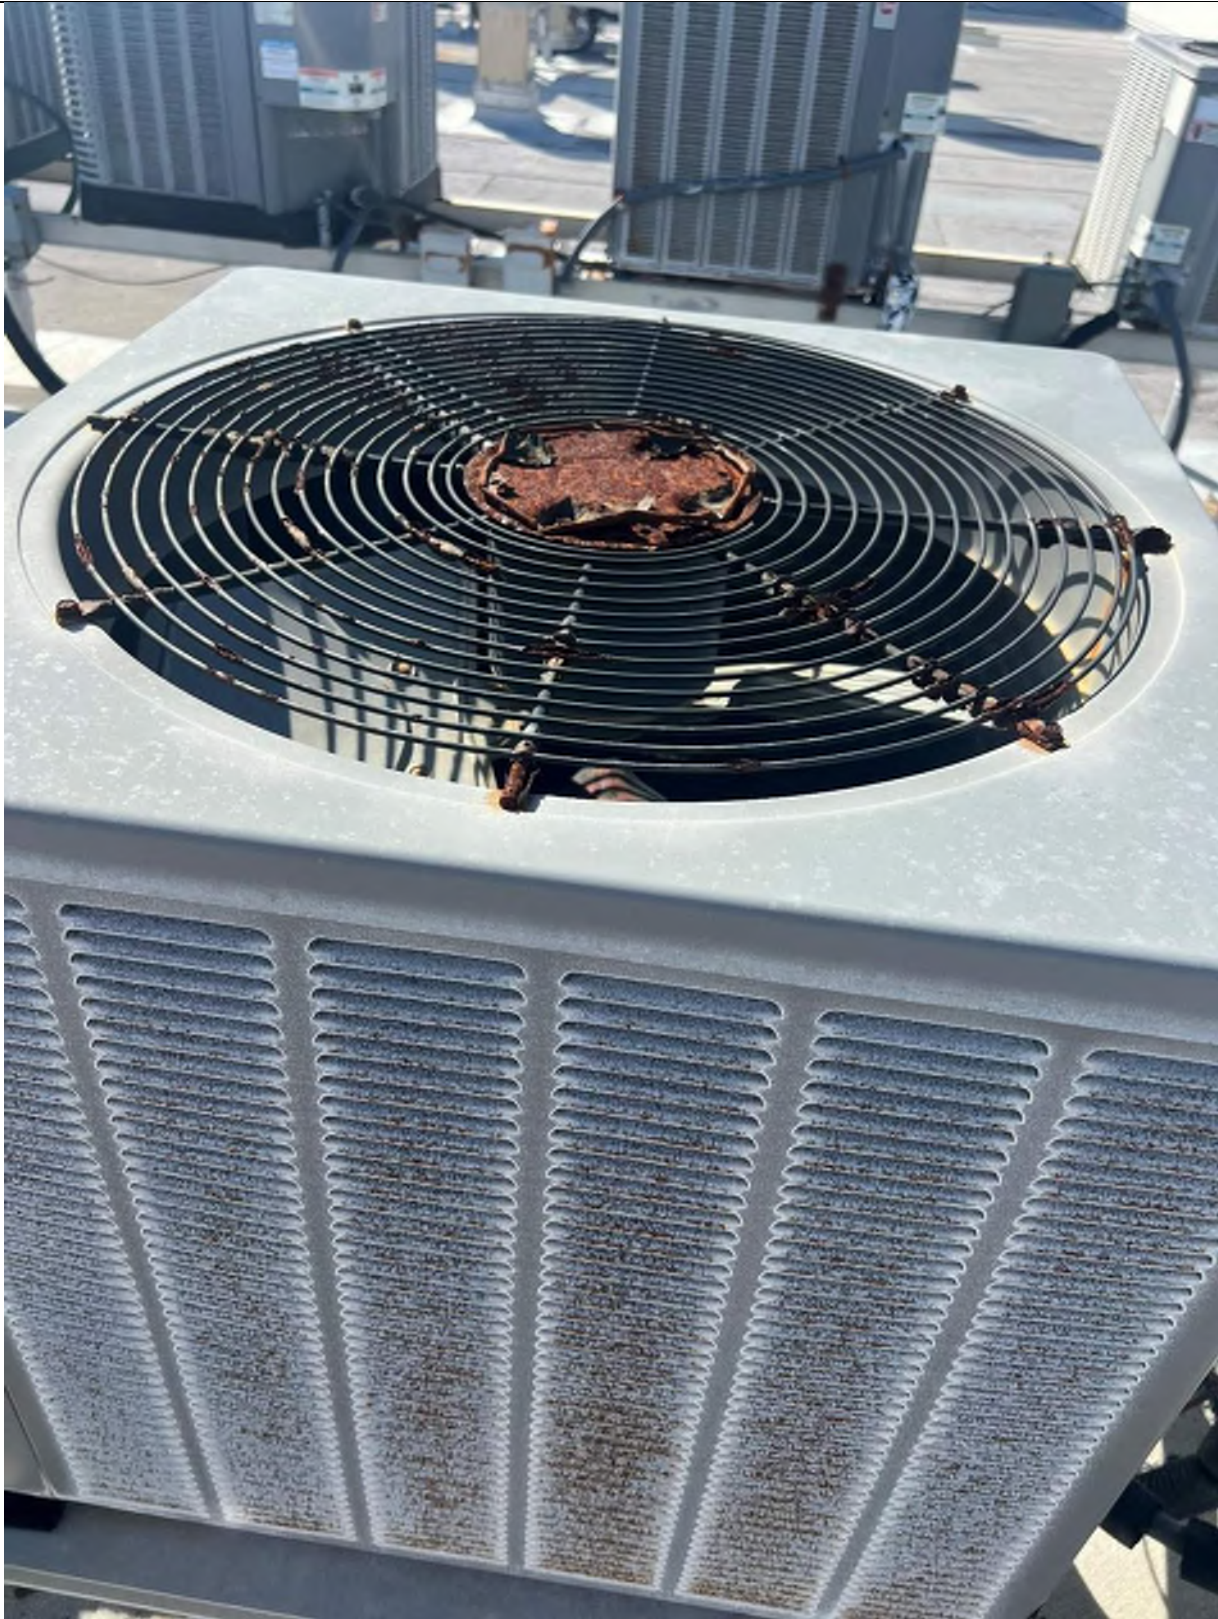
Picture 10.c.5.1

10.c.4. Package heating and cooling unit – game room - replacement cost	\$12,250
10.c.5. Package heating and cooling type and condition – game room	Although this is the responsibility of the unit owner, it is important to keep an eye on the condition of the AC units. For instance, if an A/C compressor is not properly fastened to the A/C stand, it can act as a dangerous projectile in a hurricane. Also, if the corrosion of the fan shroud gets excessive, it can cause damage to the roof/building if the fan would get dislodged. If there are holes/openings in the conduits, water can get into the building and affect all the residents. The units appear to be in fair

overall condition with minor oxidation. The majority of refrigerant lines are adequately protected with Armorflex. See pictures 10.c.5.1 and 10.c.5.2.

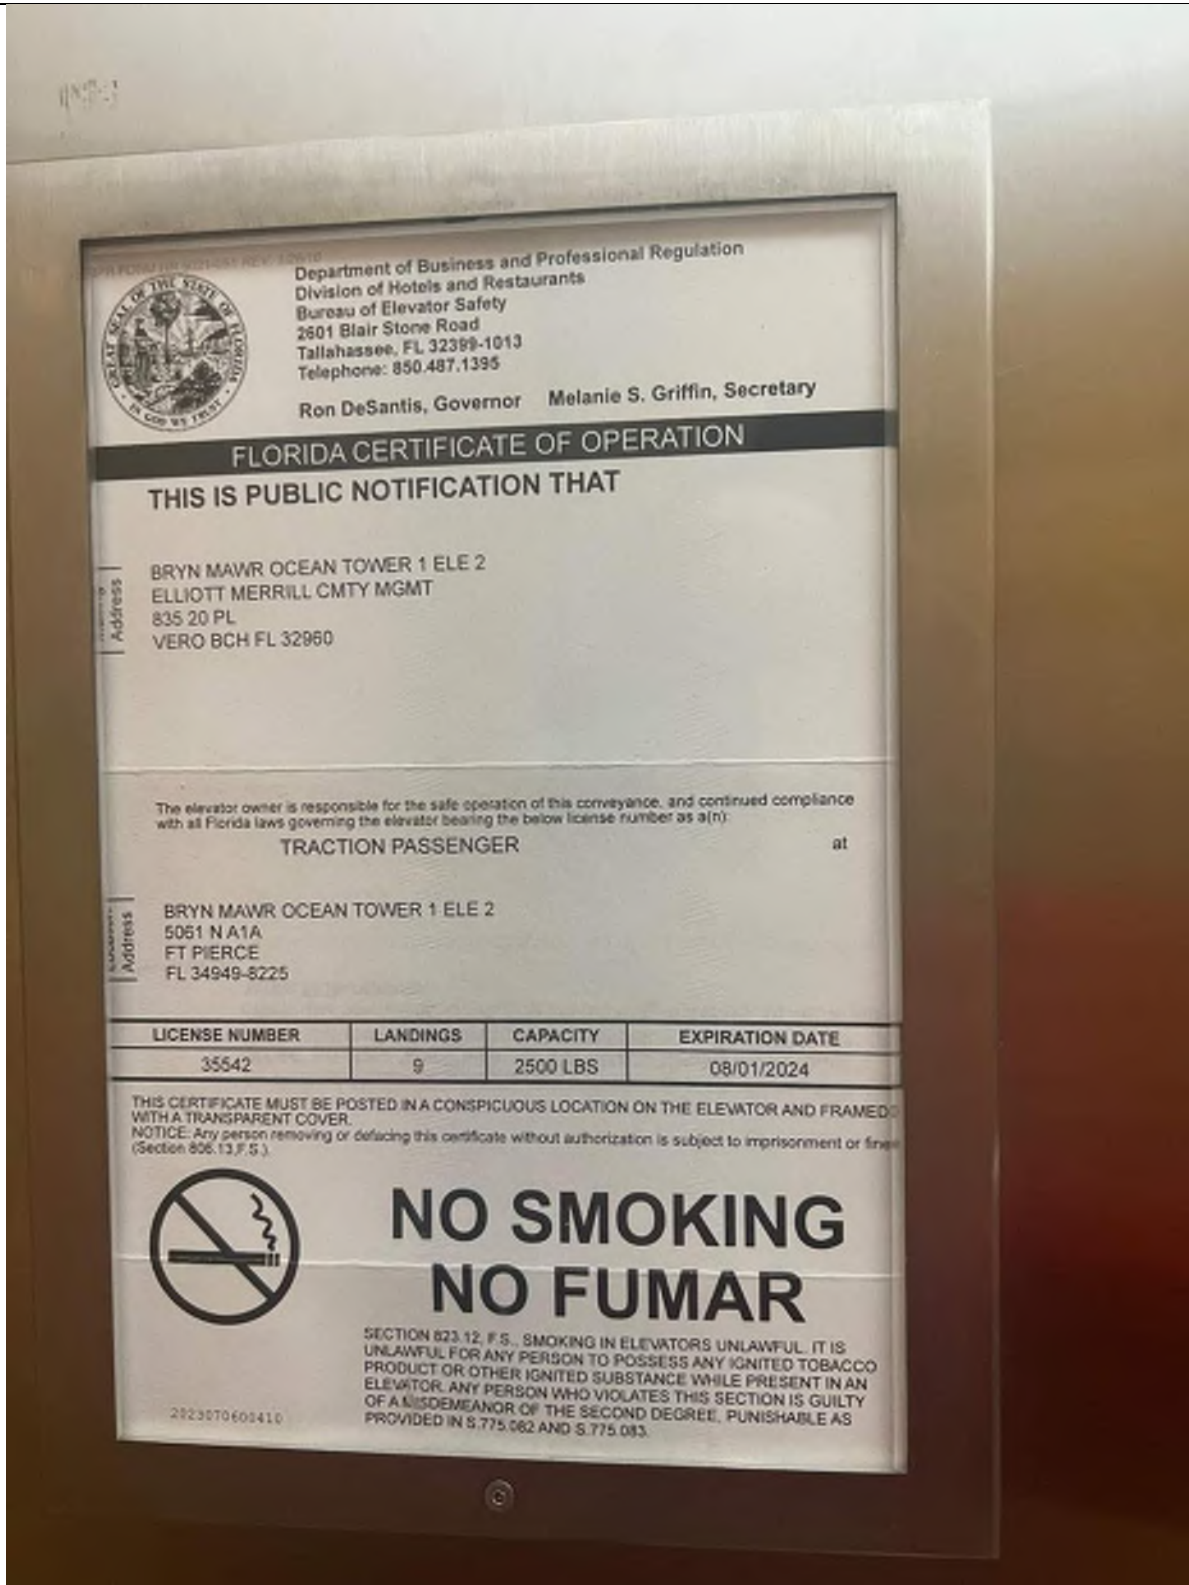
Picture 11.a.1.1

11. Elevator Systems – Non-S.I.R.S. Component	
A.S.M.E. A17.1/C.S.A B44 Safety Code for Elevators and Escalators	
11.a. 5061 N A1A (Building A)	
11.a.1 Elevator certificate	Elevators have current certificates of operation. See picture 11.a.1.1.
