Milestone Inspection Phase I Report

Bryn Mawr Ocean Towers

5055, 5059, and 5061 N Highway A1A

The intention of this report is to develop a substantially completed Milestone Inspection Phase One report per the requirements of Senate Bill 4-D and Florida Statutes 553.899.

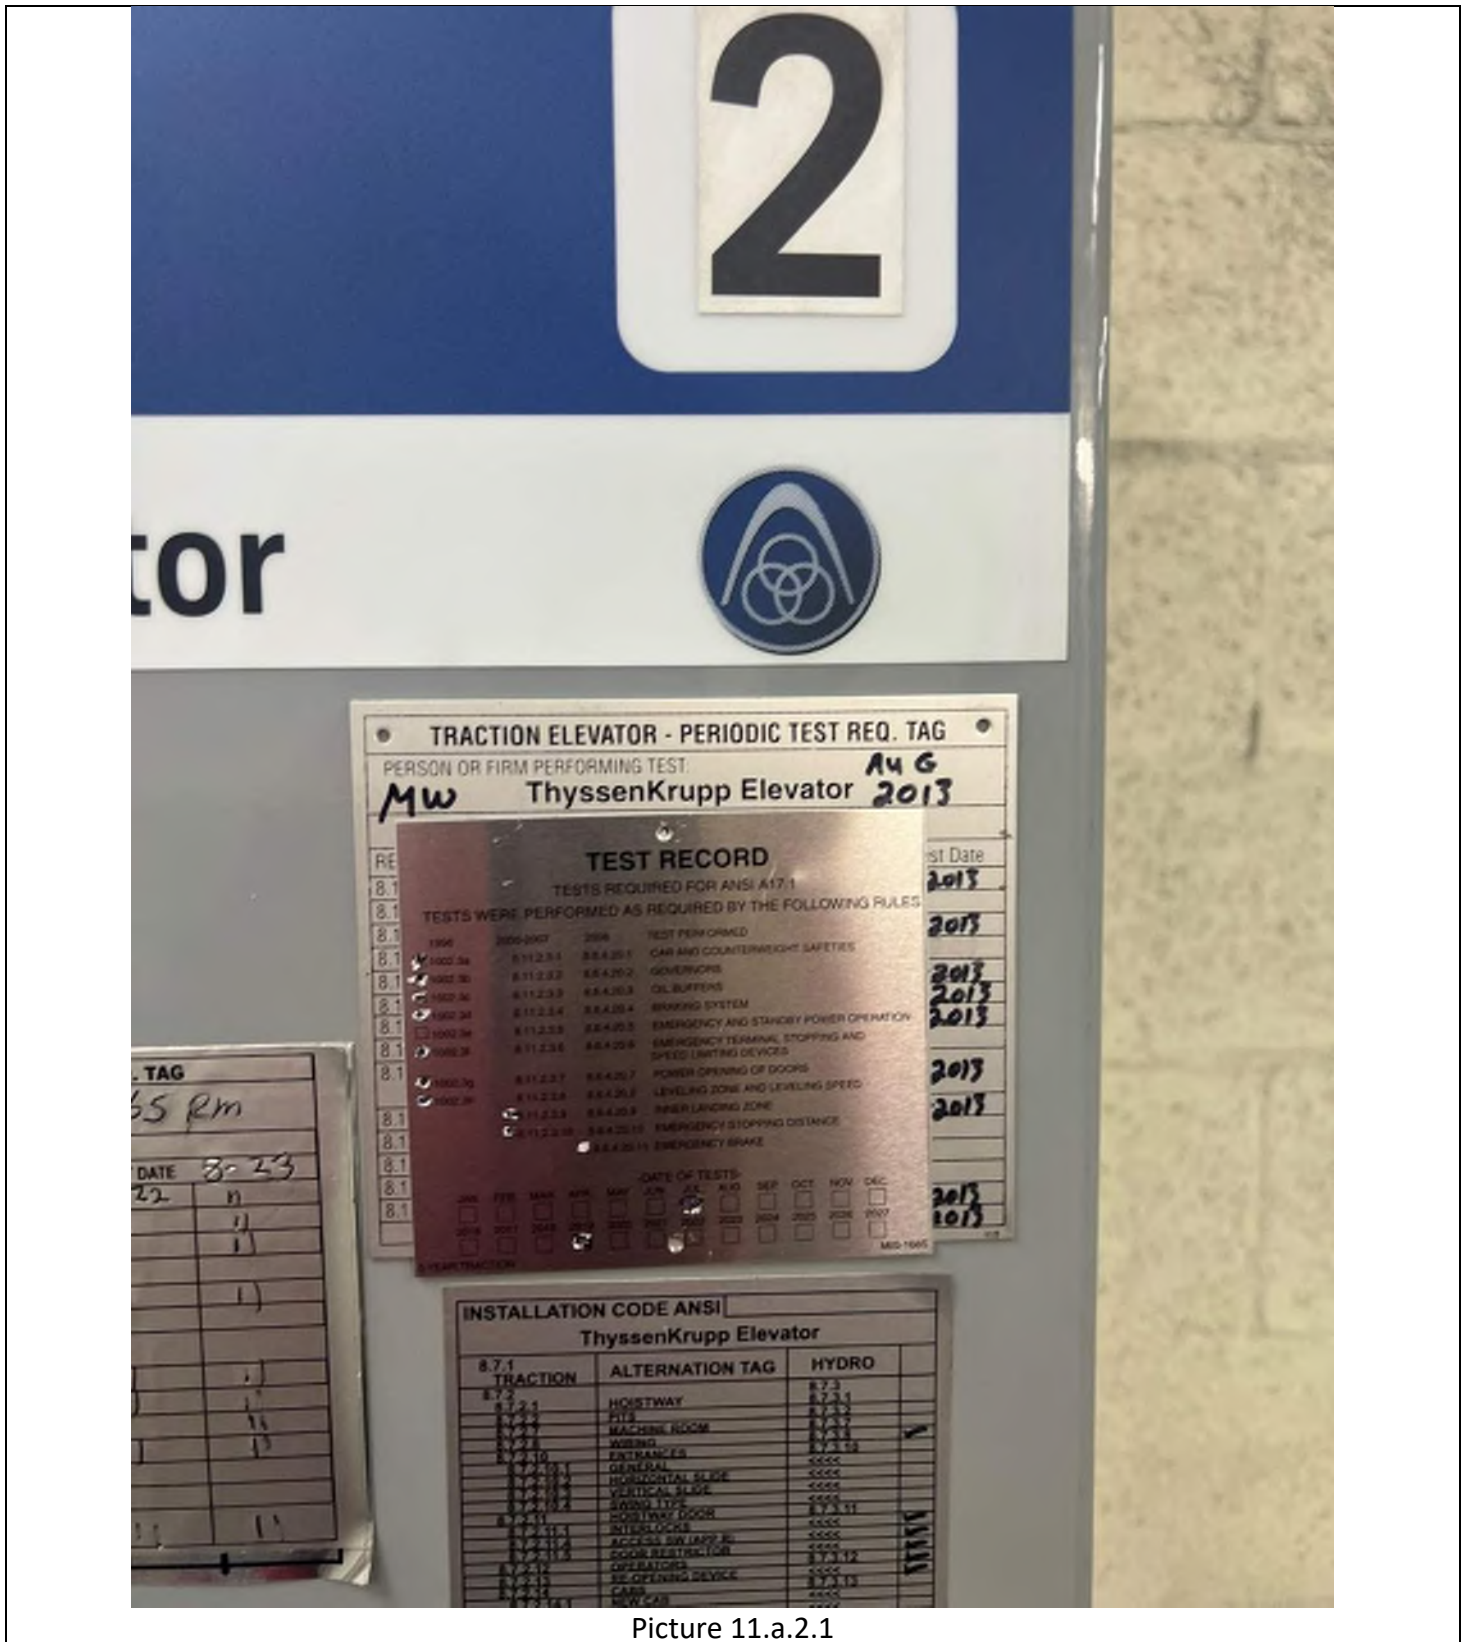
Picture 11.a.2.1

11.a.2. Elevator system and condition	The elevator is a ThyssenKrupp TAC-50 gearless traction elevator with permanent magnet AC motor. The elevator was replaced/modernized in 2013. The system has micro-processor controls and efficient AC drive system. The elevator system is in good overall condition. See pictures 11.a.2.1, 11.a.2.2 and 11.a.2.3.

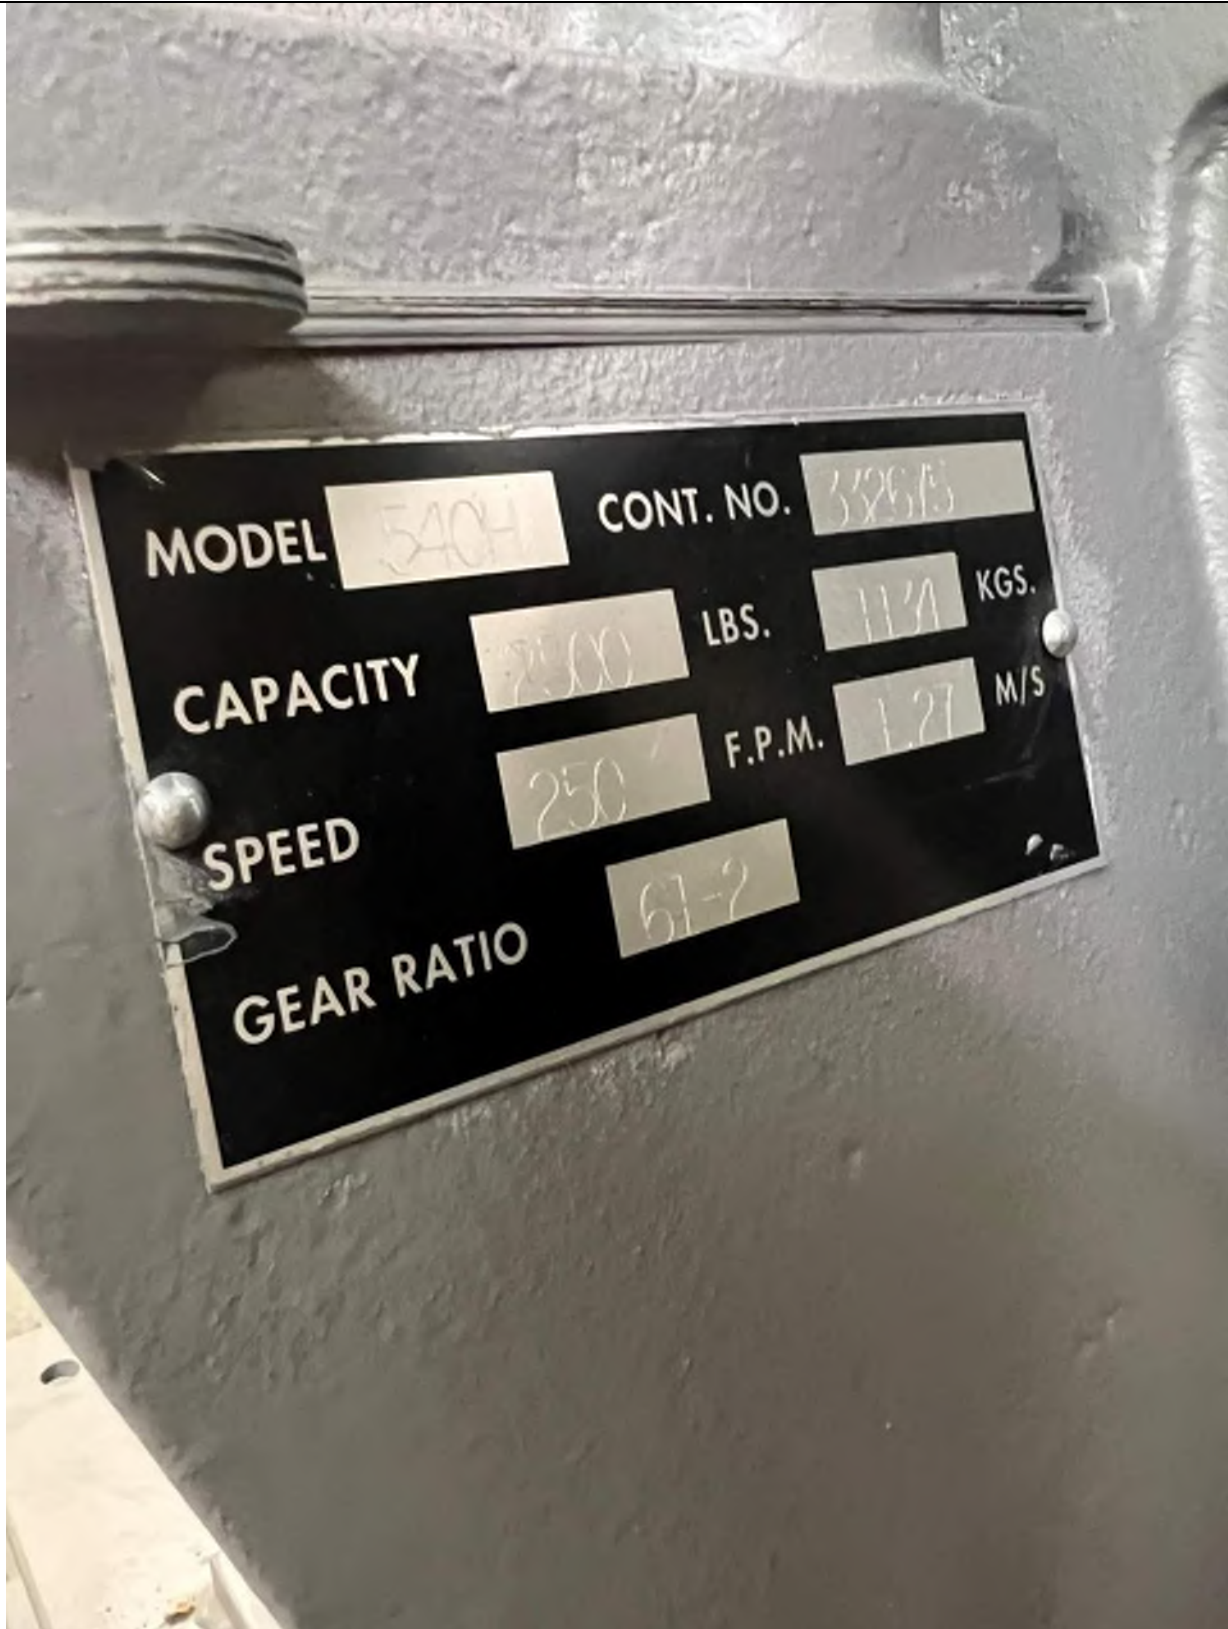
Picture 11.b.2.1

11.b. 5059 N A1A (Building B)	
11.b.1 Elevator certificate	Elevators have current certificates of operation. See picture 11.b.1.1.
11.b.2. Elevator system and condition	The elevator is a ThyssenKrupp TAC-50 gearless traction elevator with permanent magnet AC motor. The elevator was replaced/modernized in 2013. The system has micro-processor controls and efficient AC drive system. The elevator system is in good overall condition. See pictures 11.b.2.1, 11.b.2.2, and 11.b.2.2.

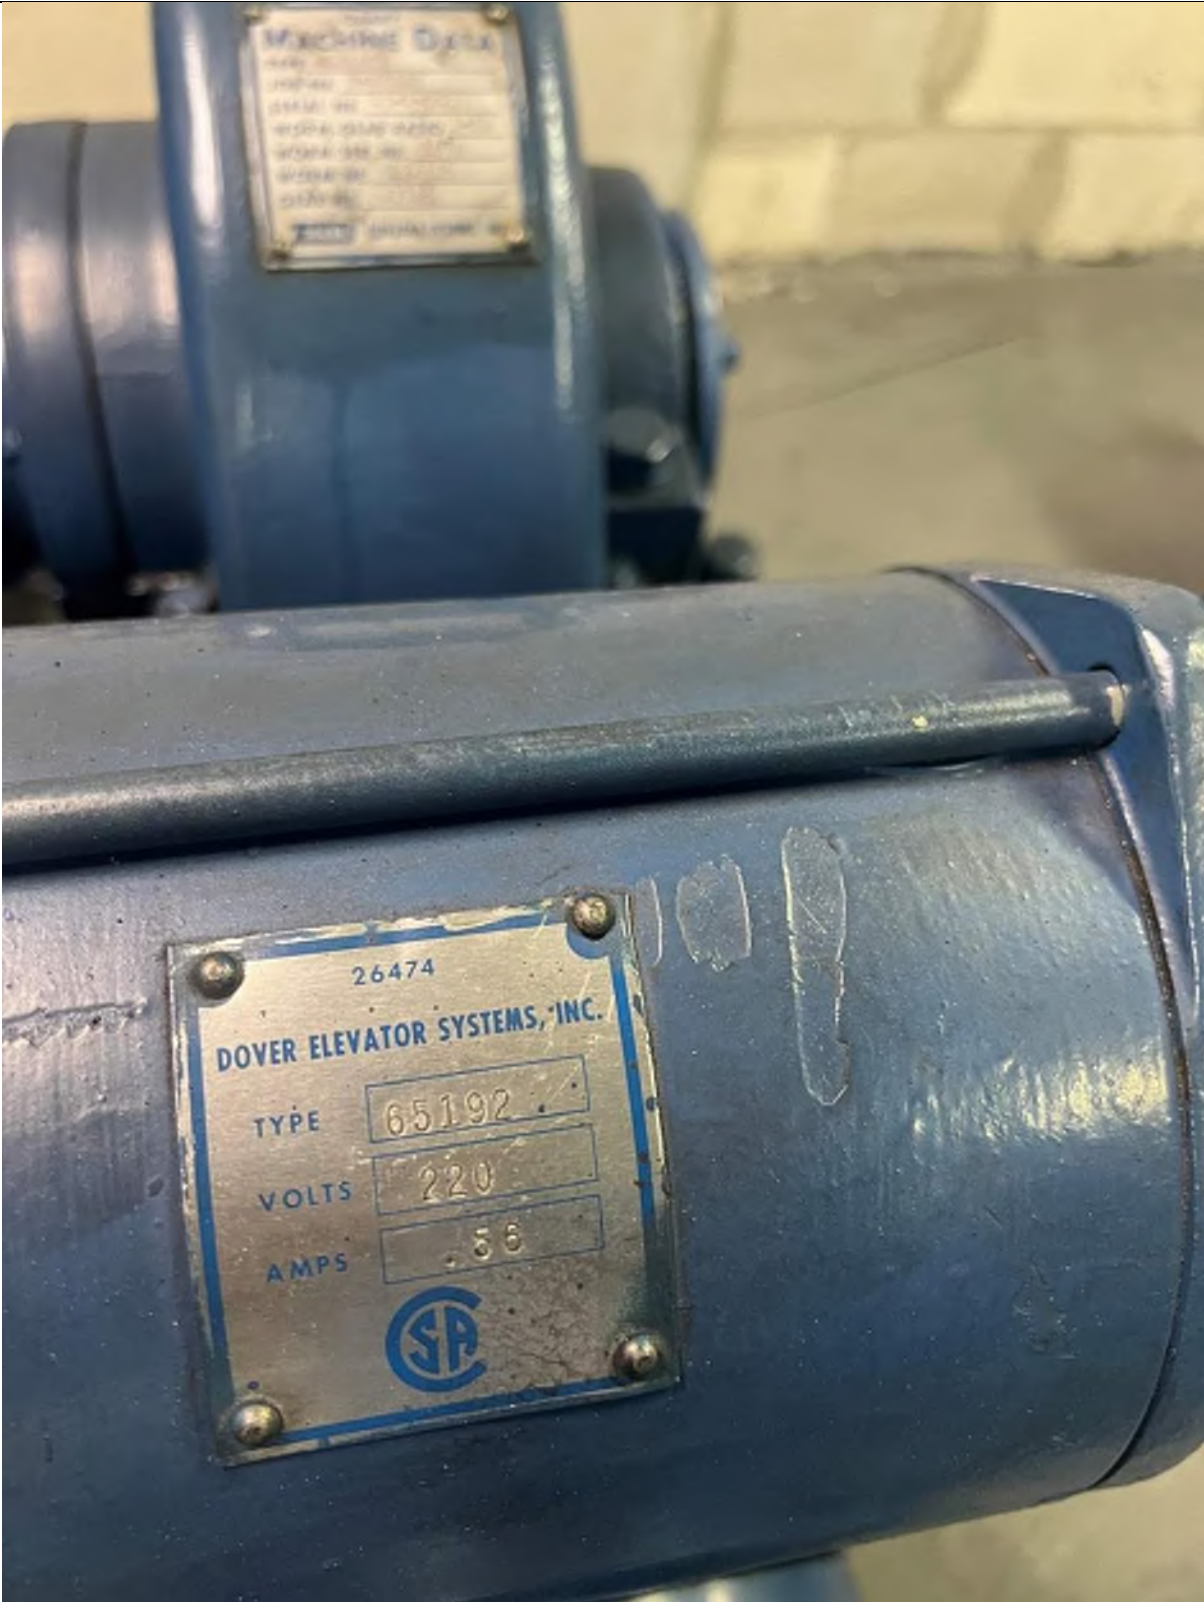
Picture 11.c.2.1

11.c. 5055 N A1A (Building C)	
11.c.1 Elevator certificate	Elevators have current certificates of operation. See picture 11.c.1.1.
11.c.2. Elevator system and condition	The elevator is a Dover composite traction elevator. The elevator was replaced/modernized in 2006. The system has an advanced 32-bit dual core processing system that makes system accurate and reliable. The elevator system is in good overall condition. See pictures 11.c.2.1 and 11.c.2.2.

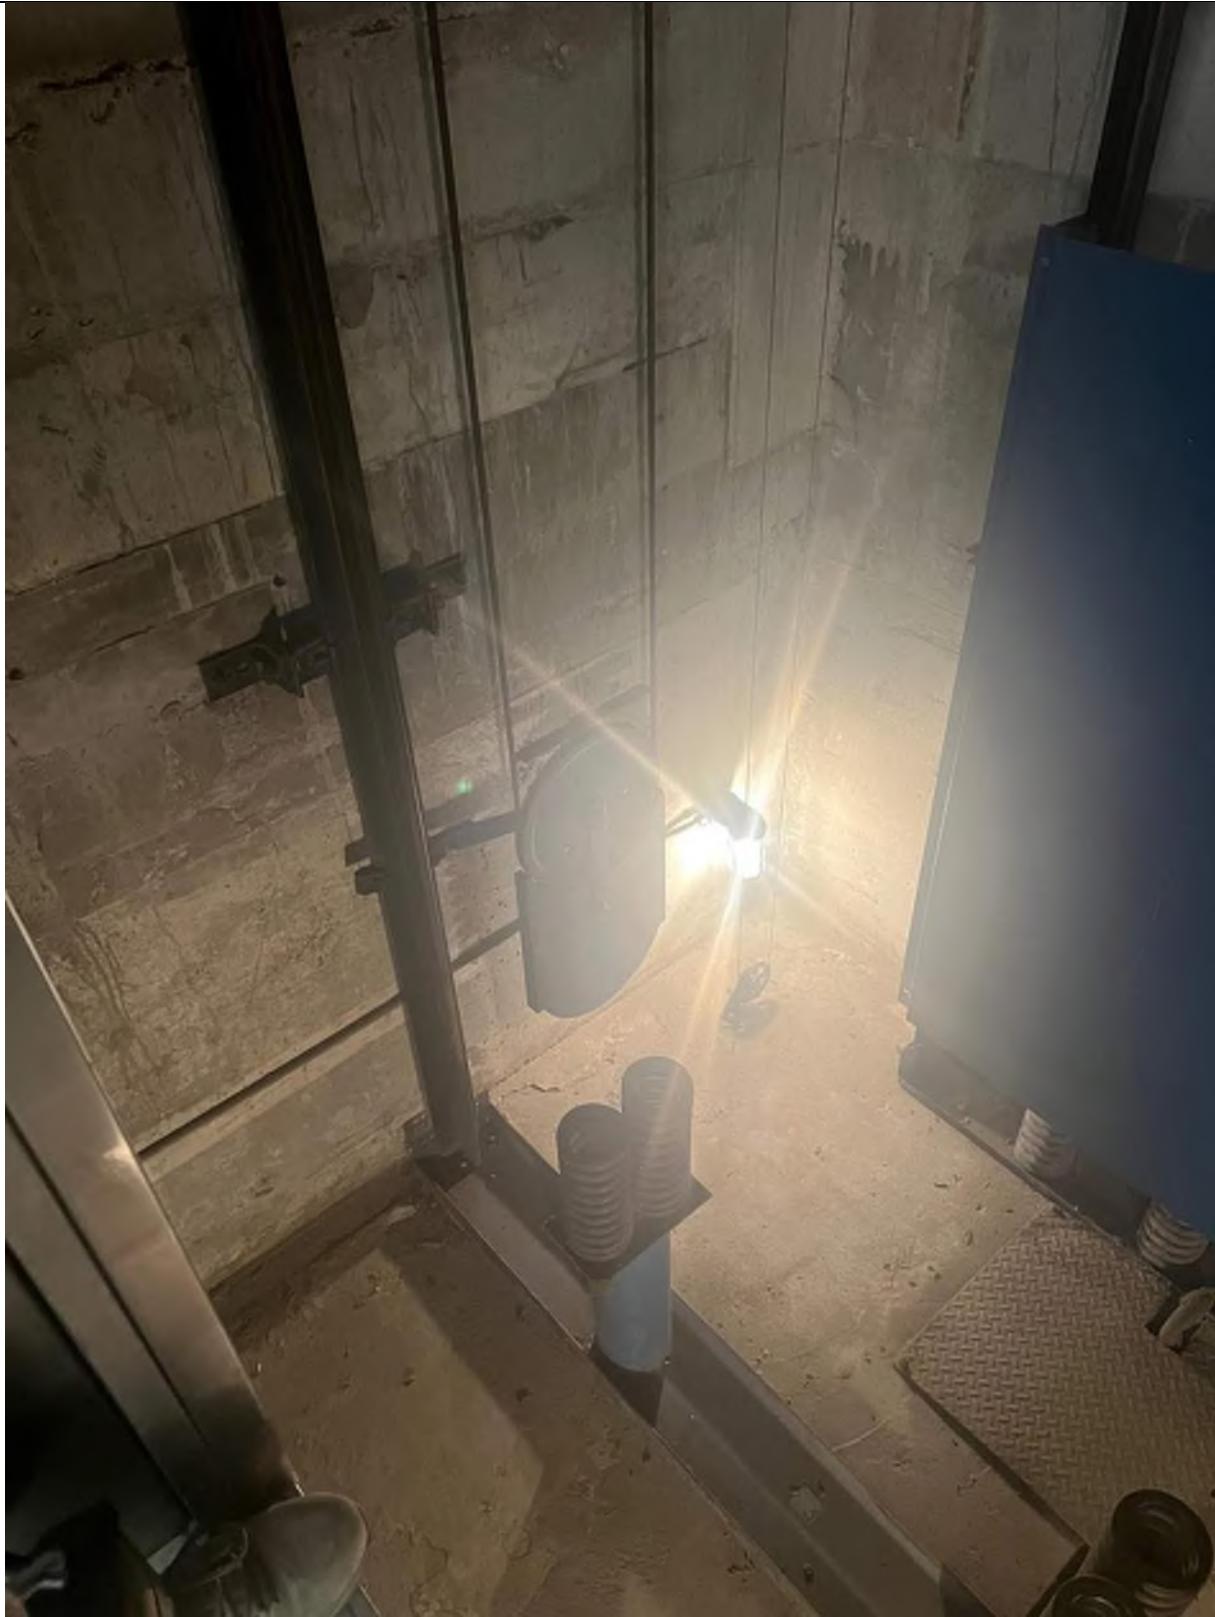
Picture 11.c.3.1

11.c.3. Elevator Pit condition	There shall be no shiny surfaces when you look into an elevator pit. The pit is clean, including the sump pumps as well as the lights are in good working order. See pictures 11.c.3.1 and 11.c.3.2. The ladders are in good condition. See picture 11.c.3.3.

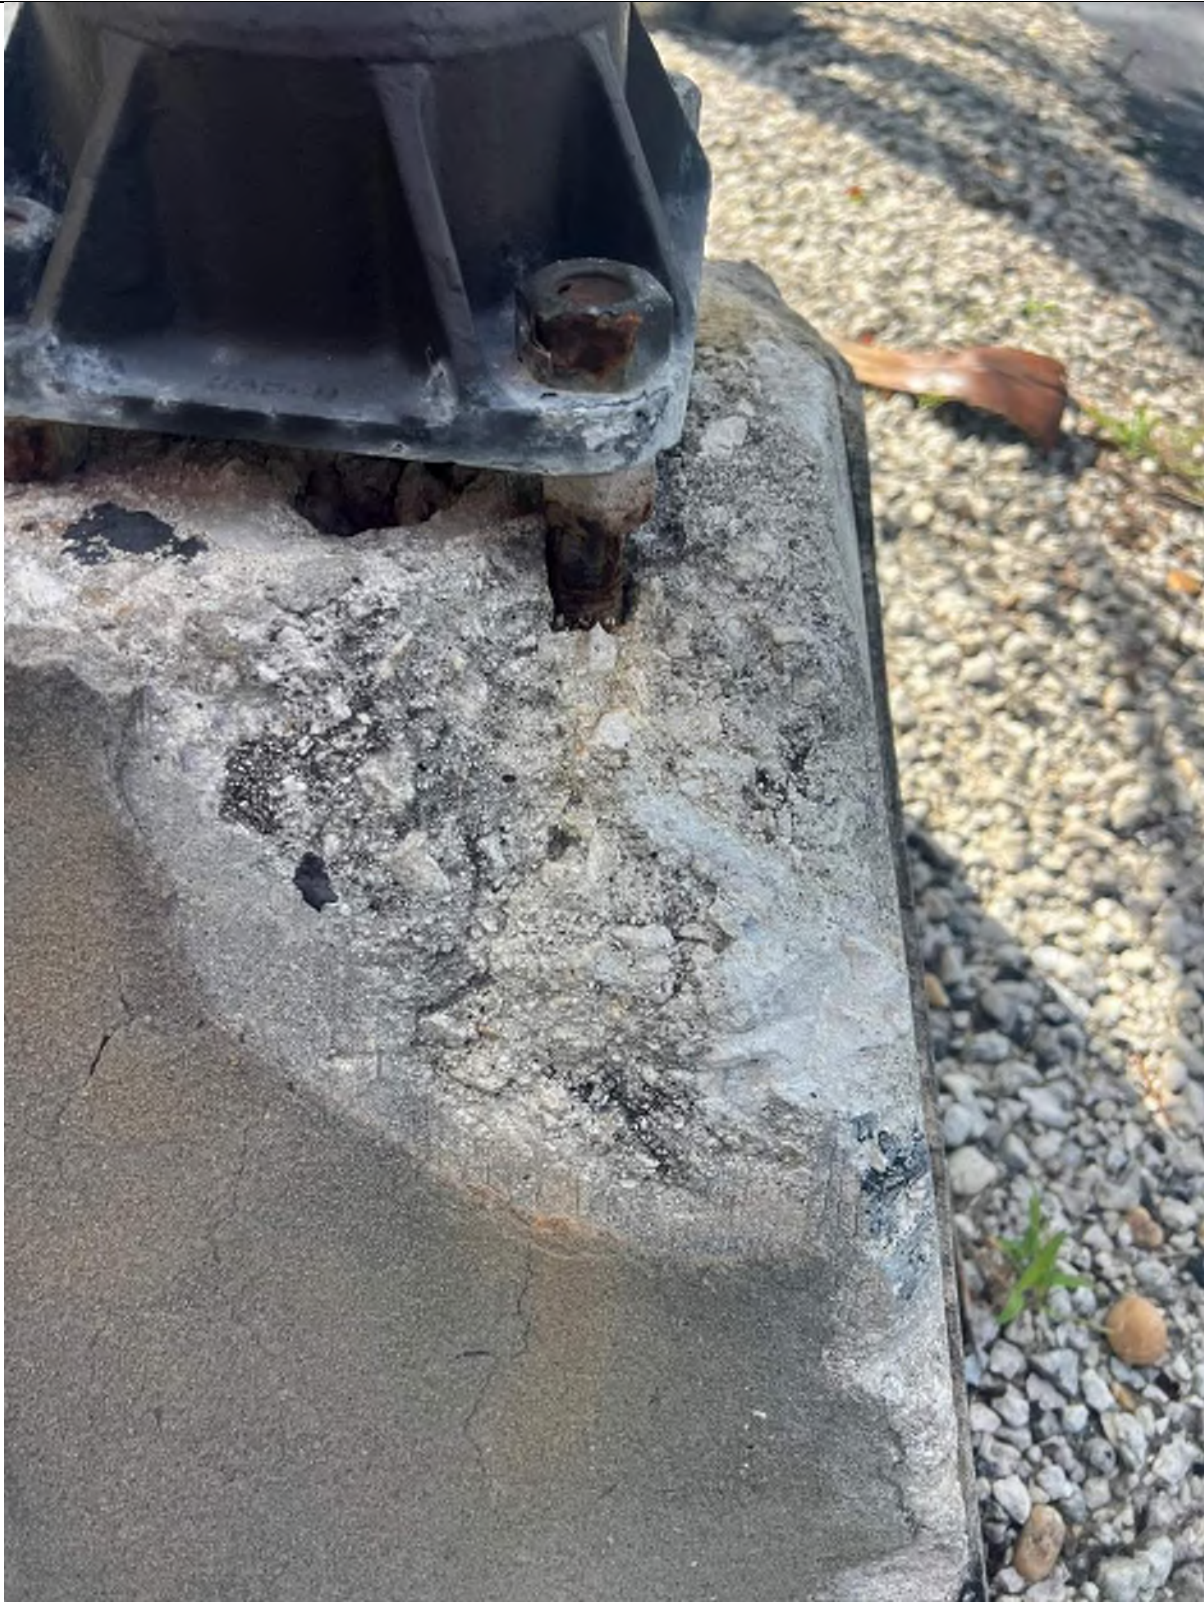
Picture 10.d.3.1

Street lights are pole mounted lights ranging from 102 volts to 277 volts and powered by means of photo cell. Street lights and pedestals are in poor overall conditions. Although lamps are replaced as they burn out, the condition of the actual street lamp pole, wiring and pedestals are in

poor shape. See pictures 12.d.3.1, 12.d.3.2 and 12.d.3.3.
12.d.3. Street lights useful life	40 year
12.d.4. Street lights remaining life	1 year
12.d.5. Street lights/pedestals replacement cost	51 street lights/pedestals x \$2,000/street light = \$102,000
12.d.6. Electrical Panels	Panels are in overall good condition and enclosures are properly rated for their function. See pictures 12.d.6.1 and 12.d.6.2.

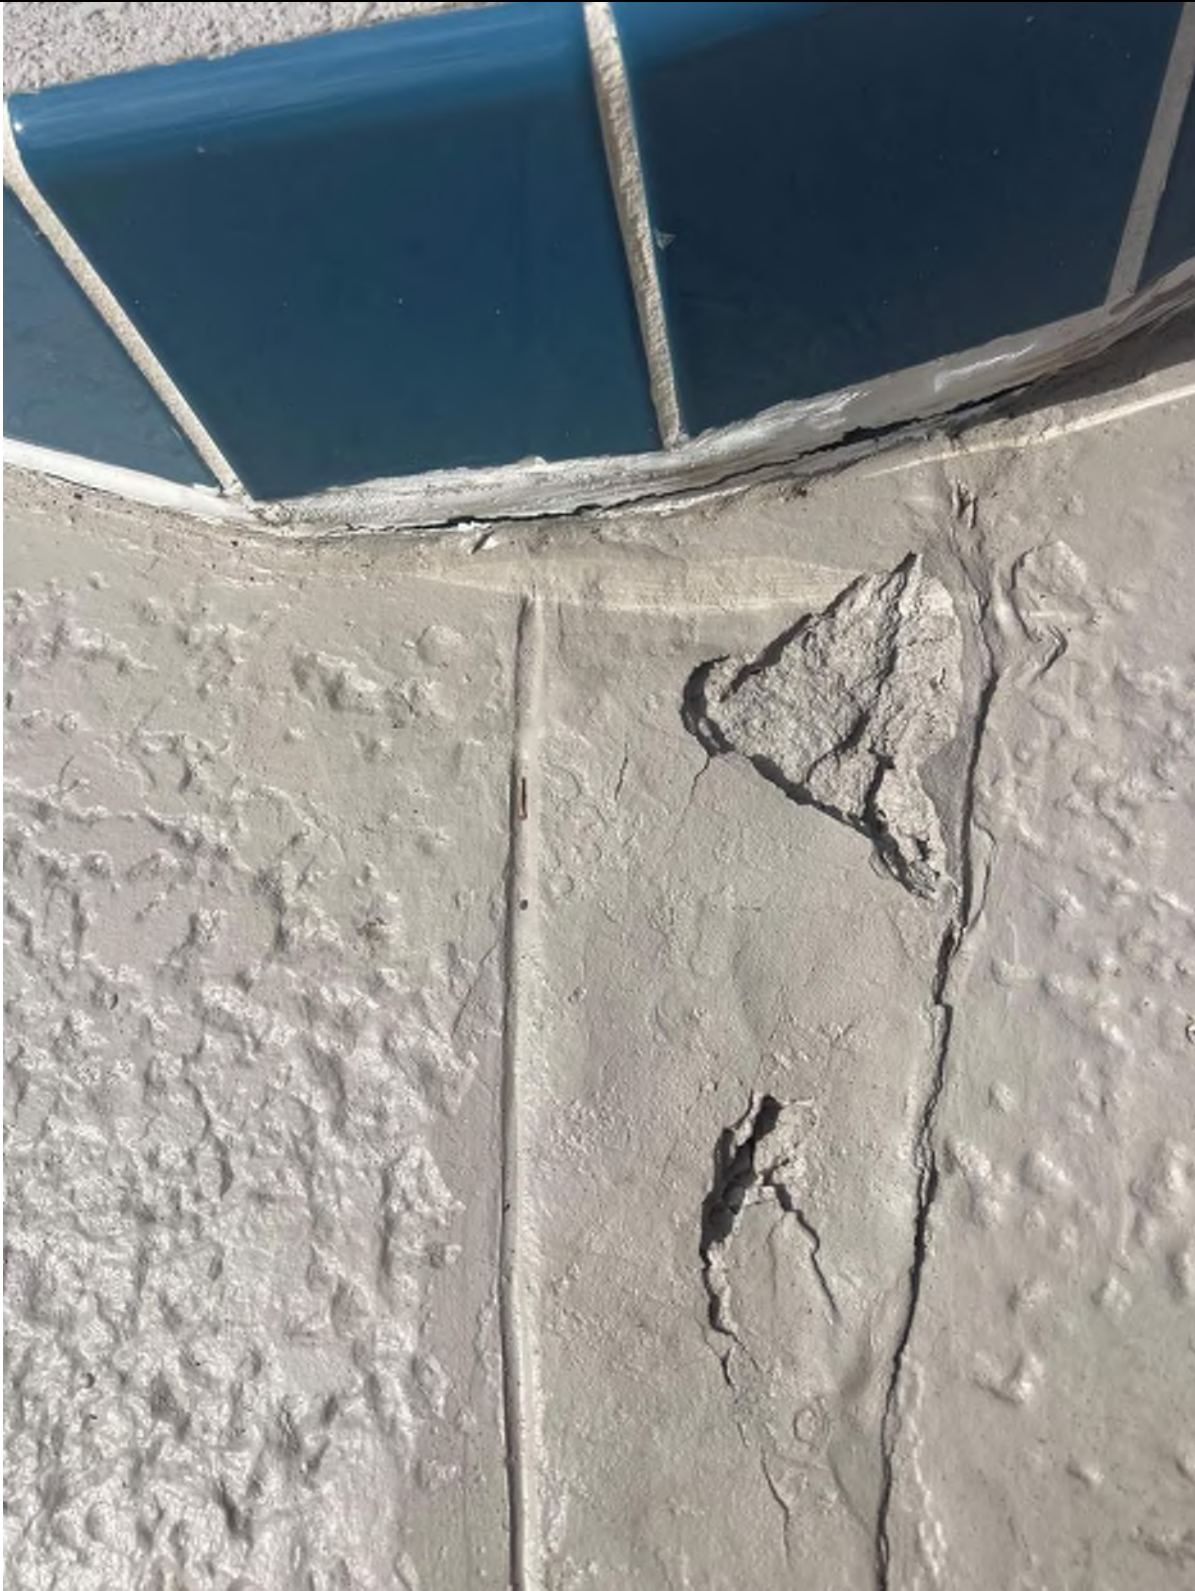
Picture 13.a.1.1

13. Pools/pool decks – Non-S.I.R.S. components	
Florida Building Code 2020	
13.a.1. Pool deck condition	Pool deck is an elastomeric waterproofing system. The pool deck is in good overall shape; however, there are some surface cracks that need to be routed and sealed/patched. The perimeter of pool tile in contact with the deck is failing and needs to be recaulked. See pictures 13.a.1.1, 13.a.1.2, and 13.a.1.3

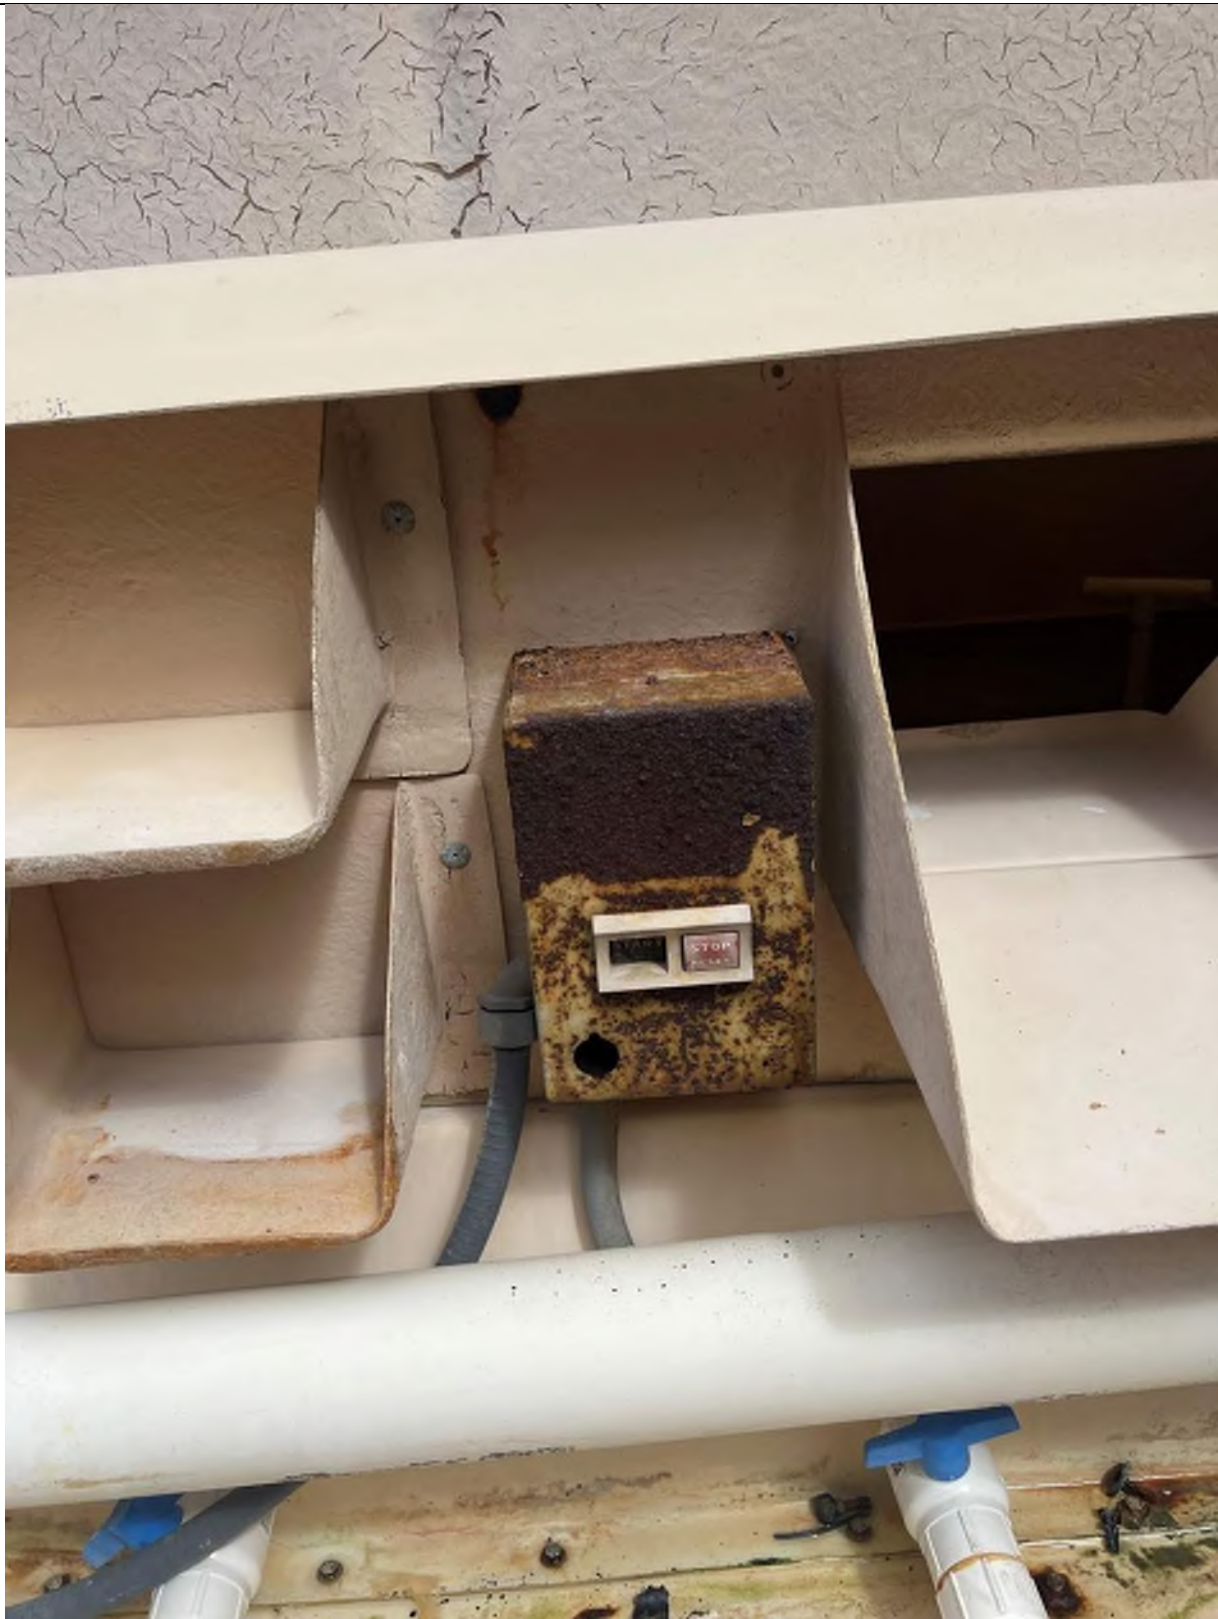
Picture 13.a.9.1

13.a.9. Pool equipment condition	The Vak-Pak CP-VDE series complete Vacuum DE filtration system for the pool is in overall fair condition. The Pentair separation tank is oxidized and in need of replacement; however, this tank is not being utilized. The enclosure is in need of a new exhaust vent and hinges. The soft start is oxidized and needs replacement. Pump motor is oxidized and needs replacement. See pictures 13.a.9.1, 13.a.9.2, 13.a.9.3, and 13.a.9.4.

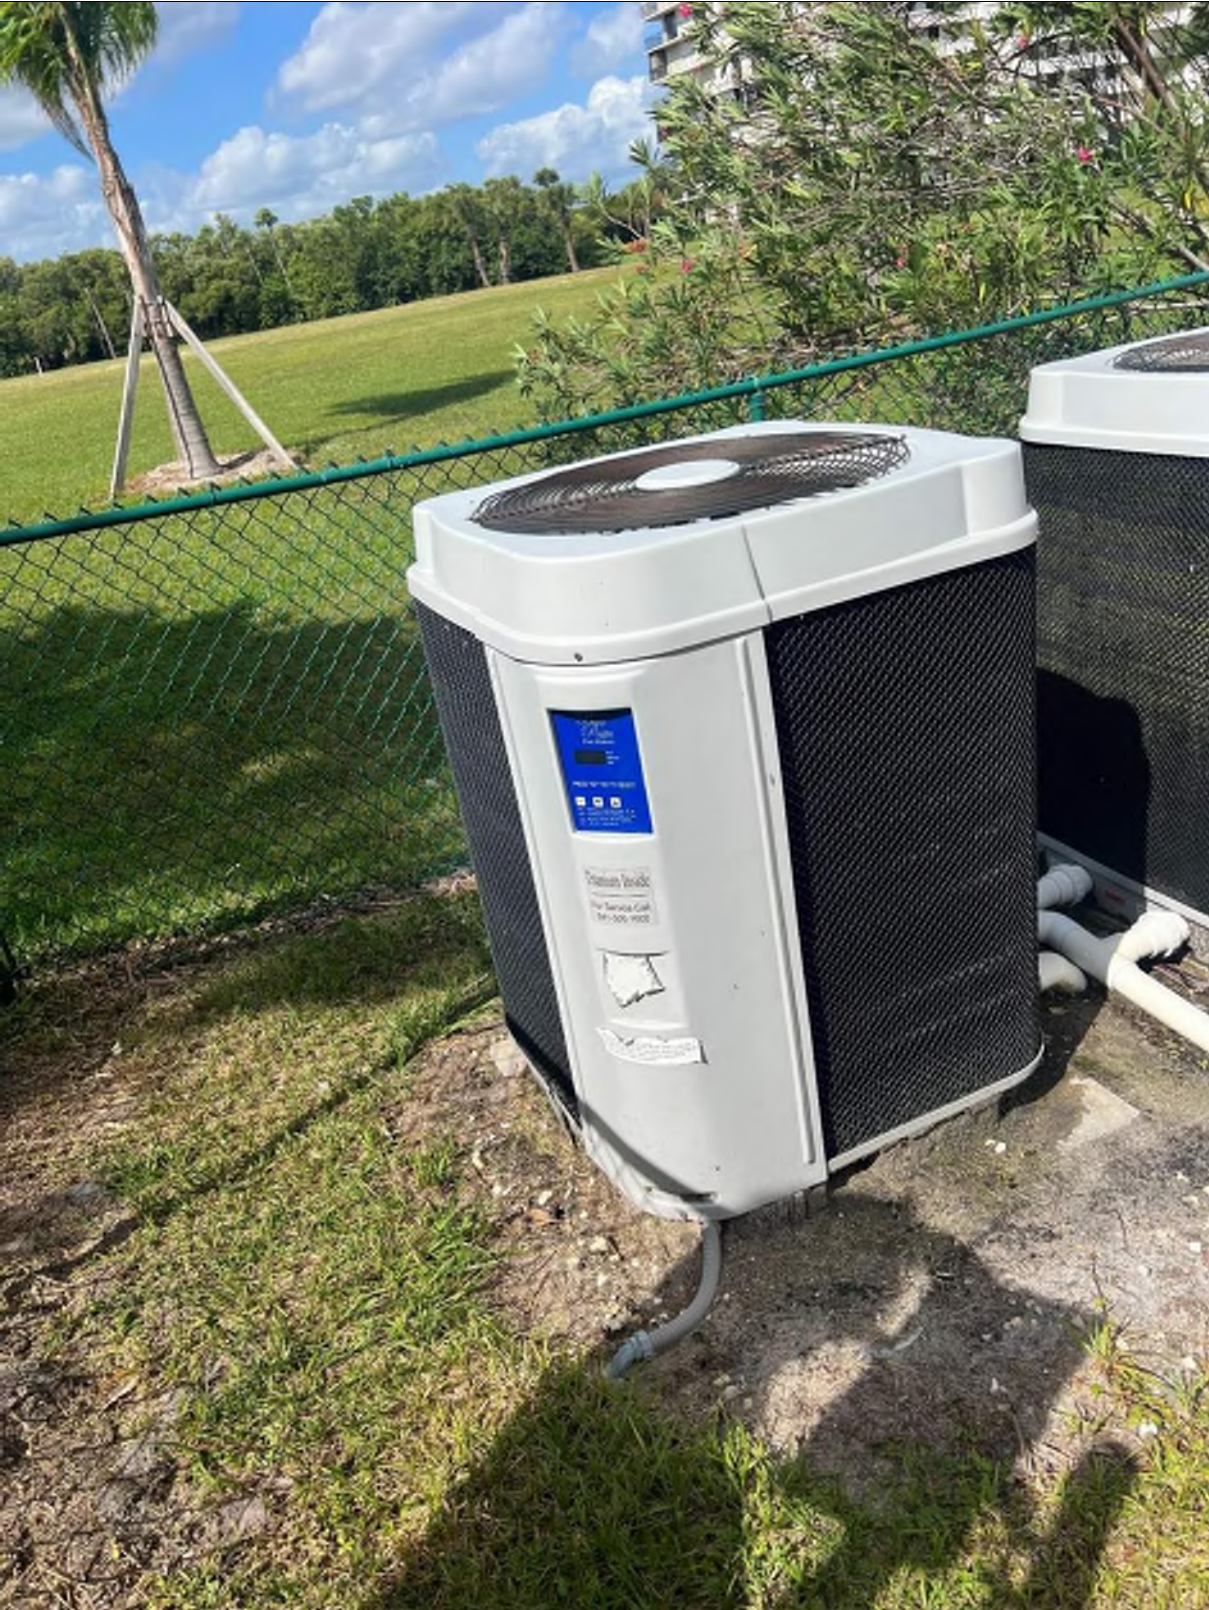
Picture 13.a.13.1

Series by Zodiac gas pool heater. The heaters are in overall good condition. See pictures 13.a.13.1, 13.a.13.2, and 13.a.13.3.
13.a.18. Pool heaters useful life	10 years
13.a.19. Pool heaters remaining life	5 years
13.a.20. Pool heaters – replacement cost	\$18,000

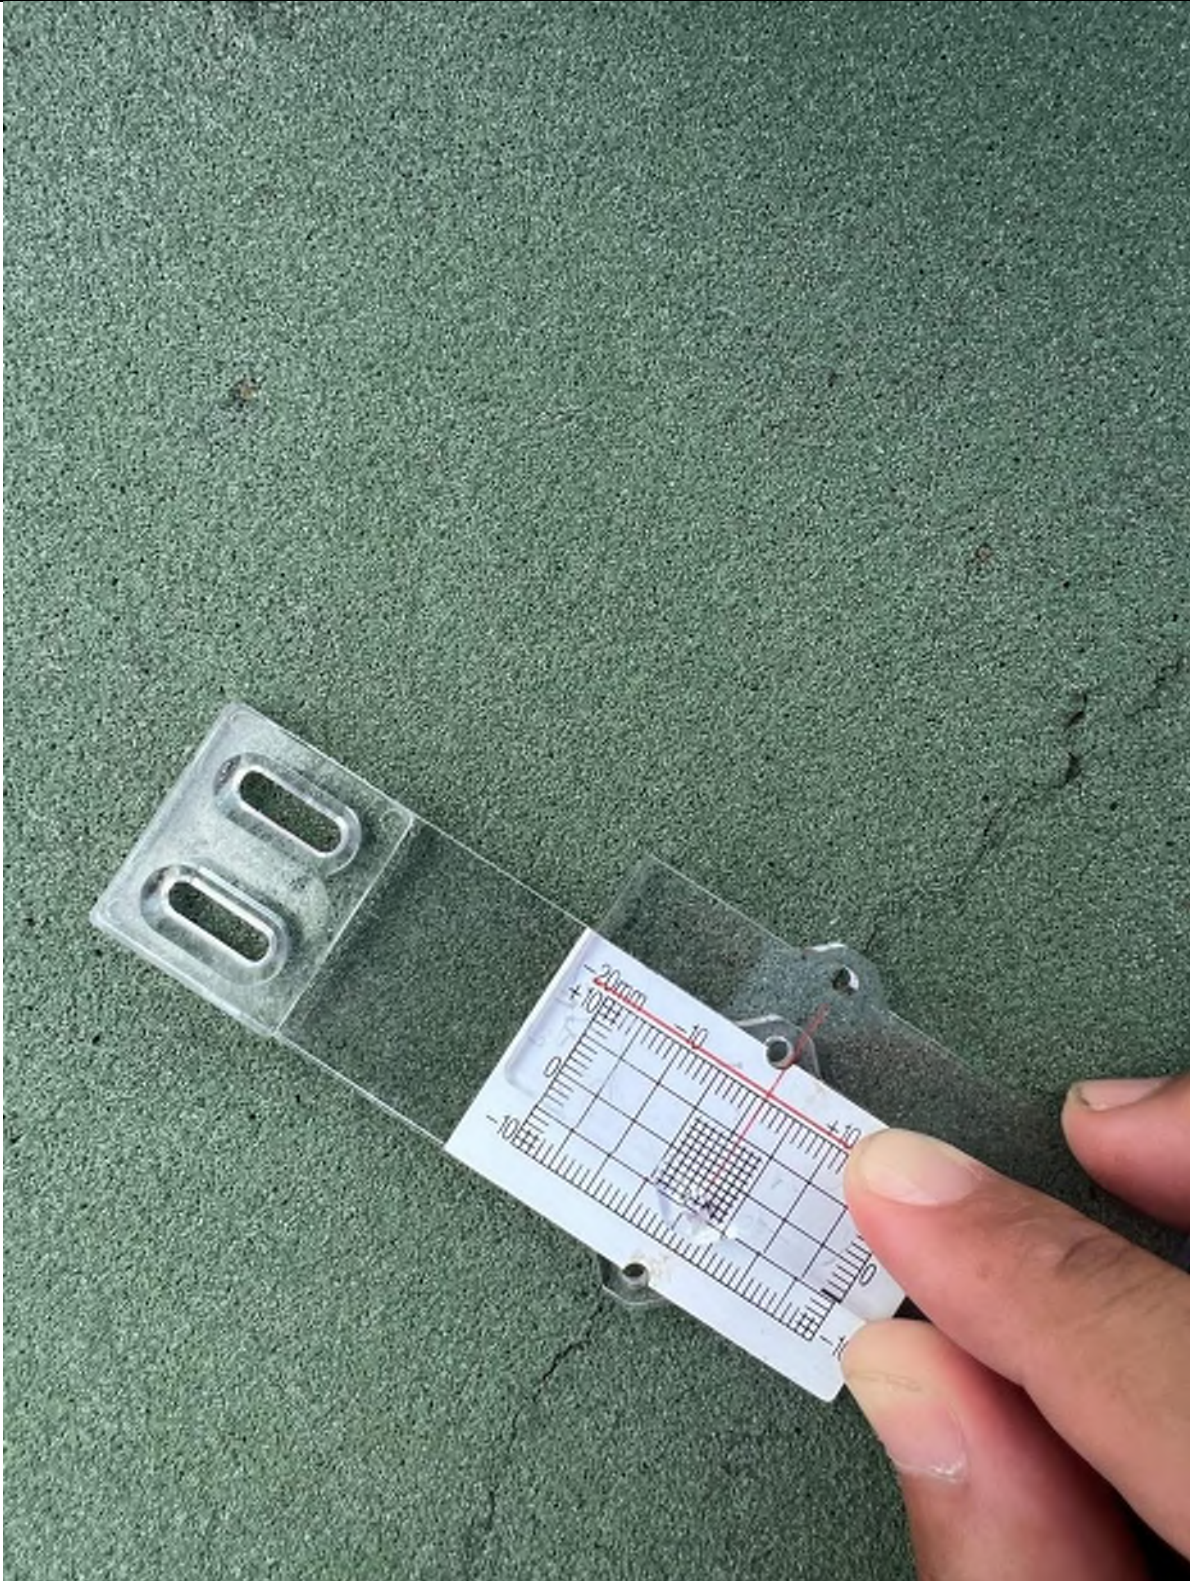
Picture 14.a.1.1

14.a.1. Tennis court, equipment, and fencing condition	Tennis court fencing was replaced in 2015 and is in poor overall condition. There is excessive corrosion, corroded fasteners, and posts are out of plumb. The netting and posts are in fair overall condition. The tennis court surface is cracking throughout. Recommend proper maintenance such as pressure washing tennis court surface. See pictures 14.a.1.1, 14.a.1.2, 14.a.1.3, and 14.a.1.4.

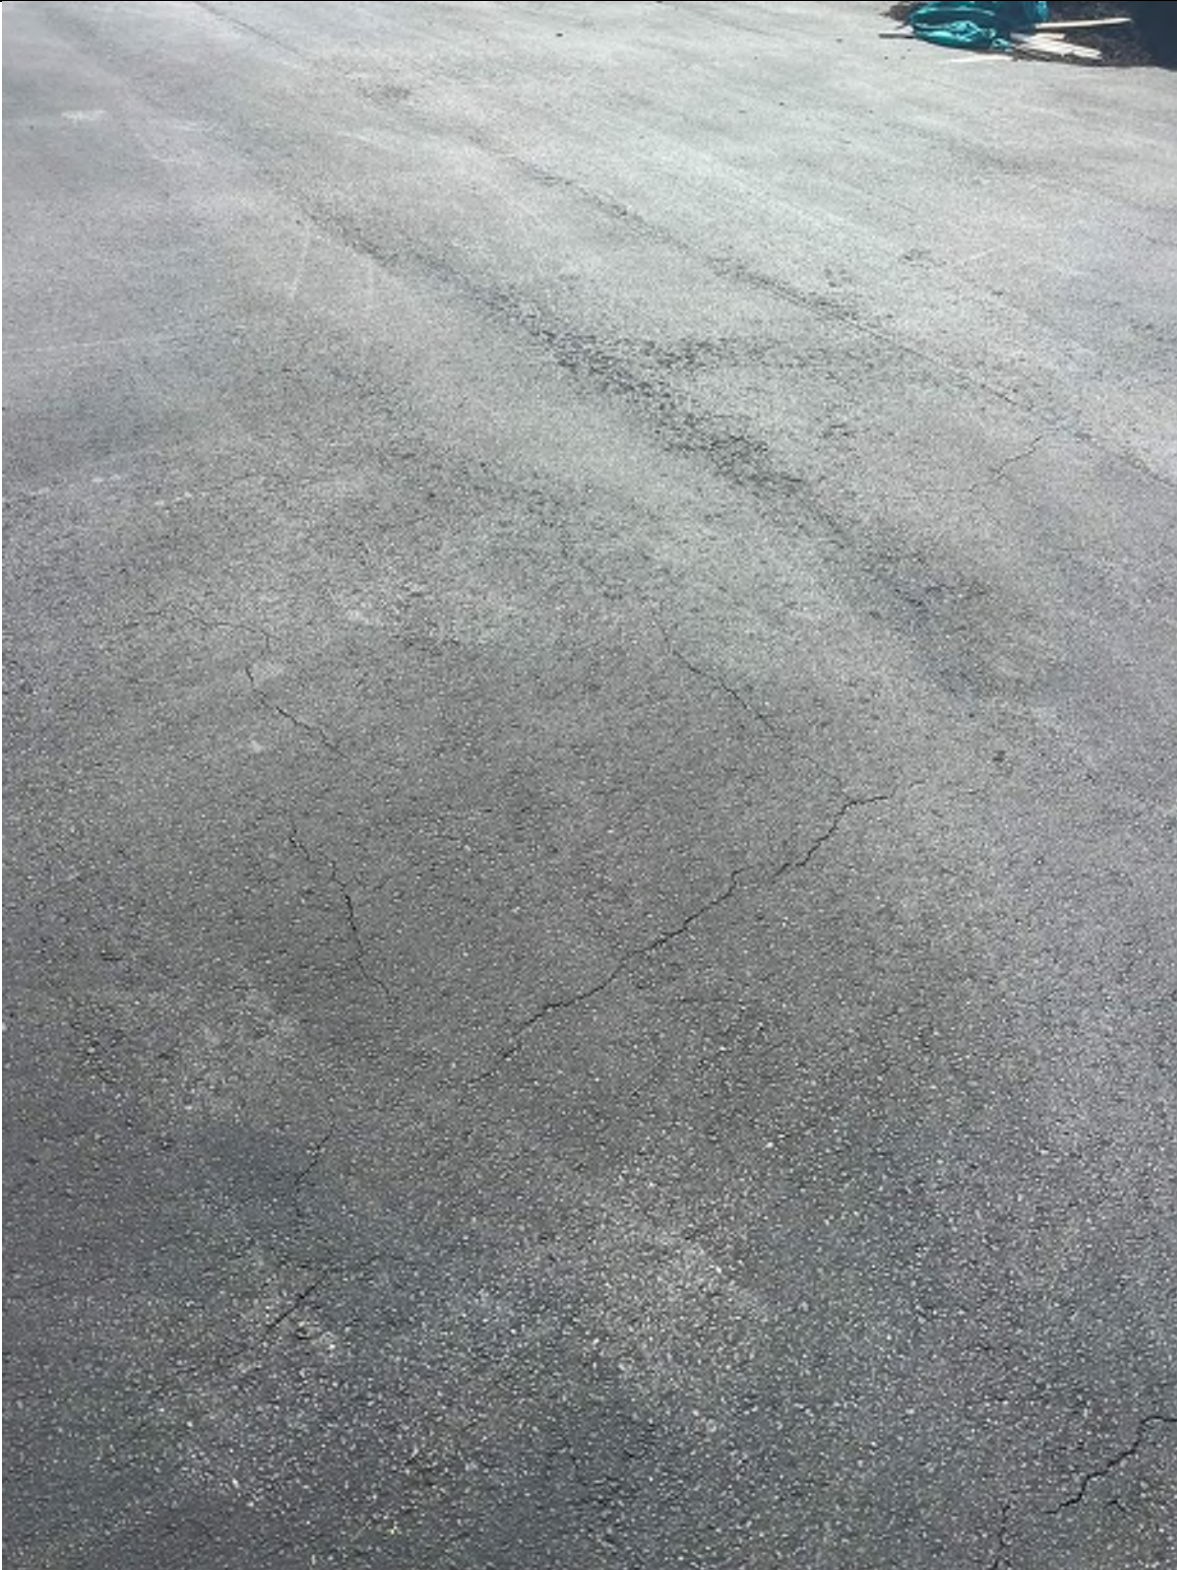
Picture 15.1.1

15. Paving – Non-S.I.R.S. component	
Florida Building Code 2020	
15.1. Driveway and parking area condition	The asphalt surfaces for the driveways and the parking areas are in good overall condition. Paving surfaces were previously resurfaced in 2022. See picture 15.1.1, 15.2.2, and 15.1.3. Recommend to keep roadway free of debris and well drained. Ensure to note and quickly correct any areas where water is ponding or surface is cracking. Cracks shall be addressed quickly so water doesn't penetrate into the subbase and cause further issues.

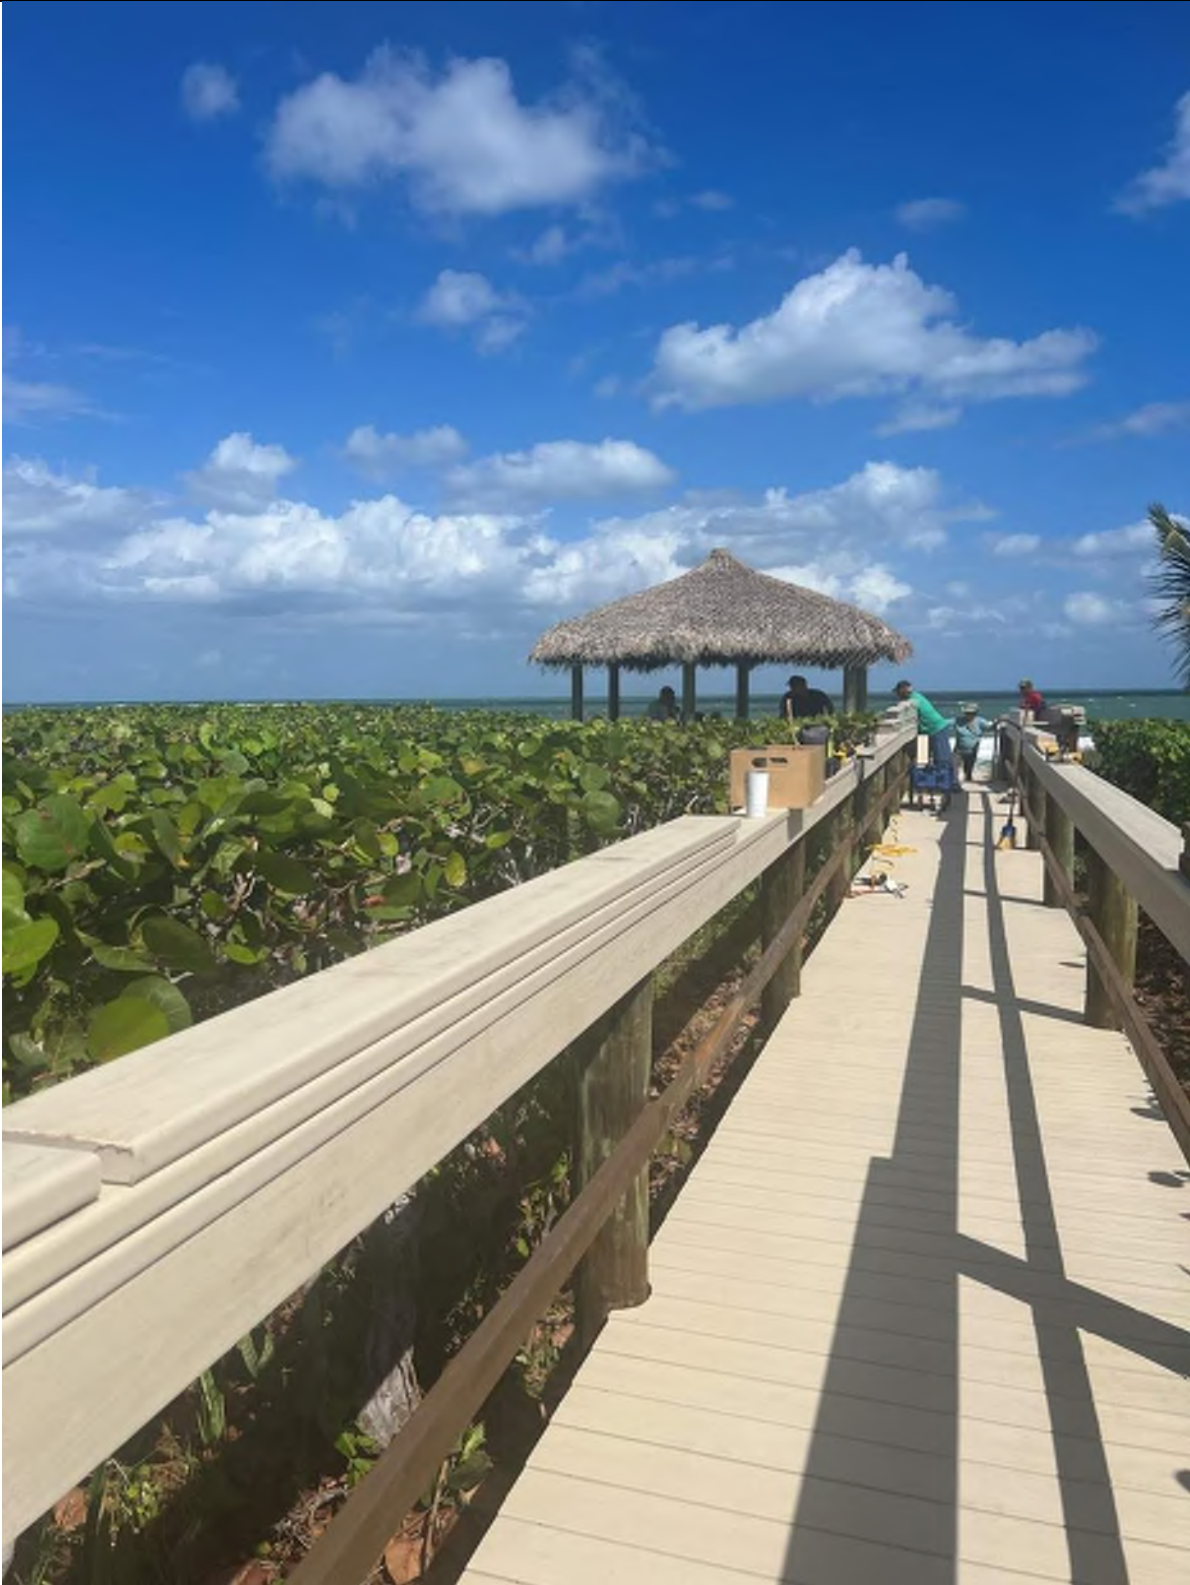
Picture 16.a.1.1

16. Boardwalks – Non-S.I.R.S. components	
Florida Building Code 2020	
16.a.1. Beach boardwalk condition	Beach boardwalk/walkover dune is in good overall condition. The boardwalk railings and gazebo benches were recently replaced with WearDeck in 2023, which is a HDPE material reinforced with fiberglass. See pictures 16.a.1, 16.a.2, and 16.a.3.
