Milestone Inspection Phase I Report

Bryn Mawr Ocean Towers

5055, 5059, and 5061 N Highway A1A

The intention of this report is to develop a substantially completed Milestone Inspection Phase One report per the requirements of Senate Bill 4-D and Florida Statutes 553.899.

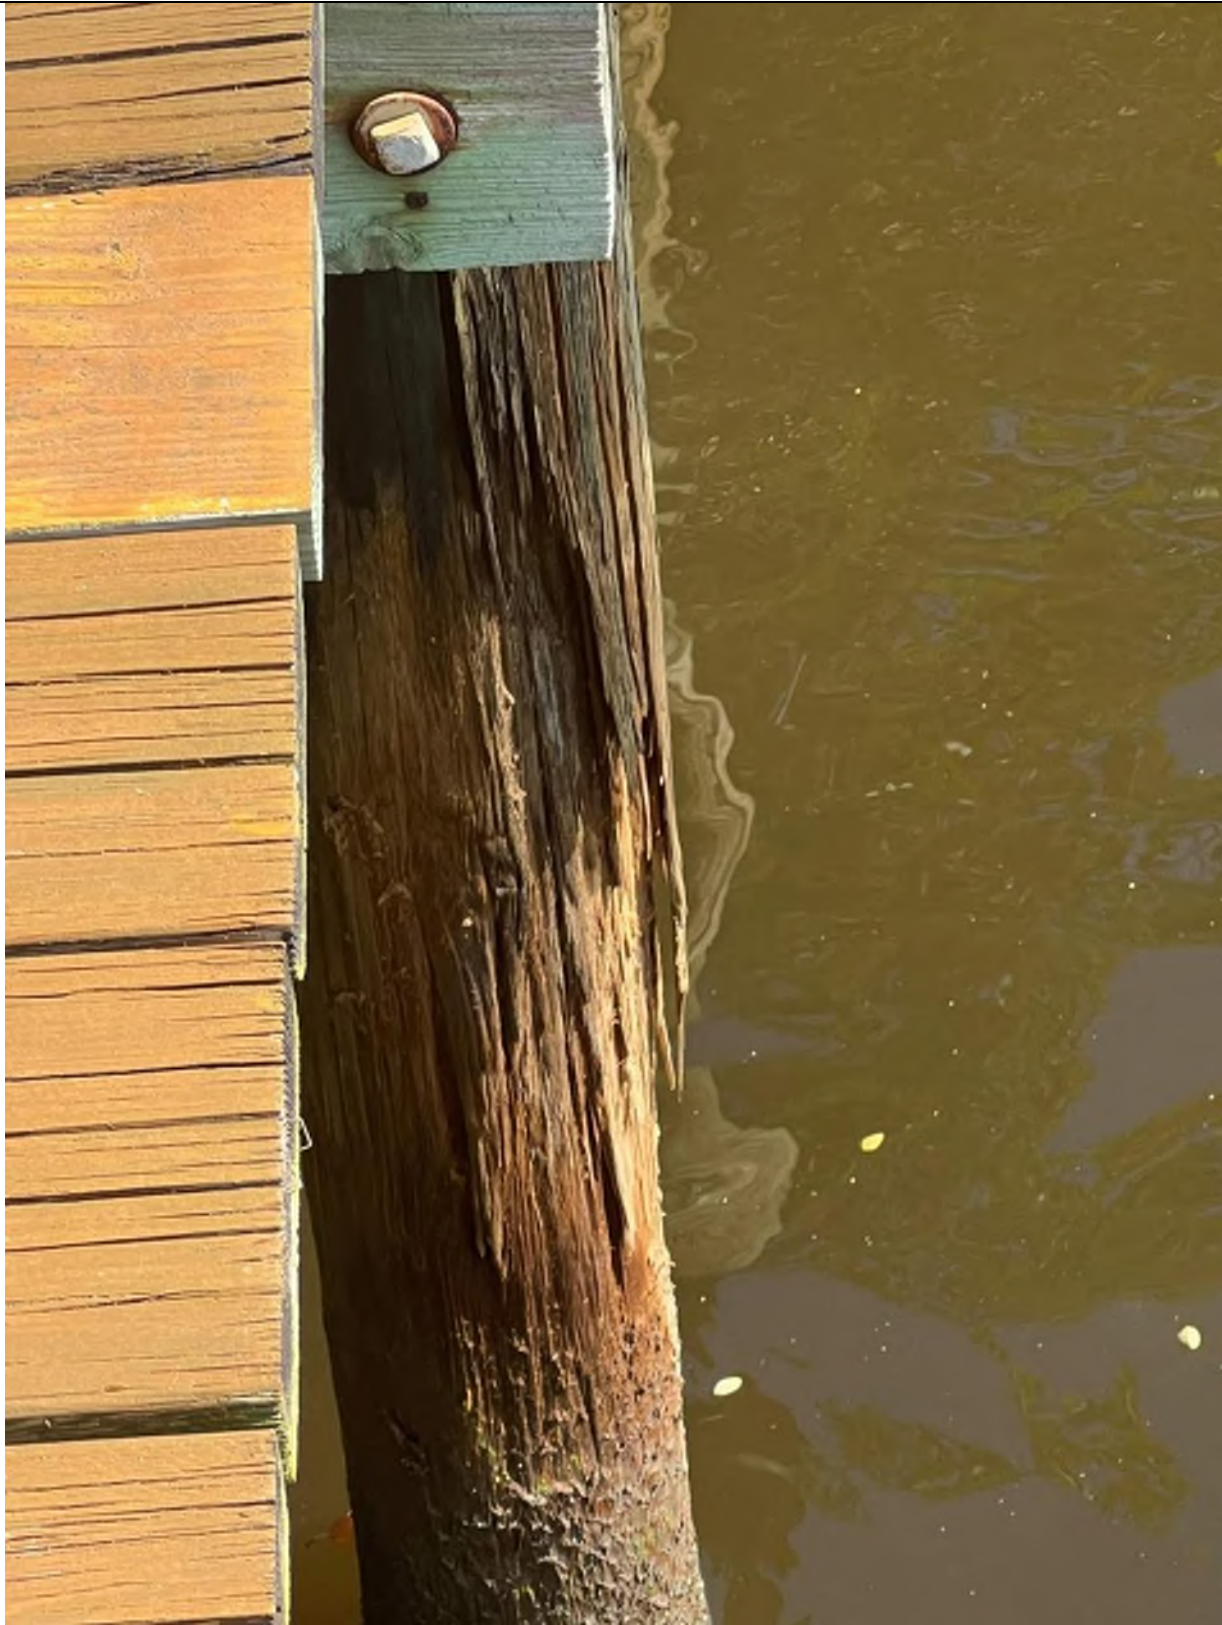
Picture 16.a.5.1

16.a.2. Beach boardwalk useful life	25 years
16.a.3. Beach boardwalk remaining life	25 years
16.a.4. Beach boardwalk replacement cost	\$55,360
16.a.5. West boardwalk at building rear condition	Boardwalk at the rear of building is in fair condition. There are some wood pilasters missing a moderate portion of the cross sectional area and there are wood pieces that are splitting and associated fasteners that have excessive corrosion. Recommend repairing section boardwalk as necessary until the end of the useful life. See pictures 16.a.5.1, 16.a.5.2, 16.a.5.3, and 16.a.5.4.

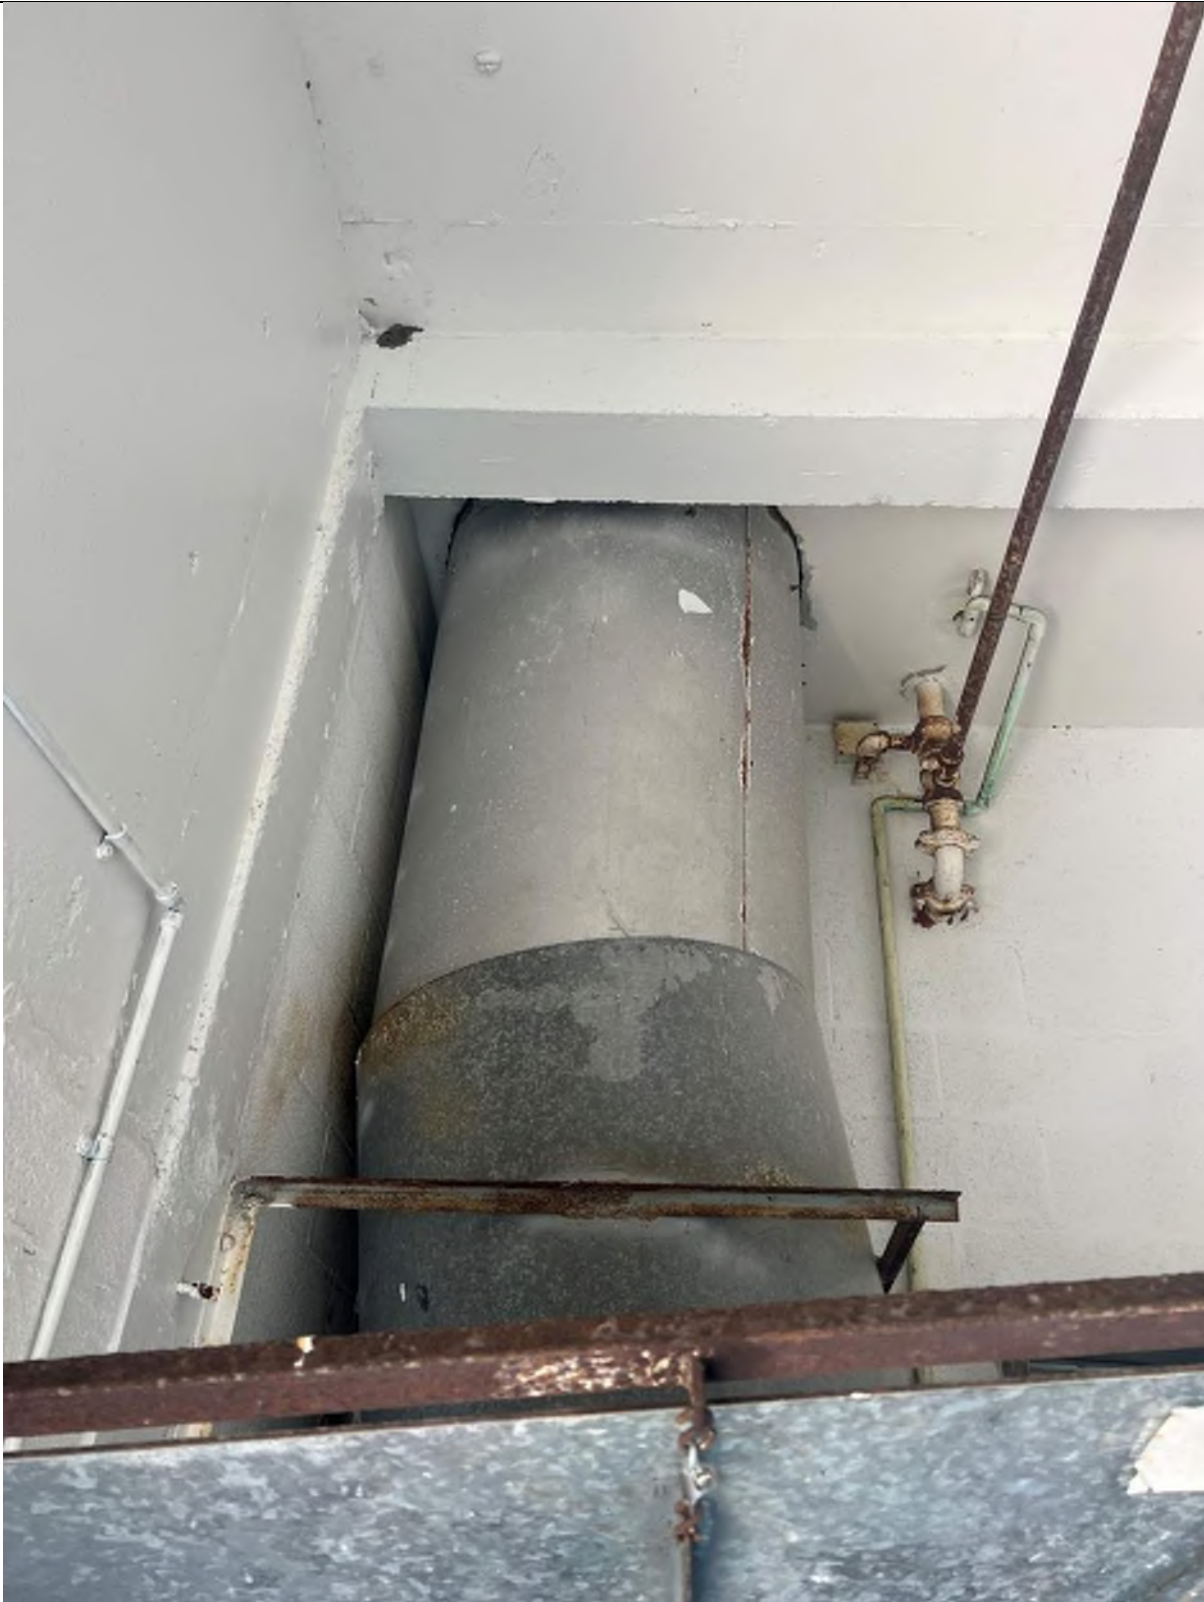
Picture 17.a.1.3

17.c 5059 N A1A (Building C)	
17.c.1. Trash chute condition	The trash chute is a 16 ga aluminized steel chute 30" in diameter with bottom hinged 21"x18" stainless steel intake doors at every floor with a "B" fire rating. There is a 1/8" clear plexiglass top. The trash chutes are in fair overall condition; however, there is oxidation present in the chute as well as the seams and anchors and recommend replacement of trash chute at the end of its useful life. See pictures 17.a.1.1, and 17.a.1.2. The trash chute undergoes preventative maintenance as the system gets flushed out/cleaned once a year. Recommend to repair the pivoted guillotine door at trash room. See picture 17.a.1.3.

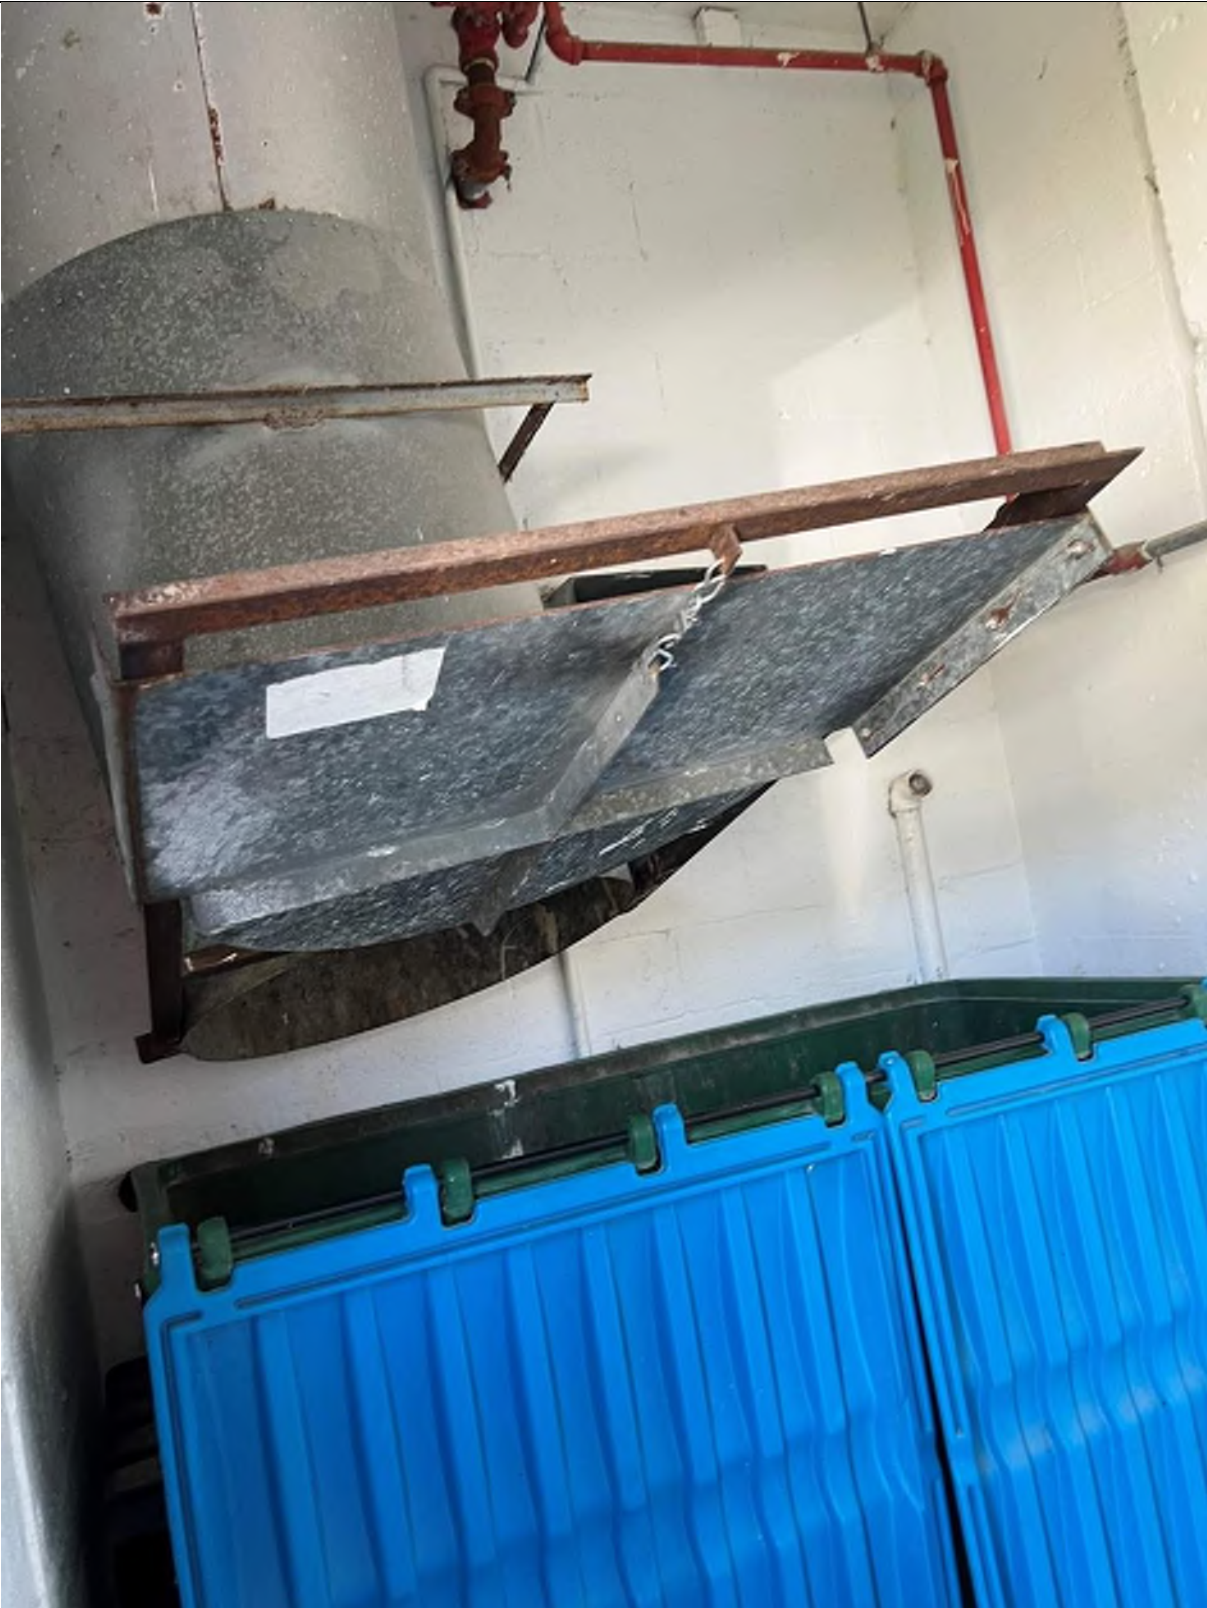
Picture 17.b.1.4

17.b 5059 N A1A (Building B)	
17.b.1. Trash chute condition	The trash chute is a 16 ga aluminized steel chute 30” in diameter with bottom hinged 21”x18” stainless steel intake doors at every floor with a “B” fire rating. There is a 1/8” clear plexiglass top. The trash chutes are in fair overall condition; however, there is oxidation present in the chute as well as the seams and anchors and recommend replacement of trash chute at the end of its useful life. See pictures 17.b.1.1, 17.b.1.2, and 17.b.3. The trash chute undergoes preventative maintenance as the system gets flushed out/cleaned once a year. Recommend to repair

the pivoted guillotine door at trash room. See picture 17.b.1.4.
17.b.2. Trash chute useful life	50 years
17.b.3. Trash chute remaining life	11 years
17.b.4. Trash chute replacement cost	\$60,000/trash chute x (2) trash chutes = \$120,000

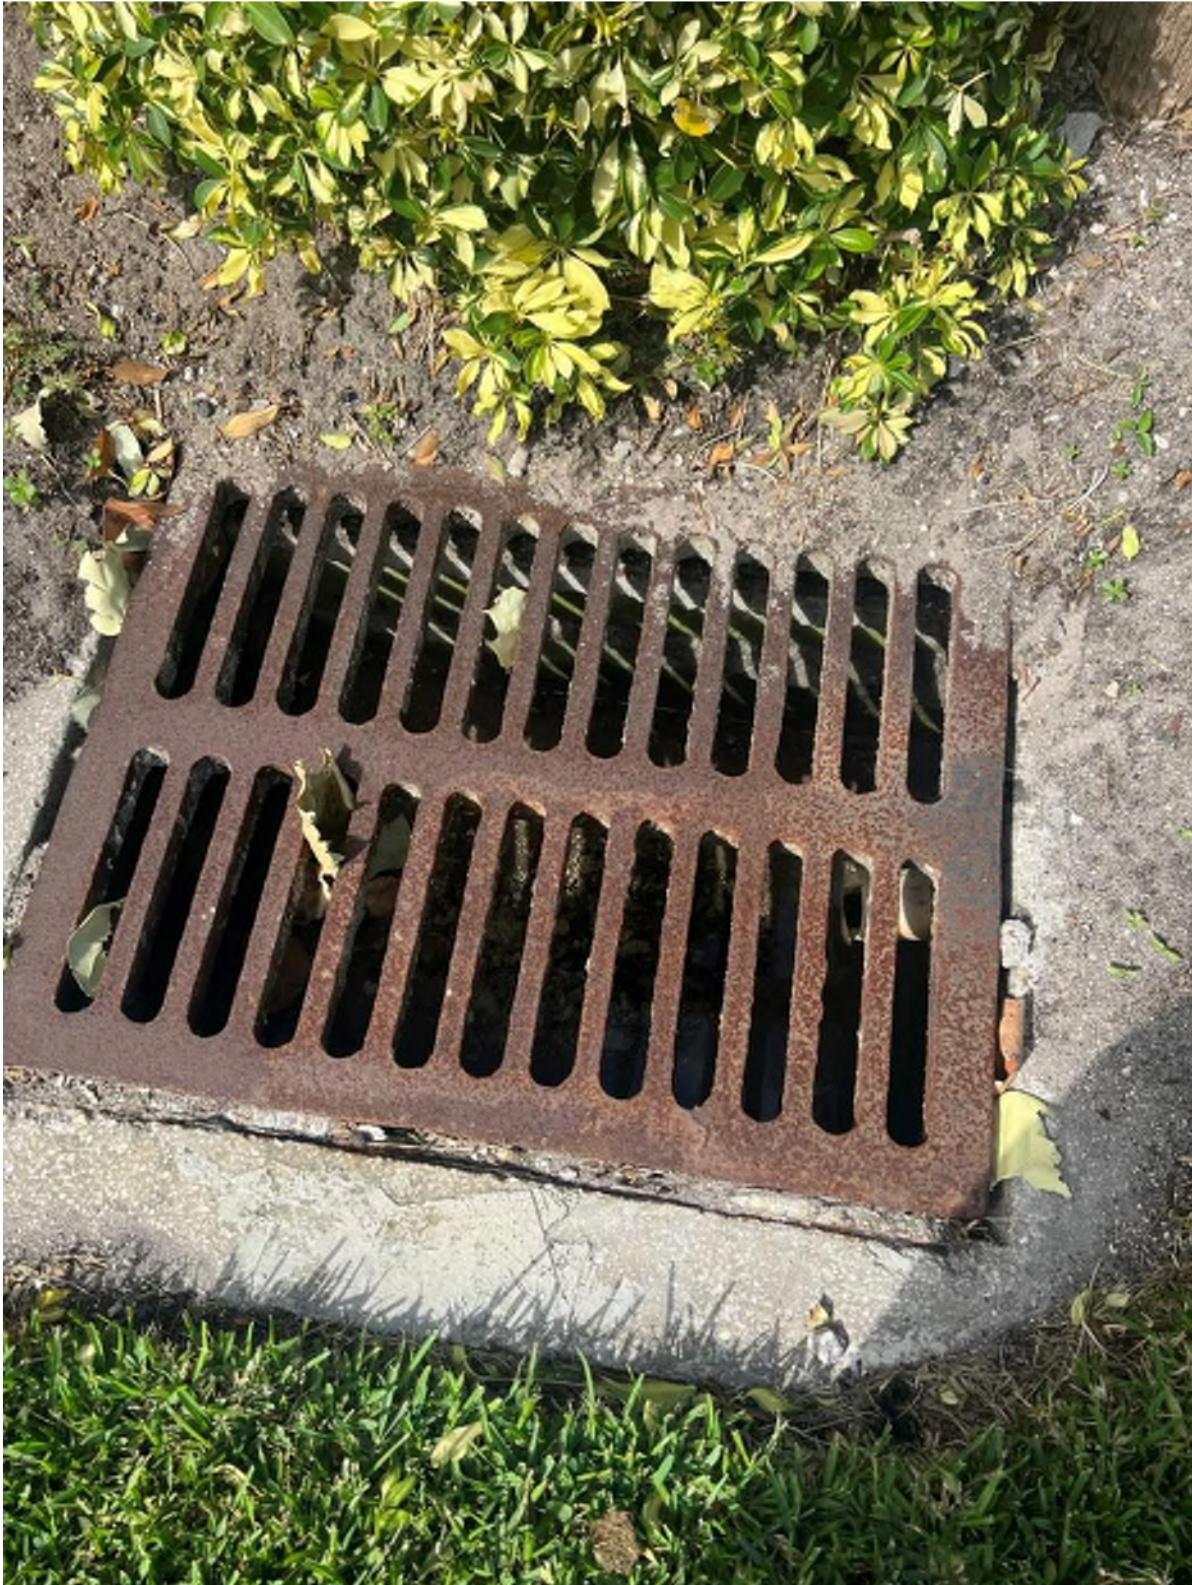
Picture 18.1.1

18. Drainage – Non-S.I.R.S. component	
Florida Building Code 2020	
19.1. Drainage	Drainage consists of type C storm inlets with cast iron grates throughout the parking lot areas. The storm pipe is 12" diameter reinforced concrete pipe (R.C.P.). There is not any evidence of drainage type issues; however, it is recommended to repair damaged sections of R.C.P. as well as jet-vac/flush the entire drainage system. It is possible that king tide can increase the overall water level, but it is advisable to jet-vac/clean the storm lines as it does appear there is a buildup of debris. See pictures 19.1.1, 19.1.2, 19.1.3, and 19.1.4.

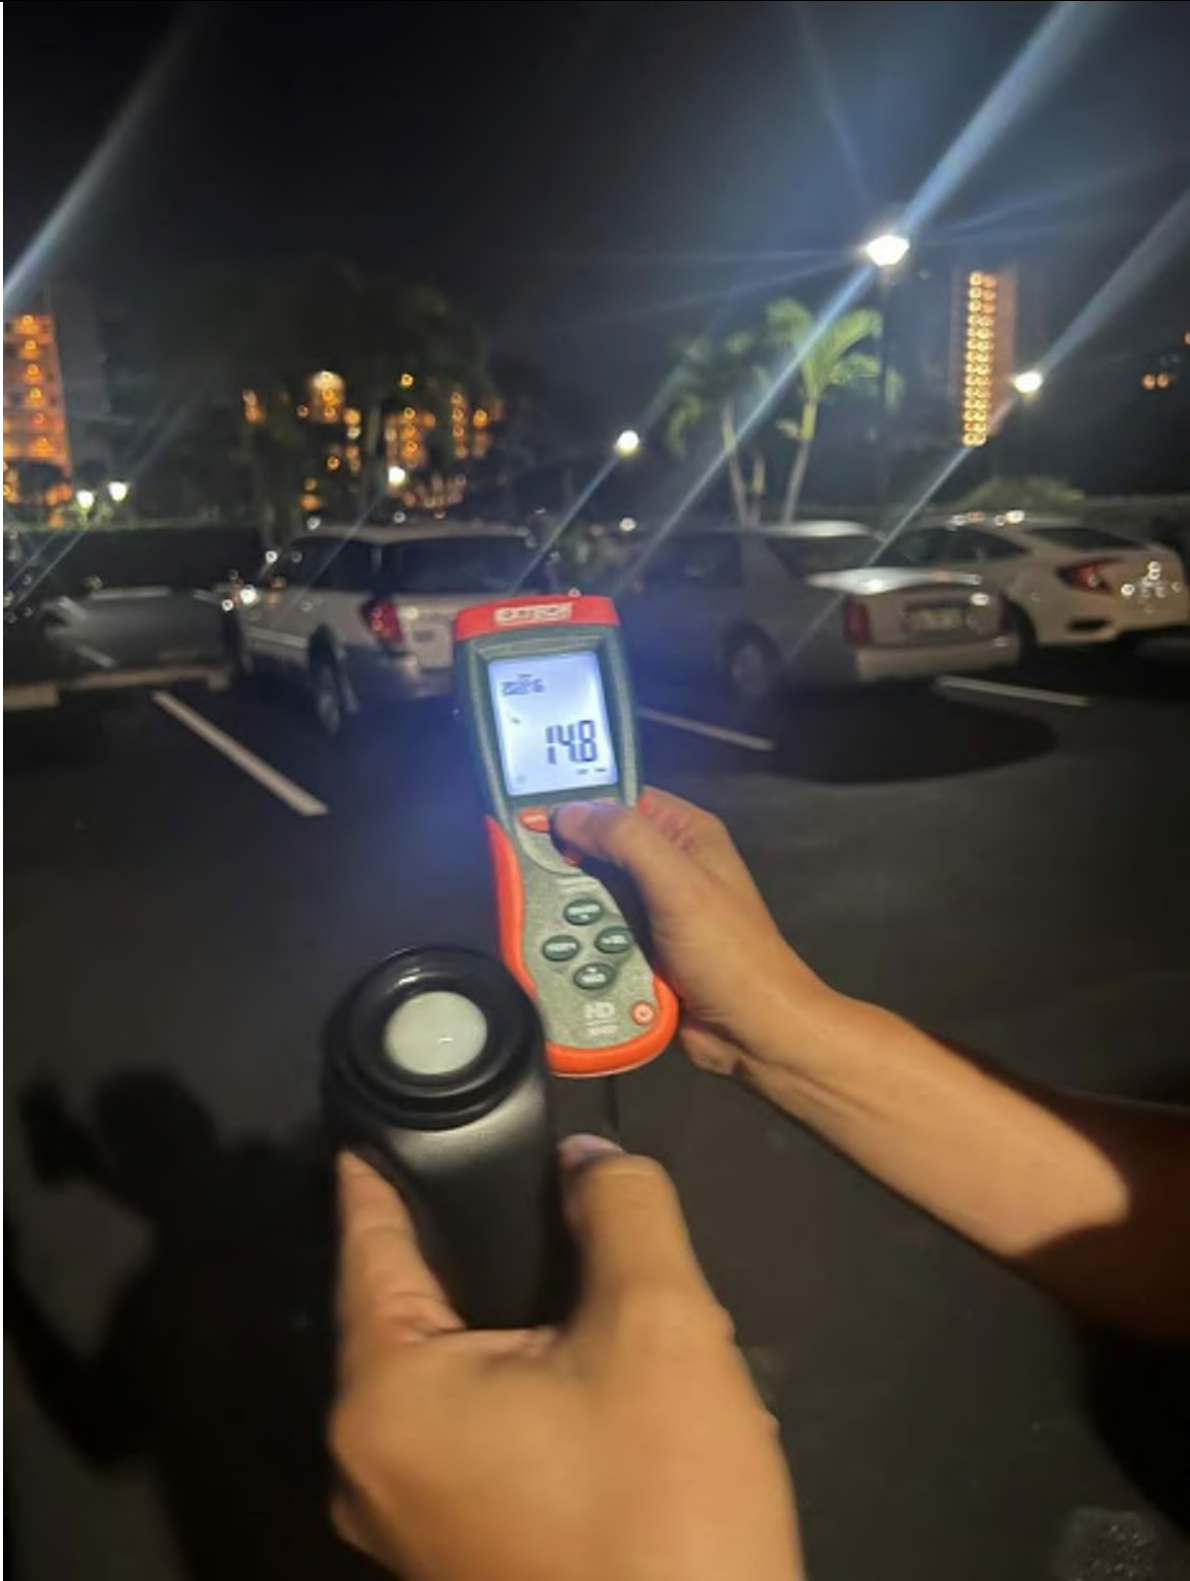
Picture 19.1.1

<p>19.1. Site luminescence</p>	<p>On October 24th at approximately 8:30pm, an Extech light meter was used to the site lumens in foot candles of the parking lot areas. All areas measured met the minimum of .5 footcandles (fc) with the average lumens exceeding 1.0 footcandles (fc). The parking lot and entryway lighting meet the minimum requirements of the St. Lucie County Municipal Code. See pictures 19.1.1, 19.1.2, and 19.1.3. See the site plan and close up views of the areas where light meter was used on picture 19.1.4, 19.1.5, 19.1.6., and 19.1.7</p>
<p>19.2. Walkway/building lights</p>	<p>All lights are in good working order, including the emergency lights and entrance lights. Lights are in overall fair condition. See picture 19.2.1, 19.2.2 and 19.2.3</p>
<p>19.3. Walkway lights useful life</p>	<p>20 years</p>
<p>19.4. Walkway lights remaining life</p>	<p>10 years</p>
<p>19.5. Walkway lights replacement cost</p>	<p>360 lights for property x \$100/light fixture - \$36,000</p>

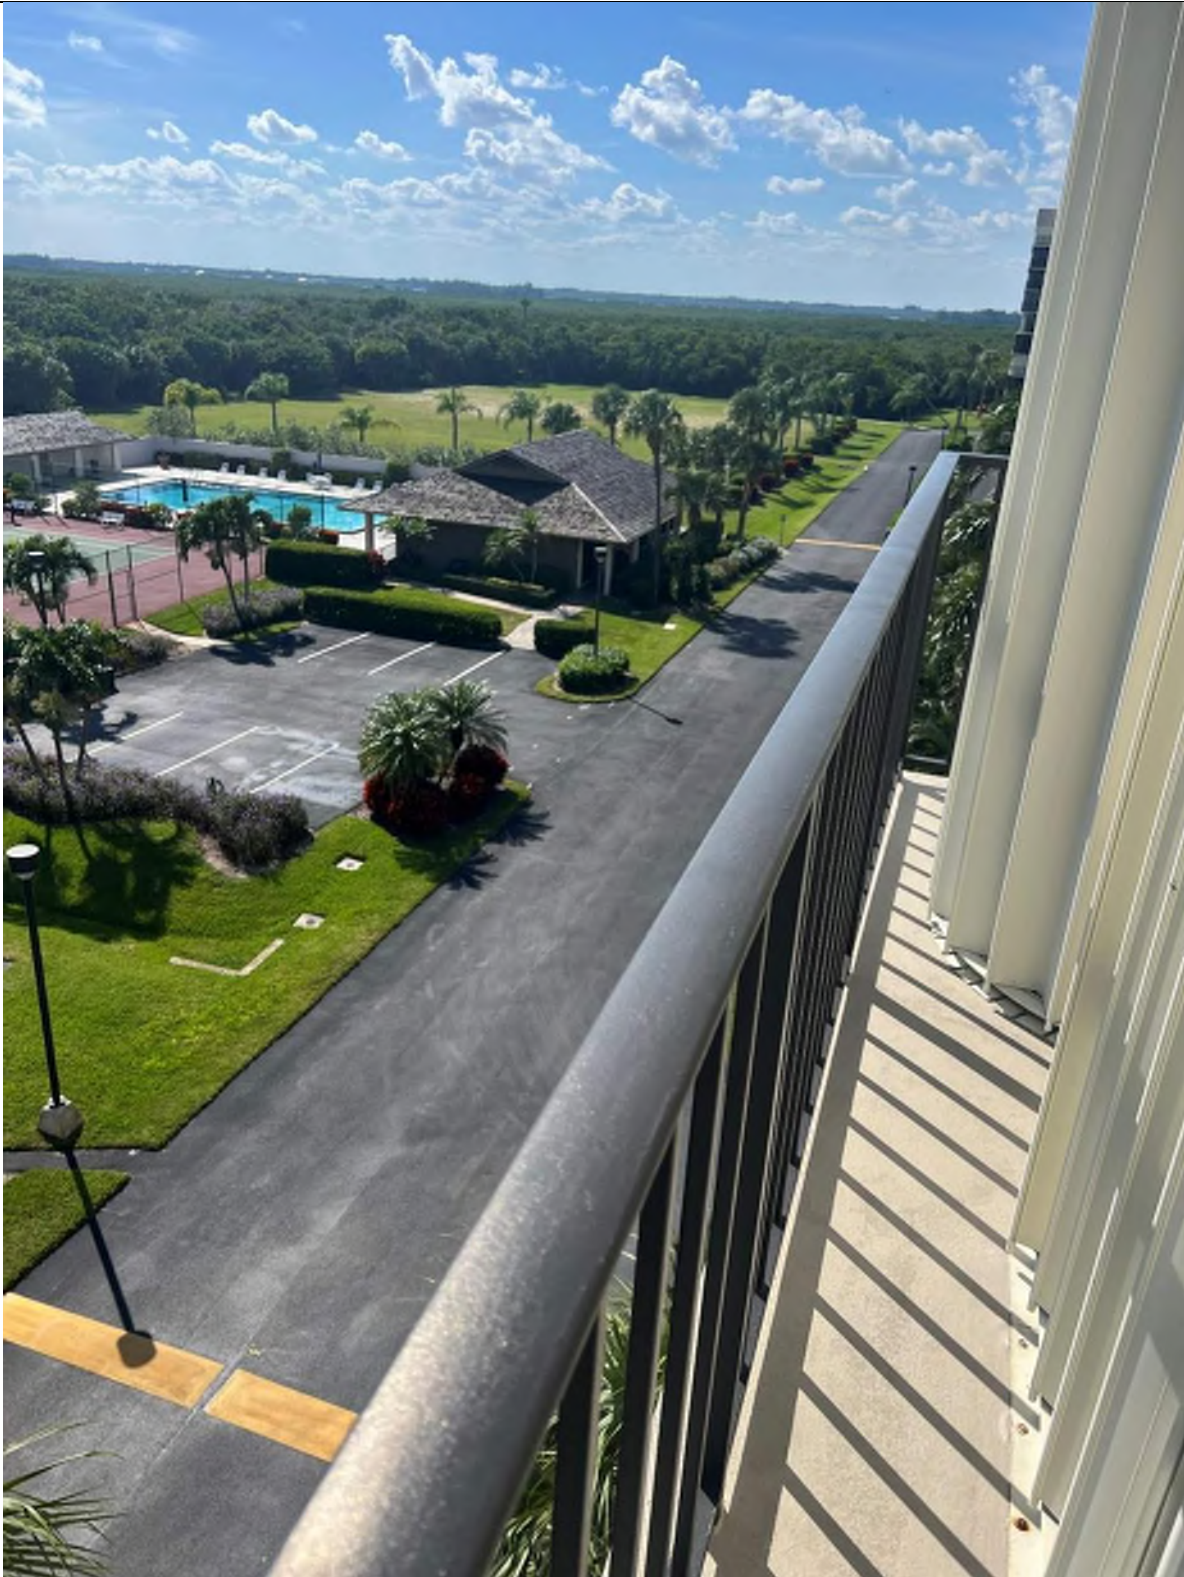
Picture 20.a.1.1

20.a.1. Aluminum railings condition	Overall fair condition. Railings exhibit some signs of wear and age; however, the railings appear to be well cared for and regularly painted, which extends the useful life of the railing. See pictures 20.a.1.1 and 20.a.1.2

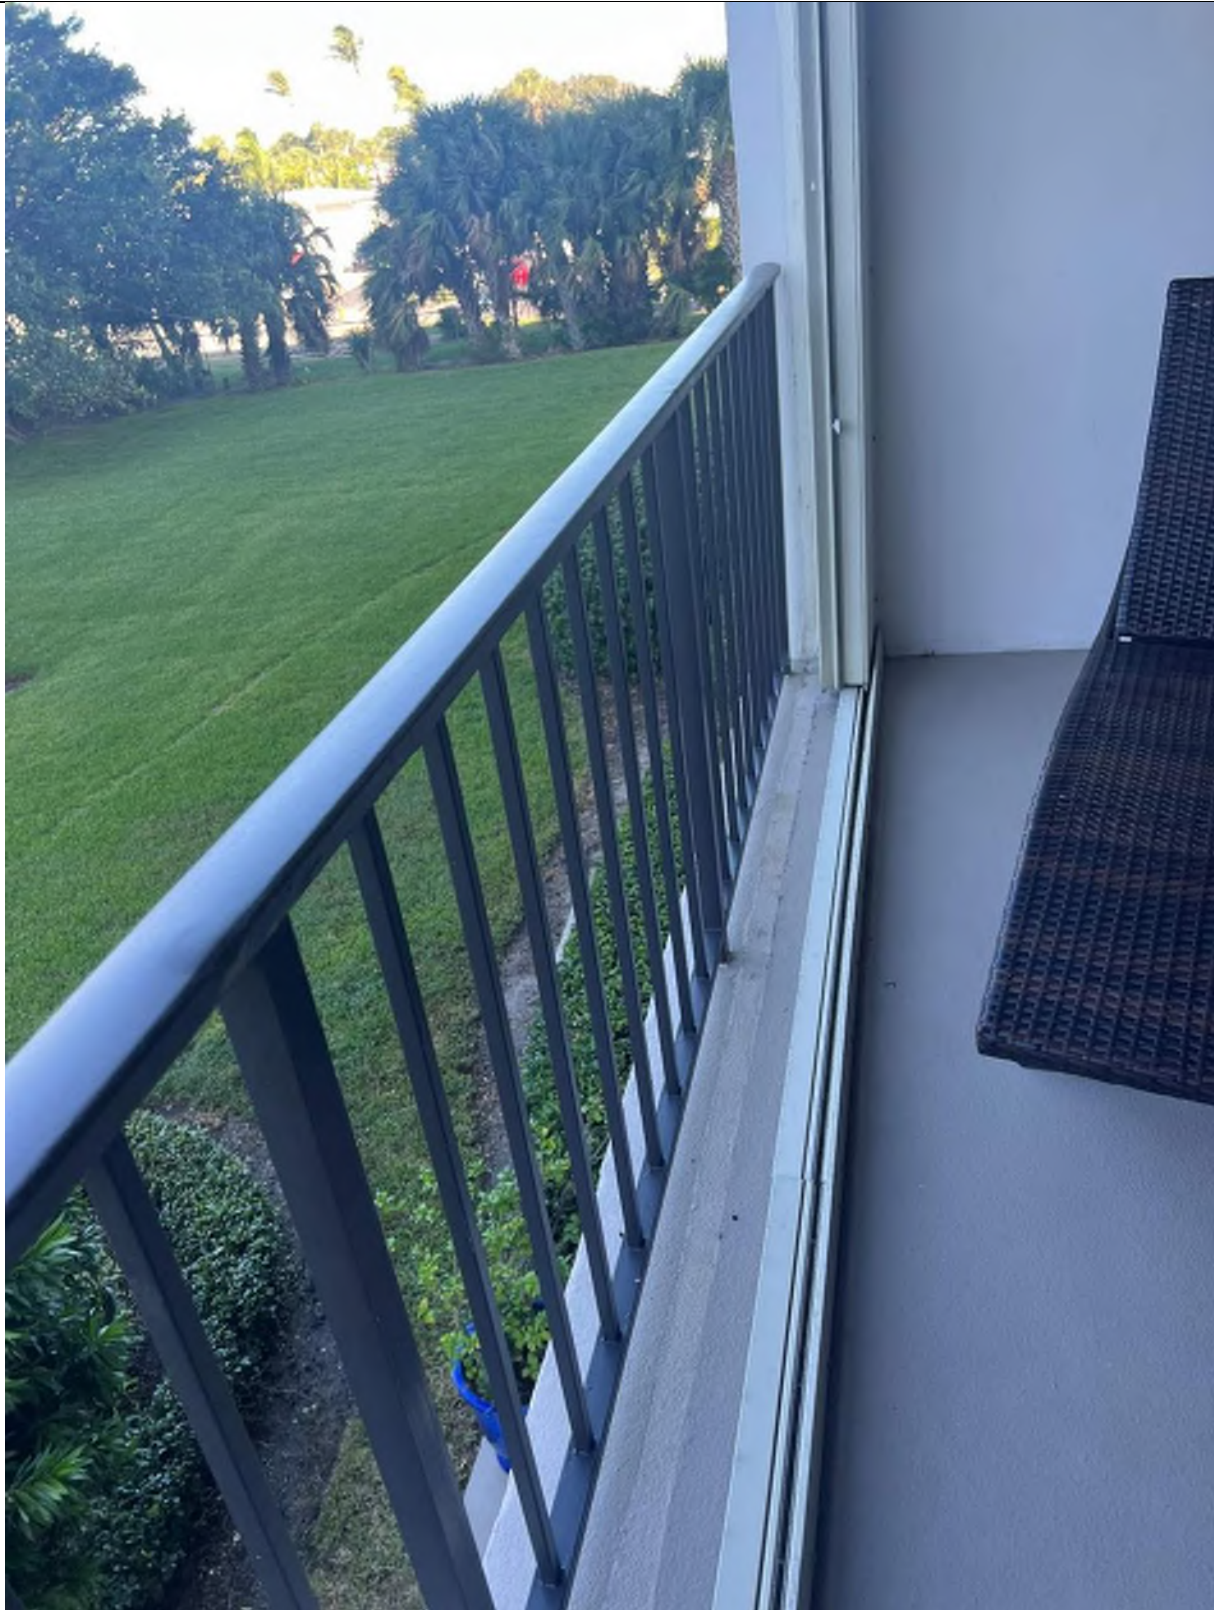
Picture 20.b.1.1

20.b. 5059 N A1A (Building B)	
20.b.1. Aluminum railings condition	Overall fair condition. Railings exhibit some signs of wear and age; however, the railings appear to be well cared for and regularly painted, which extends the useful life of the railing. See picture 20.b.1.1

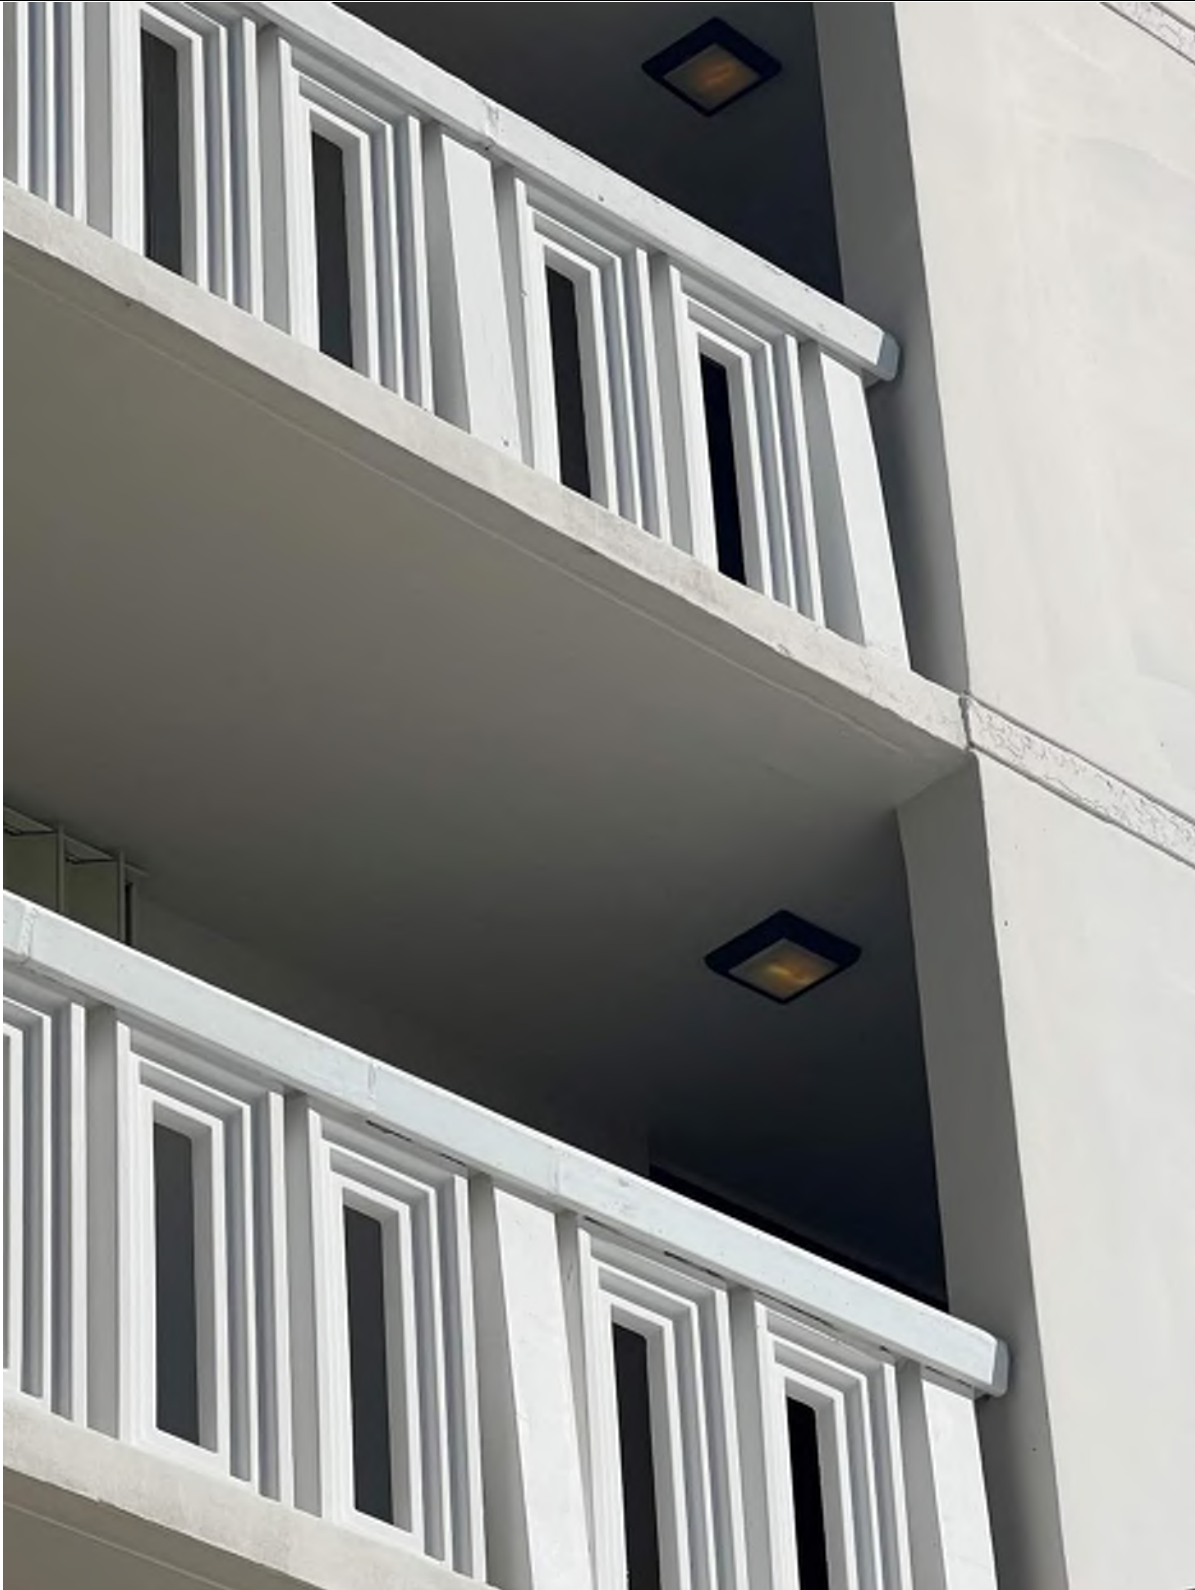
Picture 20.b.5.1

20.b.5. Precast concrete railings condition	Overall fair condition. Railings are regularly repaired and painted so as to not allow for the railings to deteriorate. Recommended repairing as necessary with full restoration of the railings every (10) years minimum. See picture 12.b.5.1 and 12.b.5.2.
