# Pointe West Community

## Tree Infrastructure Impact Assessment

Pointe West HOA Tree Assessment

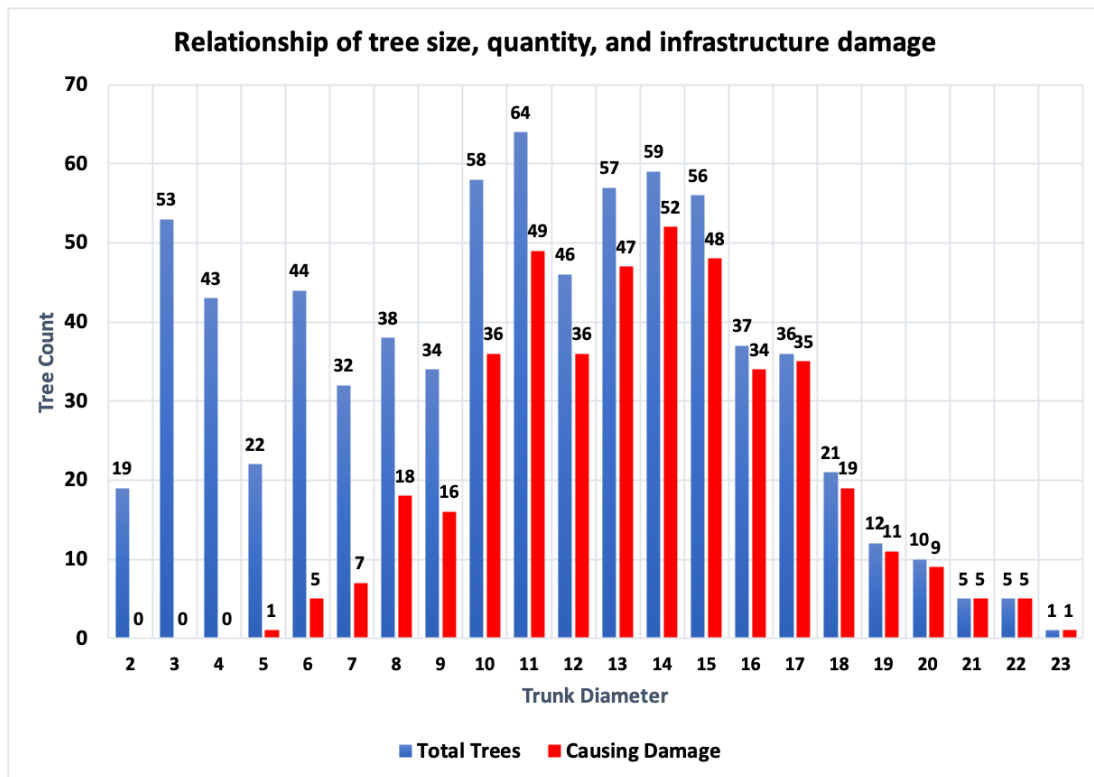
Table 2. A visual representation of the comparison of damaged trees within Table 1.

Of the 752 trees assessed, 434 trees have caused some form of infrastructure damage (Table 1). The majority of observed infrastructure damage is lifting sidewalk slab, many of which have been mitigated by concrete grinding. A further breakdown of the data shows that 418 trees are causing or have caused some degree of sidewalk lifting (Table 3). One hundred and thirty nine trees are causing valley gutter and/or street damage (Table 3).

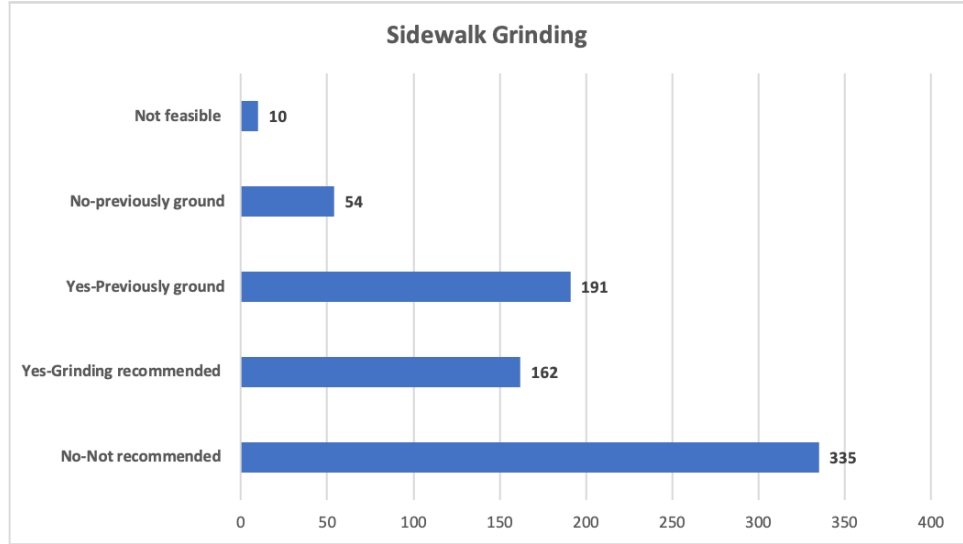
*Table 4. This table represents the analysis of past present and future sidewalk maintenance.*

effort has failed and the trip hazard has recurred. This also indicates that a decision must be made for future maintenance after the second and final slab grinding has failed. Trees categorized as “yes” indicates a first phase of grinding should take place. “Not feasible” means that grinding is no longer a viable option due to the current extent of damage and other, more involved root mitigation options must now be employed. “No-not recommended” means that there is either no lifting taking place or the lifted slab has not reached 1/4 inch in vertical height at the time of analysis.
